SERVICE BULLETIN

No. 425

Piper Aircraft Corporation

Subject: Replacement of Wing Spar Center Section Bolts

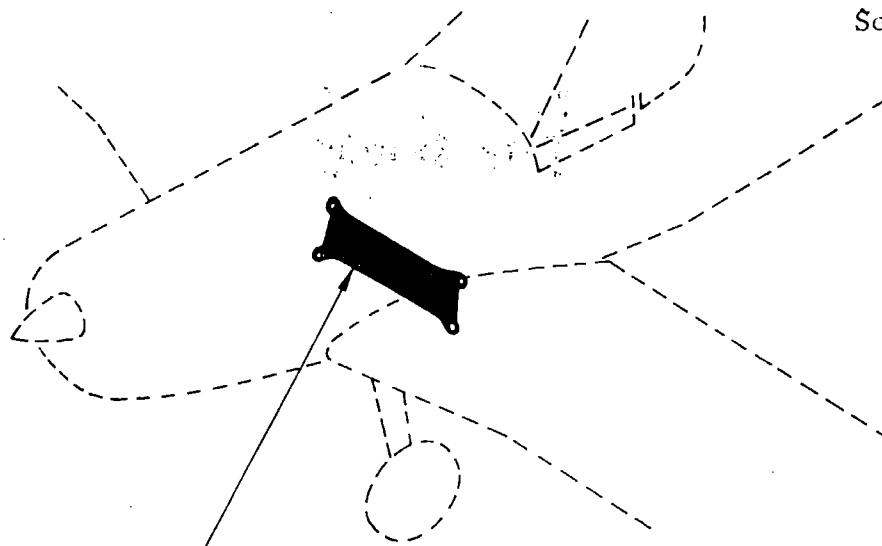
Carry Through Spar Assembly
(Refer to Detail "A" below)

Purpose: To inspect the bolt holes in the corners of the wing spar center section to insure that the holes have not become elongated and to replace the attachment bolts and associated hardware that correspond to the corner wing spar center section attachment points. (The attached sketch/instruction sheet visually depicts this area.)

1. Remove the four bolts from the corners of the wing spar center section and discard.
2. Inspect and record size of each of the four holes.
3. Enlarge these four holes to 5/16 of an inch plus .005 inch - .001 inch diameter. NOTE: If a maximum hole size of .318 inch does not eliminate evidence of elongation, contact the Customer Services Department, Vero Beach, Florida, for further information.
4. Install appropriate attachment bolts and associated hardware supplied in Piper Kit No. 760 871V, Spar Assembly Carry Through Corner Bolts Replacement, and torque to 100/140 inch pounds at the nut.
5. Make appropriate log book entry.
6. Return the service release compliance card (enclosed) with a record of hole sizes recorded per Instructions No. 2, above.
