# SERVICE BULLETIN

161A

Piper Aircraft Corporation

SUBJECT: Fire Hazard

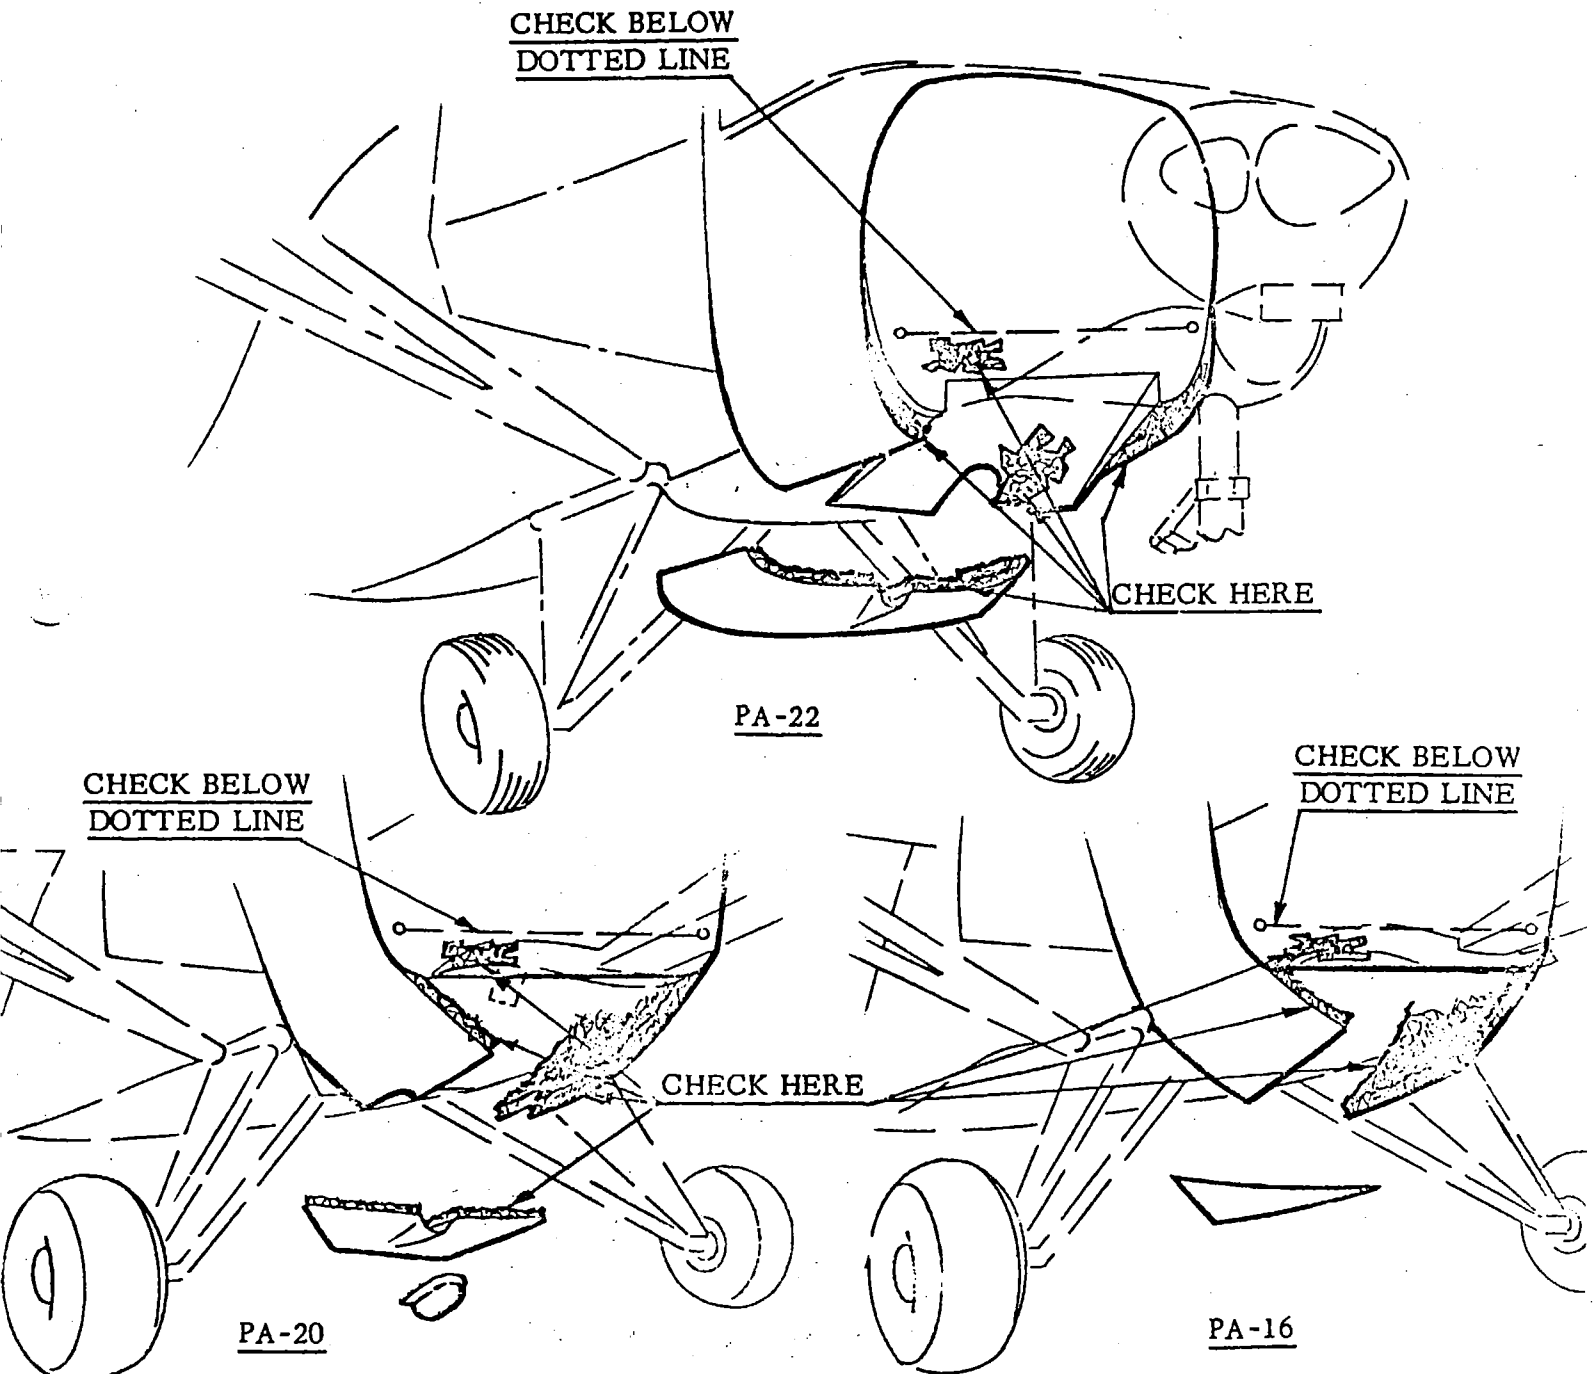
• SERVICE BULLETIN NO. 161A

To preclude the possibility of in-flight fires, the following inspection and rework is necessary to eliminate combustible material and possible ignition sources from the area aft of the firewall underneath the forward cabin floor. Access to this section may be gained by removing the metal panels or opening the fuselage side cowl panels rearward of the firewall underneath the aircraft as shown in sketches on reverse side.

Remove and/or open panels as above. Remove and discard any sound-proofing material contaminated with engine or hydraulic oil or any sound-proofing which has the plastic septum separated from the fiberglass or showing signs of drying or cracking. Replacement of a discarded blanket may be made with equivalent fiberglass. Inspect for chafing of wire insulation and replace any inferior electrical wiring. Check for reasonable clearance between hydraulic lines, electrical wires, control cables and fuel lines and provide clearance if necessary.

3. Upon completion of the above, apply a sufficient quantity of B. F. Goodrich non-hardening putty No. 21 or other acceptable aircraft materials between firewall and fuselage cowl blanket to assure an airtight seal when reassembling the opened and removed panels. Non-hardening sealing material is available through your distributor or local aviation supply house.
