VSP-33
December 18, 1981

VENDOR SERVICE PUBLICATION

To: All Piper Distributors and CORPAC's
Subject: Bendix Service Bulletins 611, 616, 617, 619

Part 1. Addition of moisture drains and sealing of vent screens in S-1200 Series Magneto Covers.

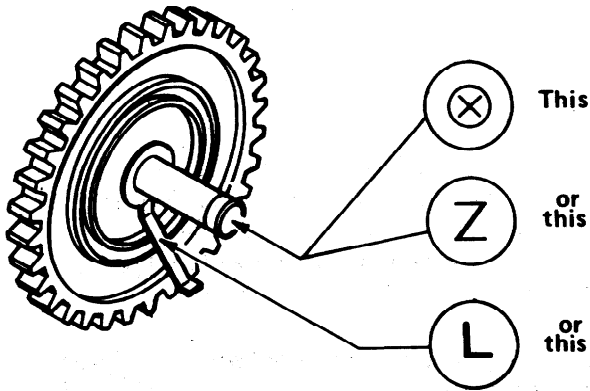
Figure 2. Location of Identification Mark(s)
on Distributor Gear

Field reports indicate that the distributor gear electrode has been found to be loose on some D-2000/2200 series magnetos. If this condition exists, the distributor gear electrode may contact the distributor block stationary electrodes causing contamination in the distributor in the form of dusty brass particles. This contamination may cause arcing within the distributor resulting in misfiring. This could in turn cause rough engine operation or cylinder or engine damage.

hours or at the next regularly scheduled inspection, whichever occurs first, and reinspected every 100 operating hours until the magneto has 500 operating hours. If the gears fail the inspection they must be replaced immediately with new, serviceable gears; if they pass each inspection they may remain in service until magneto overhaul, at which time they must be replaced with new, serviceable gears. At owner's option, gears that pass inspection may be replaced at any time during the compliance period with new, serviceable gears as identified in this paragraph and figure 2. Serviceable gears are identified by the presence of the letter "z" or the letters "x" and "o" appearing together, laser etched on the retaining ring end of the gear axle, or the letter "L" stamped on the electrode (see figure 2).

1. Remove cover from magneto and inspect the retaining ring end of the distributor gear axles for the letter "z" or the letters "x" and "o". (The letter "x" may or may not be circled by the letter "o".) If the letter "z" or the letters "x" and "o" together are laser etched on the end of the axles, the gears are serviceable and the cover can be reinstalled. Identify the magneto per

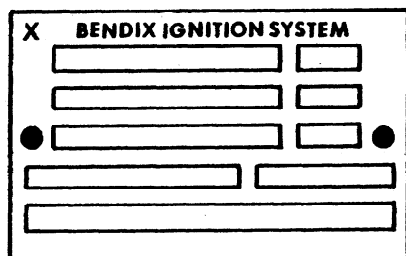
Figure 1. Location of "x" on Identification Plate

All D-3000/3200 Series (blue) Magnetos with Serial Numbers 100 through 1968 not identified by the letter "x" in the upper left corner of the identification plate (see figure 1). The "x" on the identification plate indicates previous compliance.

7. After the magneto has been reassembled with new serviceable gears, identify the magneto by stamping the letter "x" in the upper left corner of the identification plate, before the word "Bendix" (see figure 1).

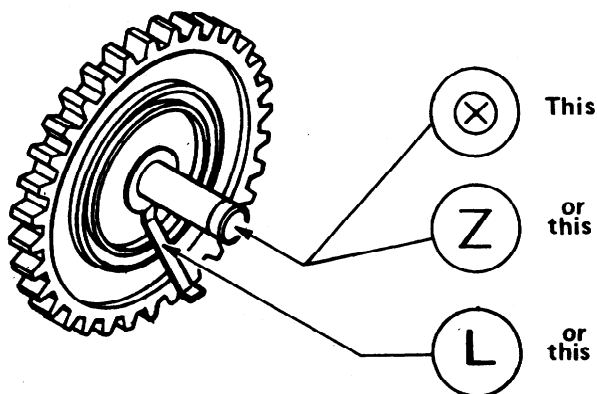
Figure 2. Location of Identification Mark(s)
on Distributor Gear

The distributor gear electrode has come loose in service on some D-3200 Series Magnetos. If this condition exists, the distributor gear electrode may

contact the distributor block stationary electrodes causing contamination in the distributor in the form of dusty brass particles. This contamination may cause arcing within the distributor resulting in misfiring. This could in turn cause rough engine operation or cylinder or engine damage. In order to preclude the possibility of service difficulties, the distributor gears of all affected D-3000 and D-3200 magnetos must be replaced.

5. Reassemble the distributor block with new serviceable gears. Serviceable gears are identified by the presence of the letter "z" or the letters "x" and "o" together, laser etched on the retaining ring end of the gear axle, or the letter "L" stamped on the electrode (see figure 2).
