SERVICE LETTER

No. 672

Piper Aircraft Corporation

Wing Rear Spar Inspection

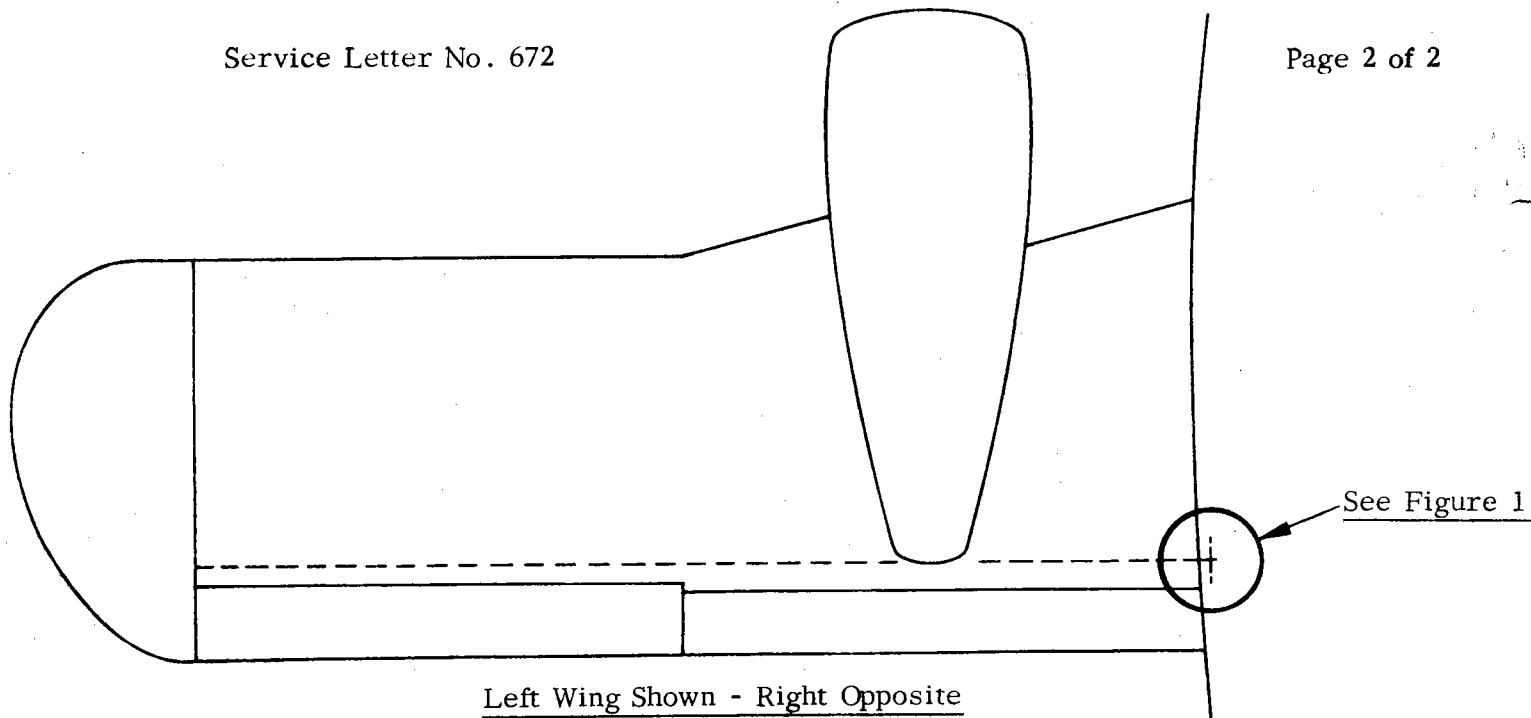
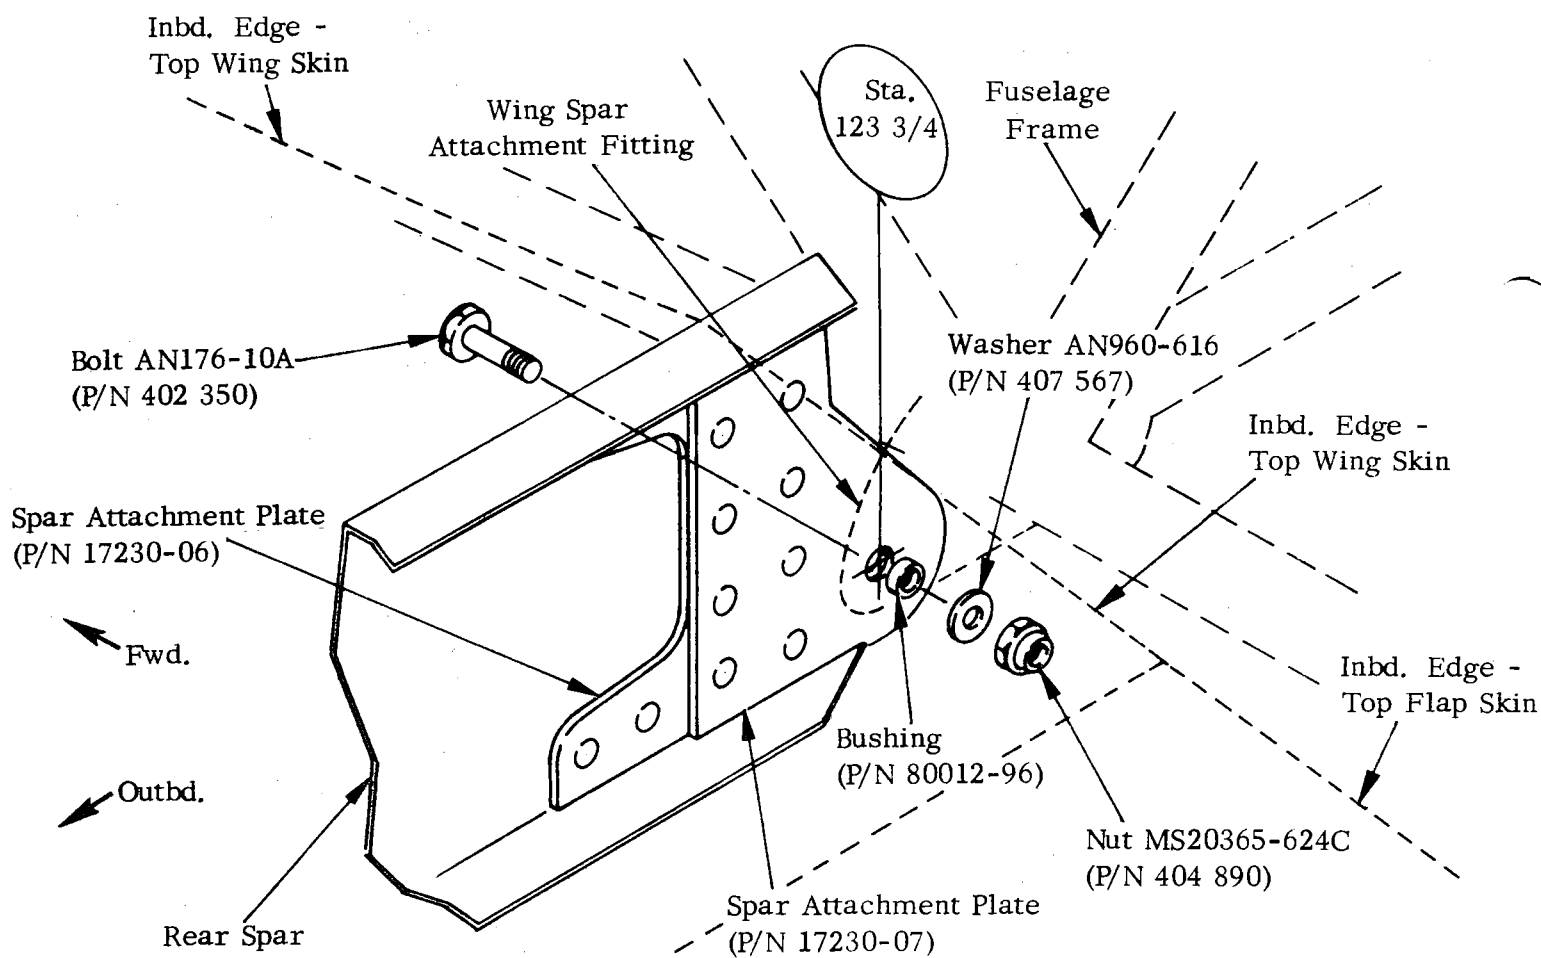
Typ. Rear Spar Attachment

A report has been received by the factory describing wrinkles in the rear inboard wing skin area, occurring on an aircraft with more than 8,000 hours total time in operation. Further examination revealed evidence of wear and cracking in the wing rear spar and rear spar attachment plates.

1. Inspect rear spar attachment plates and adjacent spar area for signs of wear and/or cracks; also inspect attachment hardware and bushing for signs of wear.
2. If signs of wear and/or cracks are evident, replace parts as required; ascertain that attachment hardware is installed as shown.
