# SERVICE LETTER

No. 546A

Piper Aircraft Corporation  
(Supersedes Service Letter No. 546)

Lock Haven, Pennsylvania, U.S.A.  
March 10, 1970

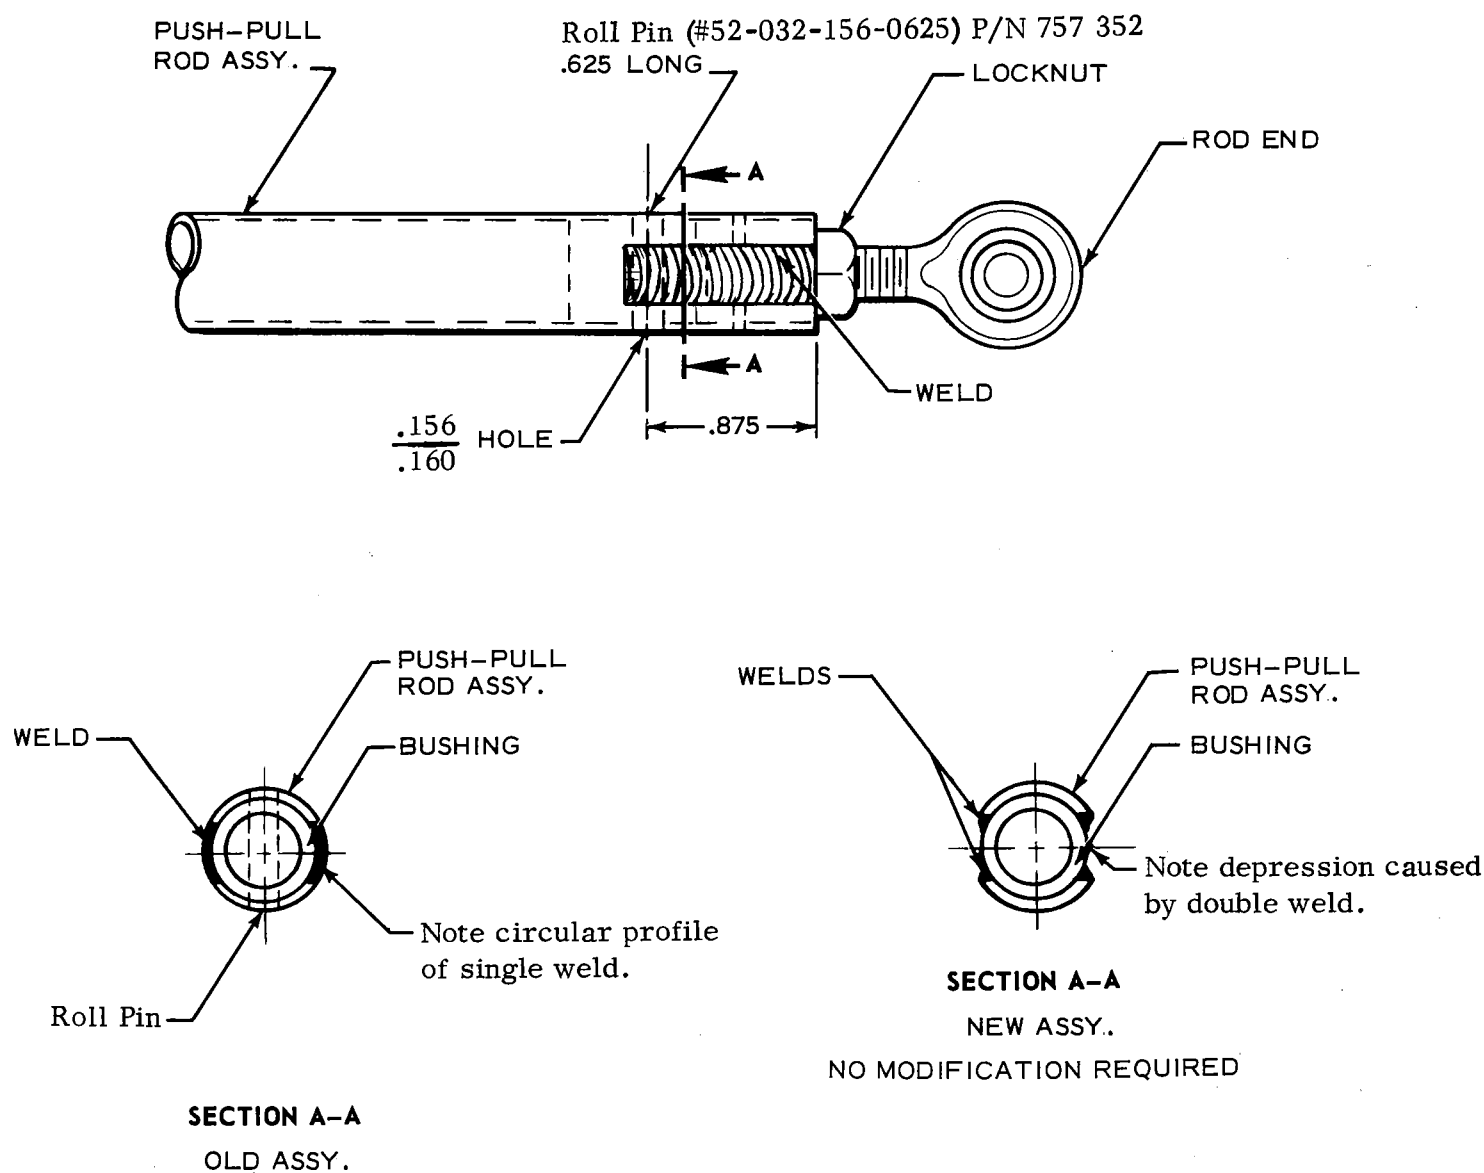
SKETCH "A"

<u>Part Number</u>	<u>Nomenclature</u>	<u>Code</u>
21109-00	Rod-Nose Gear Push-Pull	Modify "old" style (purchased from the factory prior to December 31, 1964)
21109-00	Nose Gear Push-Pull Rod Assemblies per <u>Instructions No. 1</u> ; reference attached sketch to determine difference between "old" and "new" rod assemblies.

Note: If any doubt exists as to the type of weld (old or new) on the subject rod assembly, roll pins should be installed.

b. Measure .875 of an inch from each end of the rod assembly as shown in Sketch A.

c. Drill a  $\frac{.156}{.160}$  inch hole through the rod and bushing. A six inch drill bit is recommended.

Drilled hole must be perpendicular to the welds. It is necessary to maintain the .875 inch dimension and the hole through the center of the rod assembly as shown in Sketch A.

d. Insert roll pin, .625 inch long into the hole drilled in the rod assembly. Using 3/4" plastic type electricians tape, wrap rod assembly directly over the roll pin. Two turns are recommended. This tape will prevent moisture from entering roll pin center.

f. Repeat steps b. thru d. at the opposite end of the rod assembly in the nose gear wheel well.
