The New Piper Aircraft, Inc.  
2926 Piper Drive  
Vero Beach, Florida, U.S.A. 32960

# SERVICE No. 1026 BULLETIN

Distribution of Parker Hannifin Airborne  
Service Letter 48, "Inspection/Replacement  
of dry air pump flexible couplings".

**Service Letter Number:** 48

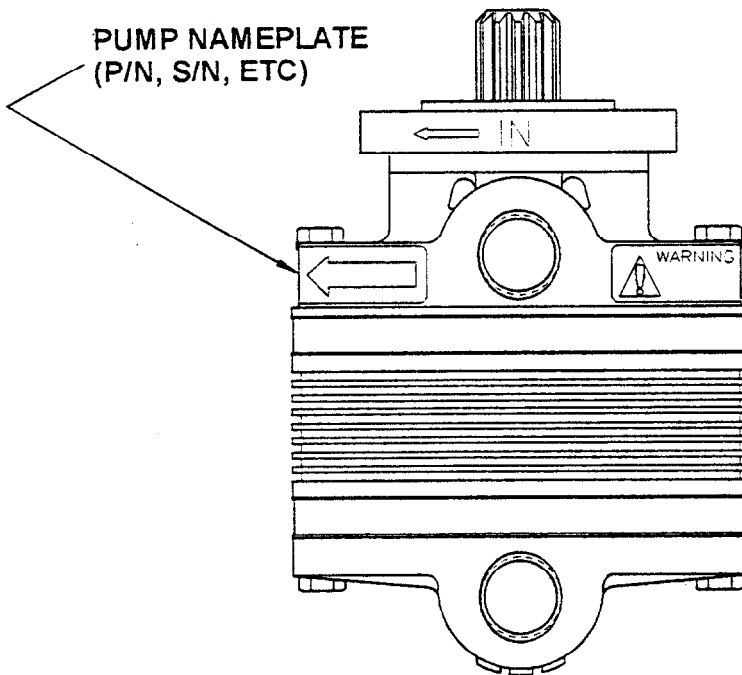
**FIGURE 1**

**Applicability:** Airborne dry air pumps, conversion kits and flexible coupling kits with the following part numbers/serial numbers which have not been inspected per this service letter as identified in step number seven of the procedure listed below. These components were shipped from Airborne between 1/1/98 and 10/13/98. Refer to Figure 1 for location of part number/serial number nameplate.
