**PIPER CONSIDERS
COMPLIANCE MANDATORY**

**Distribution of Textron Lycoming
Service Bulletin 529A, "Reprint of
Crane/Lear Romec Service Bulletin No.
101SB020, Rev.2"**

Service Bulletin No. 529A
 (Supersedes Service Bulletin No. 529)
 Engineering Aspects are
 FAA Approved

THIS SERVICE BULLETIN REPLACES SERVICE BULLETIN NO. 101SB018 FOR AFFECTED MODELS.**FUEL PUMP – Torquing of Relief Valve Cover Screws.****1. Planning Information.****A. Effectivity.**

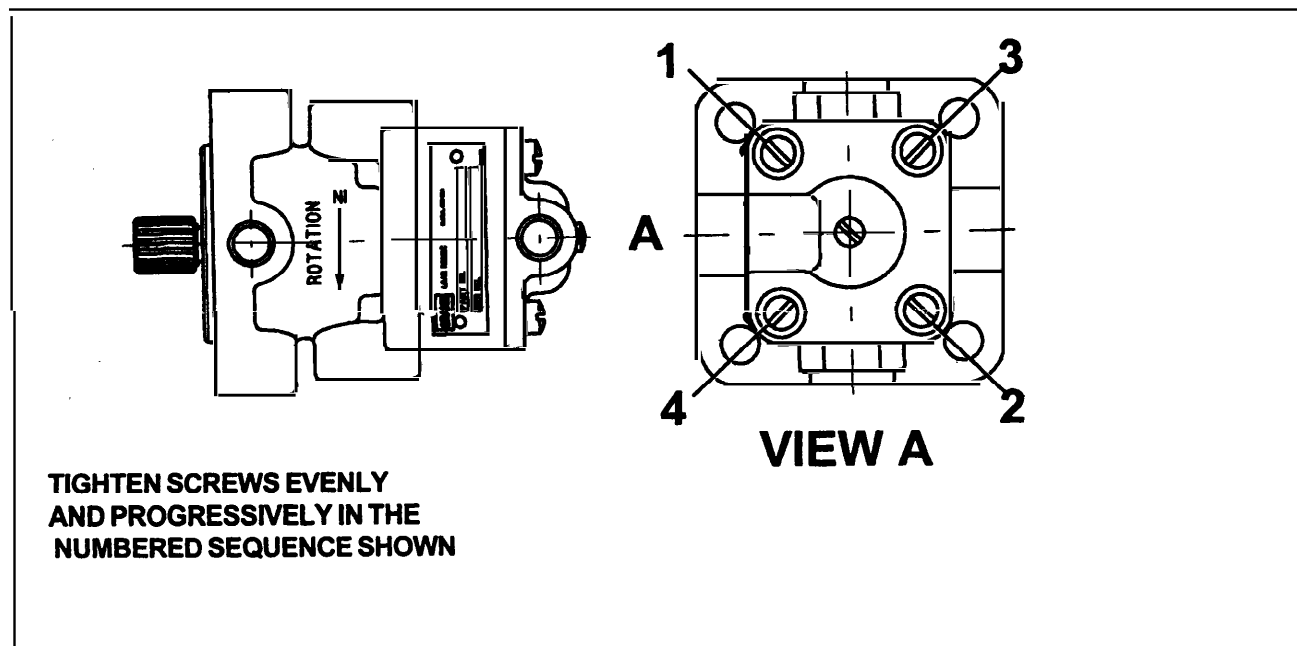
Torquing Sequence – RG17980 Series
Figure 1

There have been field reports of fuel leakage past the relief valve gasket on several of the above listed fuel pumps. This condition could result in a fire hazard, fuel flow fluctuation, or engine stoppage.

- (a) If pump is accessible without removing it from aircraft, the following check shall be performed.
- (b) Visually inspect the split line between the pump housing and relief valve housing for any evidence of noticeable gasket extrusion adjacent to the pump inlet & outlet ports. If there is evidence of noticeable extrusion, replace the pump per applicable engine maintenance instructions.
- (c) Check the tightness of relief valve cap attaching screws using a torque indicating screwdriver. Minimum torque shall be 23 inch-pounds. Torque shall be checked in the tightening direction.
- (d) If screws are loose, remove safety-wire and tighten screws evenly and progressively in a criss cross pattern to 23-25 inch-pounds torque in the sequence shown in figures 1 and 2.

- (a) Visually inspect the split line between the pump housing and relief valve housing for any evidence of noticeable gasket extrusion adjacent to the pump inlet & outlet ports. If there is evidence of noticeable extrusion, replace the pump per applicable engine maintenance instructions.
- (b) Check the tightness of relief valve cap attaching screws using a torque indicating screwdriver. Minimum torque shall be 23 inch-pounds. Torque shall be checked in the tightening direction.
- (c) If screws are loose, tighten screws evenly and progressively in a criss cross pattern to 23-25 inch-pounds torque in the sequence shown in figure 1 and 2.
