SERVICE BULLETIN

No. 257

Piper Aircraft Corporation

<u>Subject:</u>	Piper Navajo Modifications (see below)
<u>Models Affected:</u>	PA-31 Navajo
<u>Compliance Date:</u>	Prior to but not later than the next 50 hours of operation
<u>Availability of Parts:</u>	Piper Dealer
<u>Expiration Date of Warranty:</u>	March 31, 1968

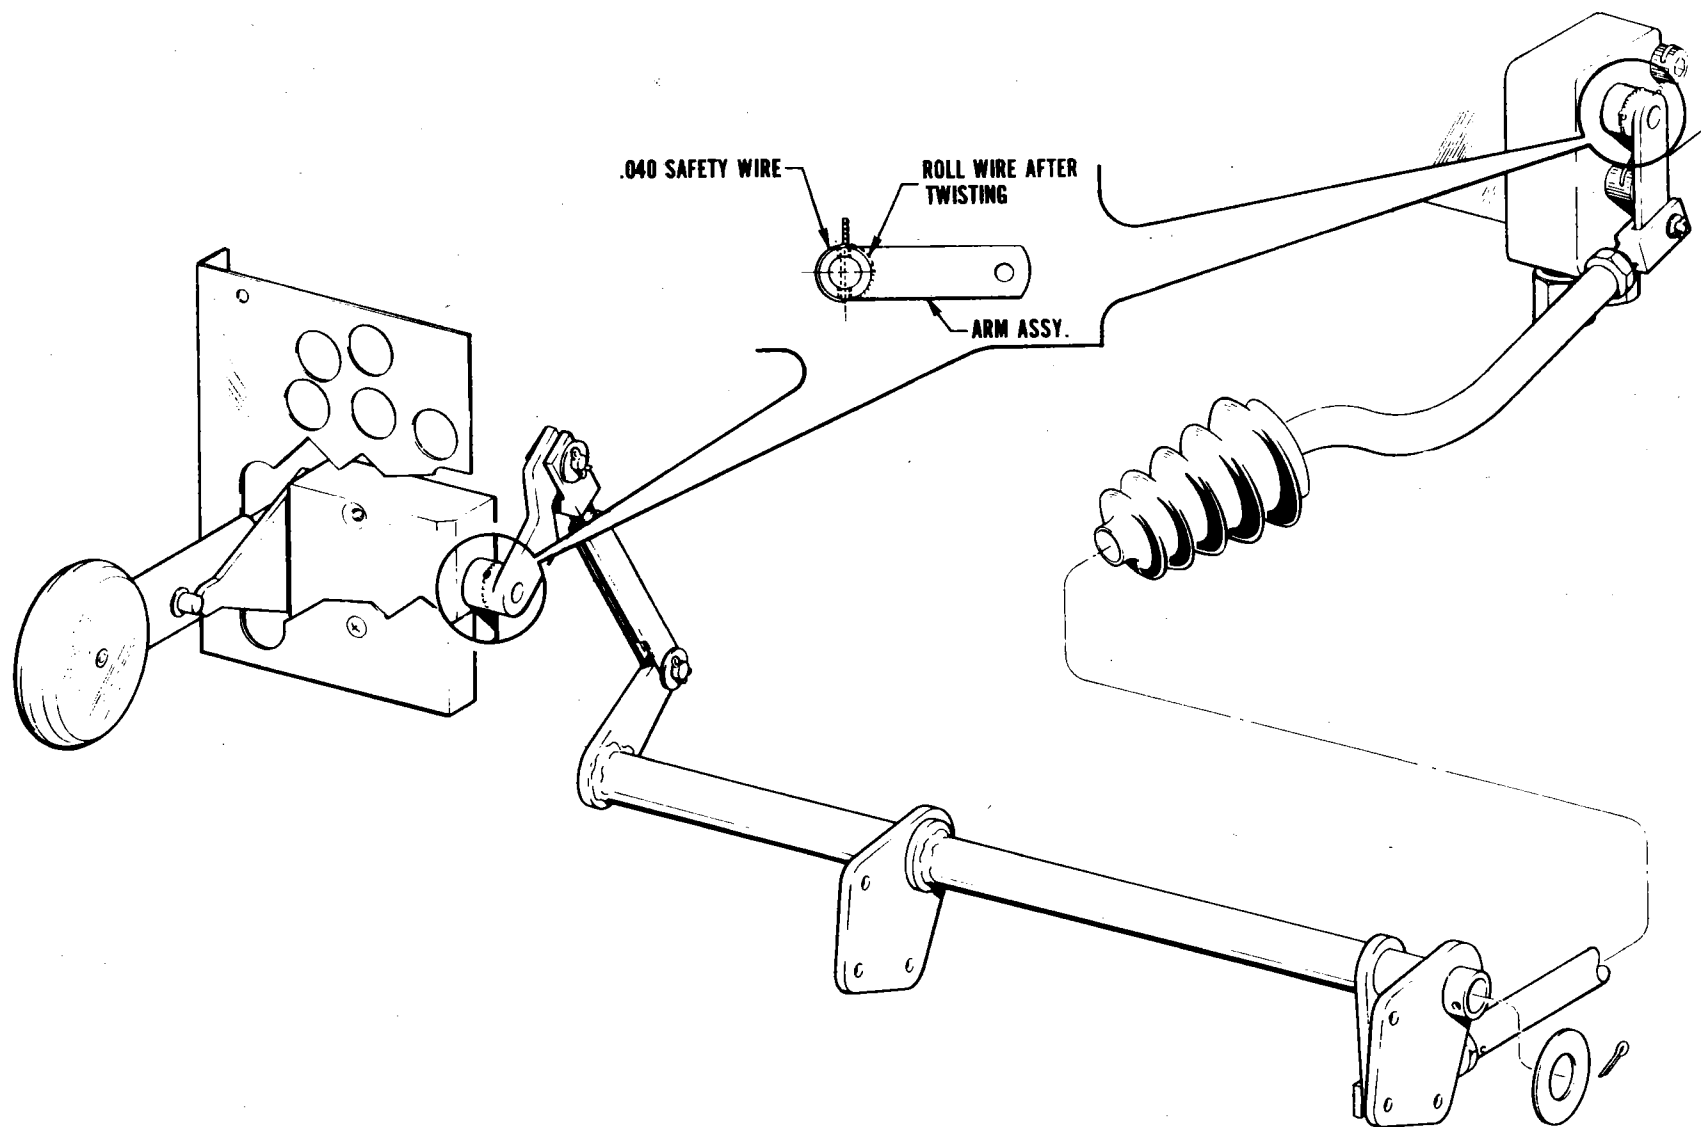
SECTION I

<u>Subject:</u>	Securing of Roll Pins on Landing Gear Selector Mechanism
<u>Serial Numbers Affected:</u>	31-2 to 31-49 incl., 31-51, 31-53, 31-54, 31-56, 31-57
<u>Reason For Bulletin:</u>	Securing of landing gear selector mechanism roll pins with .040 steel safety wire.
<u>Material Required:</u>	.040 Steel Safety Wire
<u>Installation Instructions:</u>	See sketch attached
<u>Warranty Labor Allowed:</u>	One (1) Hour

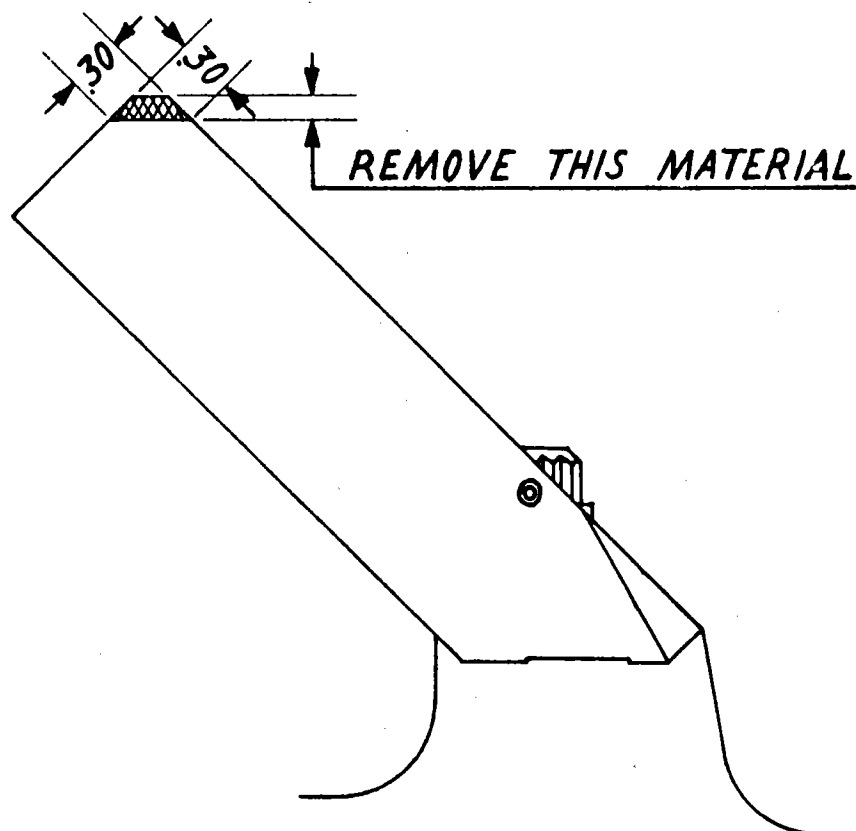
Subject: Counterweight rework for Hartzell Propeller Model HC-E2YK-2/C8475-4 on the Piper PA-31 Aircraft.

Discussion: In order to use the Piper spinner model which is smaller in diameter, the counterweights must be reworked.

Recommended Procedure: Scribe lines on the counterweights according to the new dimensions shown on the sketch. Remove material to the scribed lines with a file, abrasive wheel or similar tool.

Clean the machined surface with a cleaner and paint with a metal primer or equivalent protective paint.
