# SERVICE BULLETIN

No 276

Piper Aircraft Corporation

Subject: Aileron Cable/Floorboard Support Channel Clearance

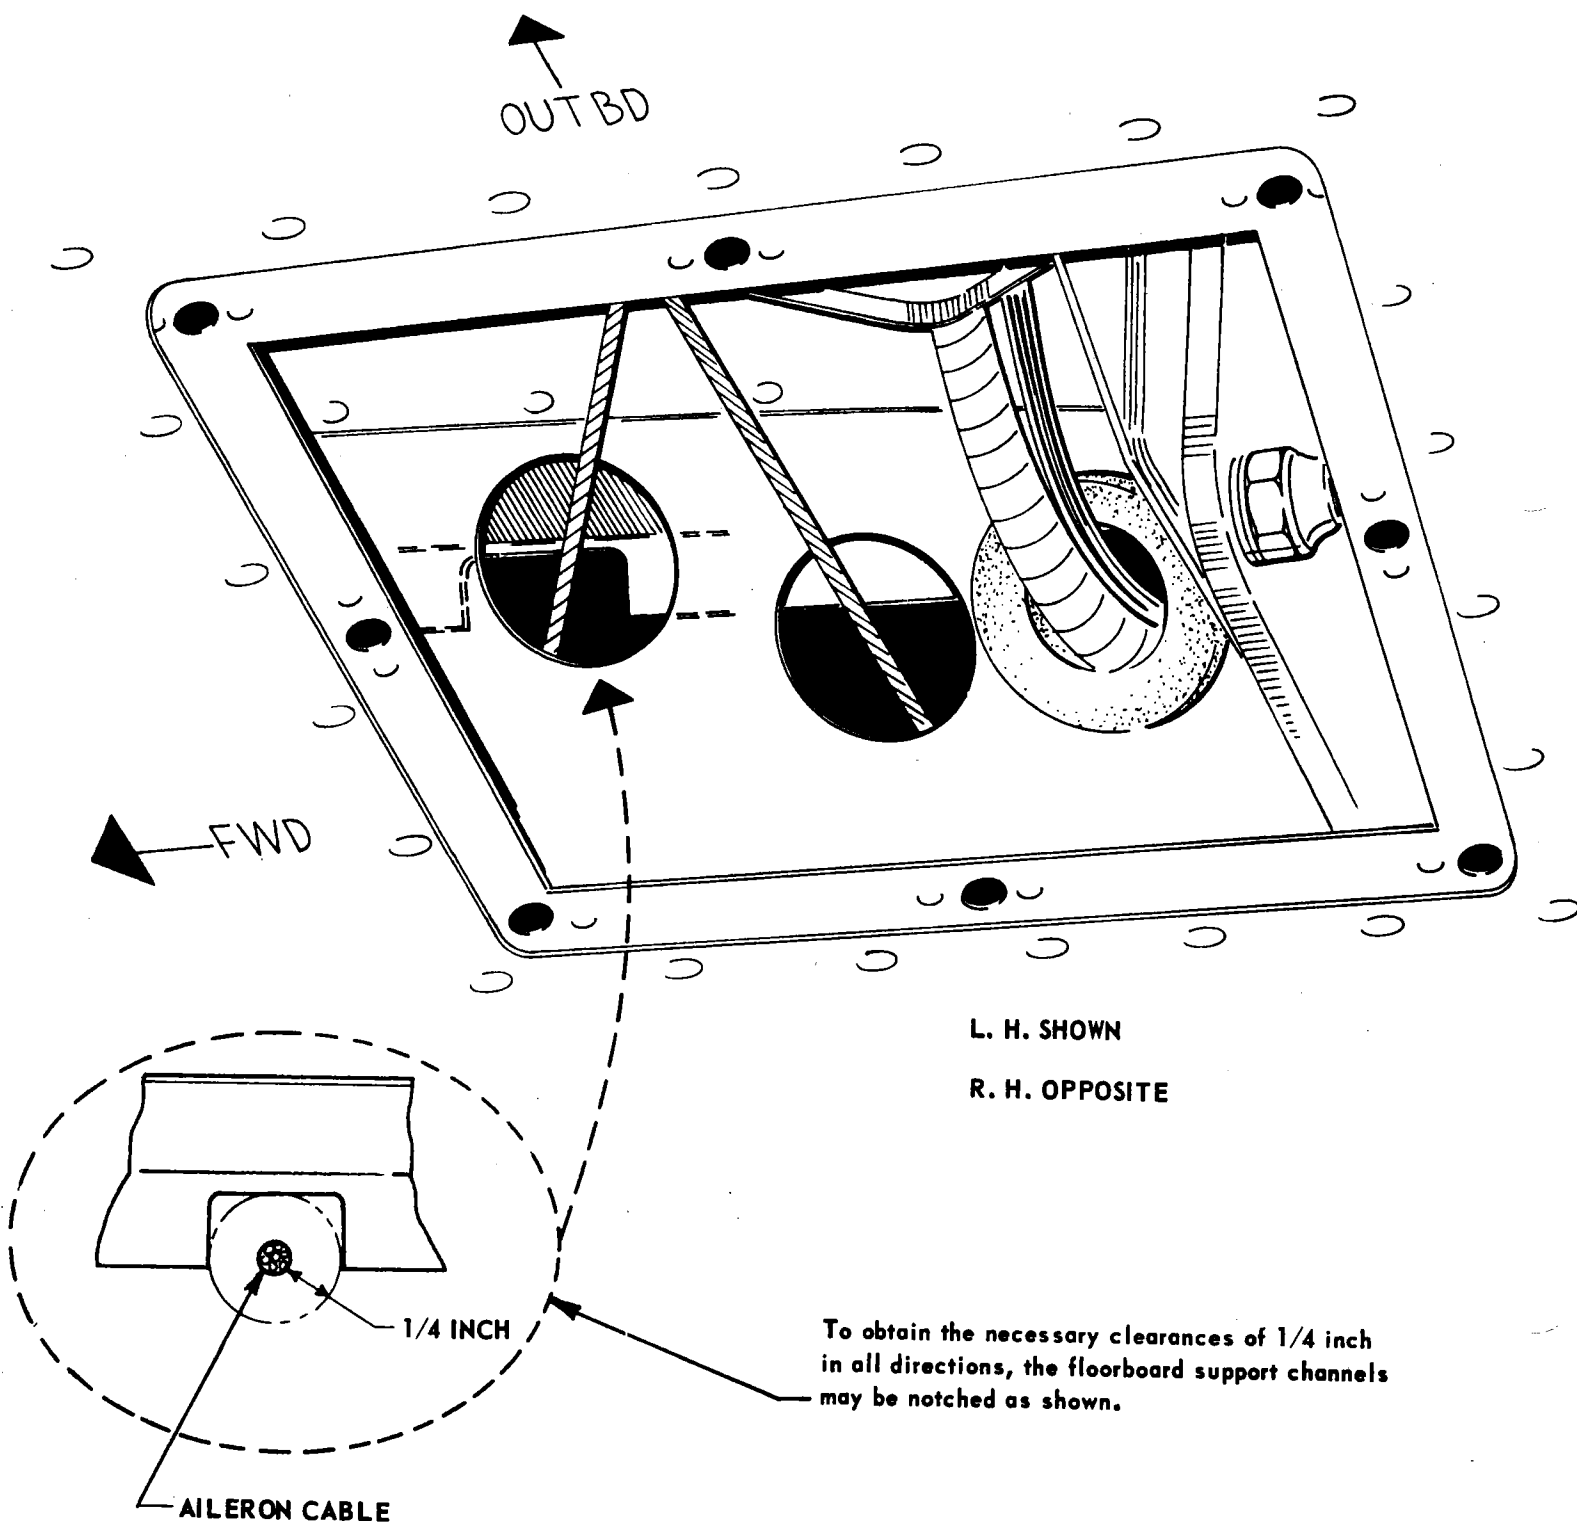
Purpose: An inspection is required to determine that the primary  
aileron control cables have a minimum clearance of  
1/4 inch from the floorboard support channels.

- (1.) Remove louvered access plates (part number 43004-00) from the left and right wing root fillets, and visually inspect the above referenced floorboard support channels and aileron control cables.
- (2.) If clearance of 1/4 inch or more exists between the aileron control cables and floorboard support channels (in all directions), no further action is required.  
If the inspection reveals that the above referenced clearance minimums do not exist, it will be necessary to rework the floorboard channels to obtain the required minimum clearance (per sketch on reverse side of this bulletin).
- (3.) If the inspection reveals that the aileron cables have been damaged, they must be replaced.
