# SERVICE BULLETIN

No. 280

Subject: Case leakage of R. C. Allen 3" Artificial Horizon  
(See attached R. C. Allen Inc., Service Bulletin No. 1.)

SERVICE BULLETIN

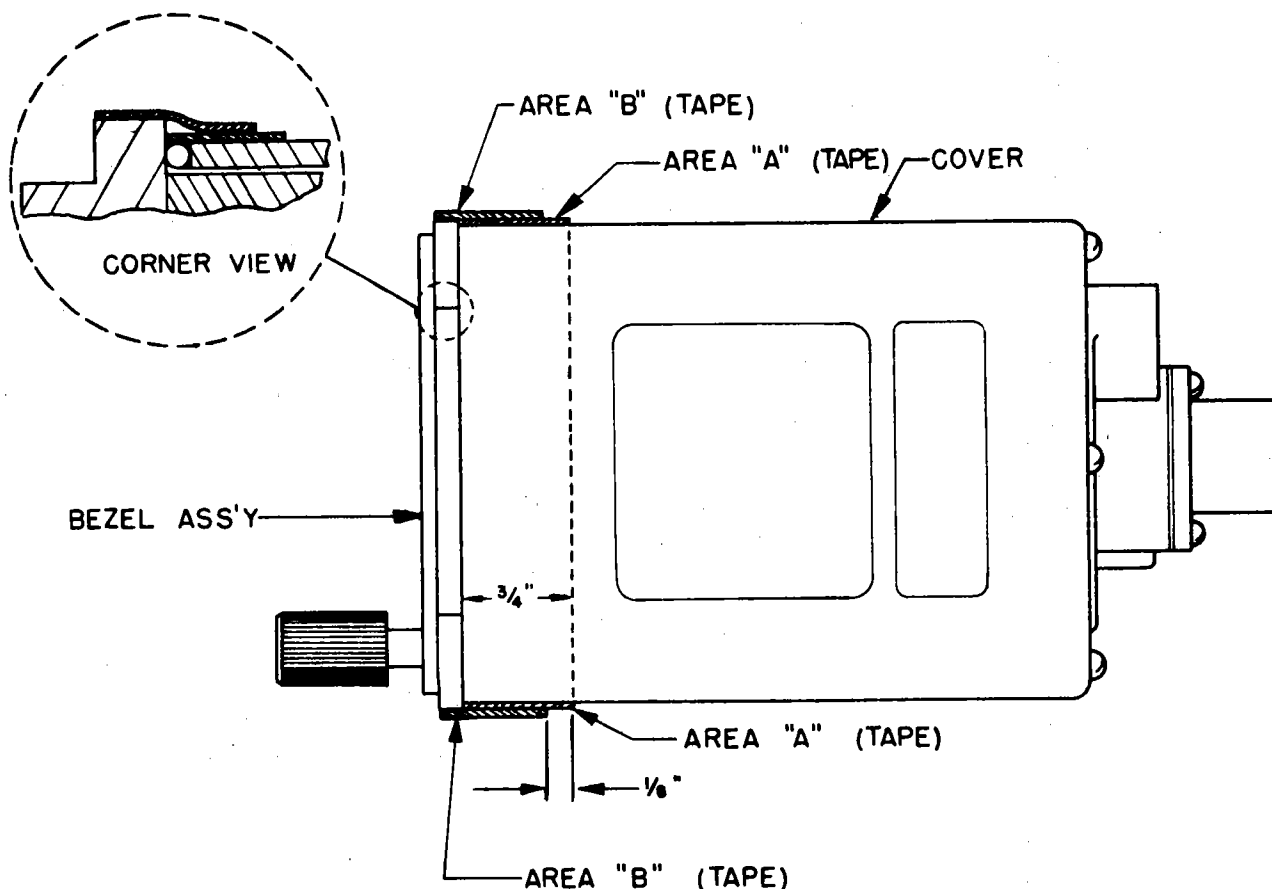
Figure 1. Application of Pressure Sensitive Tape.

Some deterioration of the gasket used to seal the case to the bezel has been experienced. Such deterioration may occur due to the action of ozone and/or the action of certain solvents to which the gasket may have been exposed. If not corrected, the deterioration may result in leaks which can lead to reduction of vacuum system pressure, sluggish horizon performance and eventually complete failure of the gyro system.

2. Refer to Figure 1 and apply one wrap of pressure sensitive tape, 3/4 inch wide, around the horizon as shown in Area "A". Pull the tape as it is being applied so that a slight amount of stretching occurs. The edge of the tape must butt against the rear surface of the bezel assembly and lay firmly against the cover. Overlap the tape approximately two inches.

3. Again refer to Figure 1 and apply one additional wrap of the tape over that just applied as shown in Area "B". Apply this wrapping so that the edge of the tape is flush with the front surface of the bezel assembly. Stretch as required so that the tape lays smoothly around the irregular corners of the bezel. Overlap the tape approximately two inches.
