SERVICE BULLETIN

No. 286

Piper Aircraft Corporation

<u>Subject:</u>	Main Landing Gear (Inboard) Door Hinge Attaching Rivets
<u>Models Affected:</u>	PA-31 and PA-31-300 Navajo
<u>Serial Numbers Affected:</u>	31-2 to 31-292 incl.
<u>Compliance Time:</u>	Prior to but not later than the next 50 hours of operation
<u>Purpose:</u>	Provide instructions to replace existing main landing gear (inboard) door hinge attaching rivets (1/8 in. diameter) with larger diameter (5/32 in.) type MS20470AD5-10 (Piper part number 420 236) rivets.
<u>Instructions:</u>	<p>Using standard rivet removal practices, remove existing 1/8 in. diameter rivets that attach the main landing gear (inboard) door hinge (part number 41984-00, fore and aft) to the door hinge attachment angles (part numbers 42048-00, fore and 42048-01, aft). A no. 21 drill is required for drilling the proper size hole for the 5/32 in. diameter rivets.</p> <p>Reassemble door hinges to door hinge attachment angles, using 5/32 in. diameter rivets type MS20470AD5-10, Piper part number 420 236. (See sketch on reverse side of this bulletin.)</p>

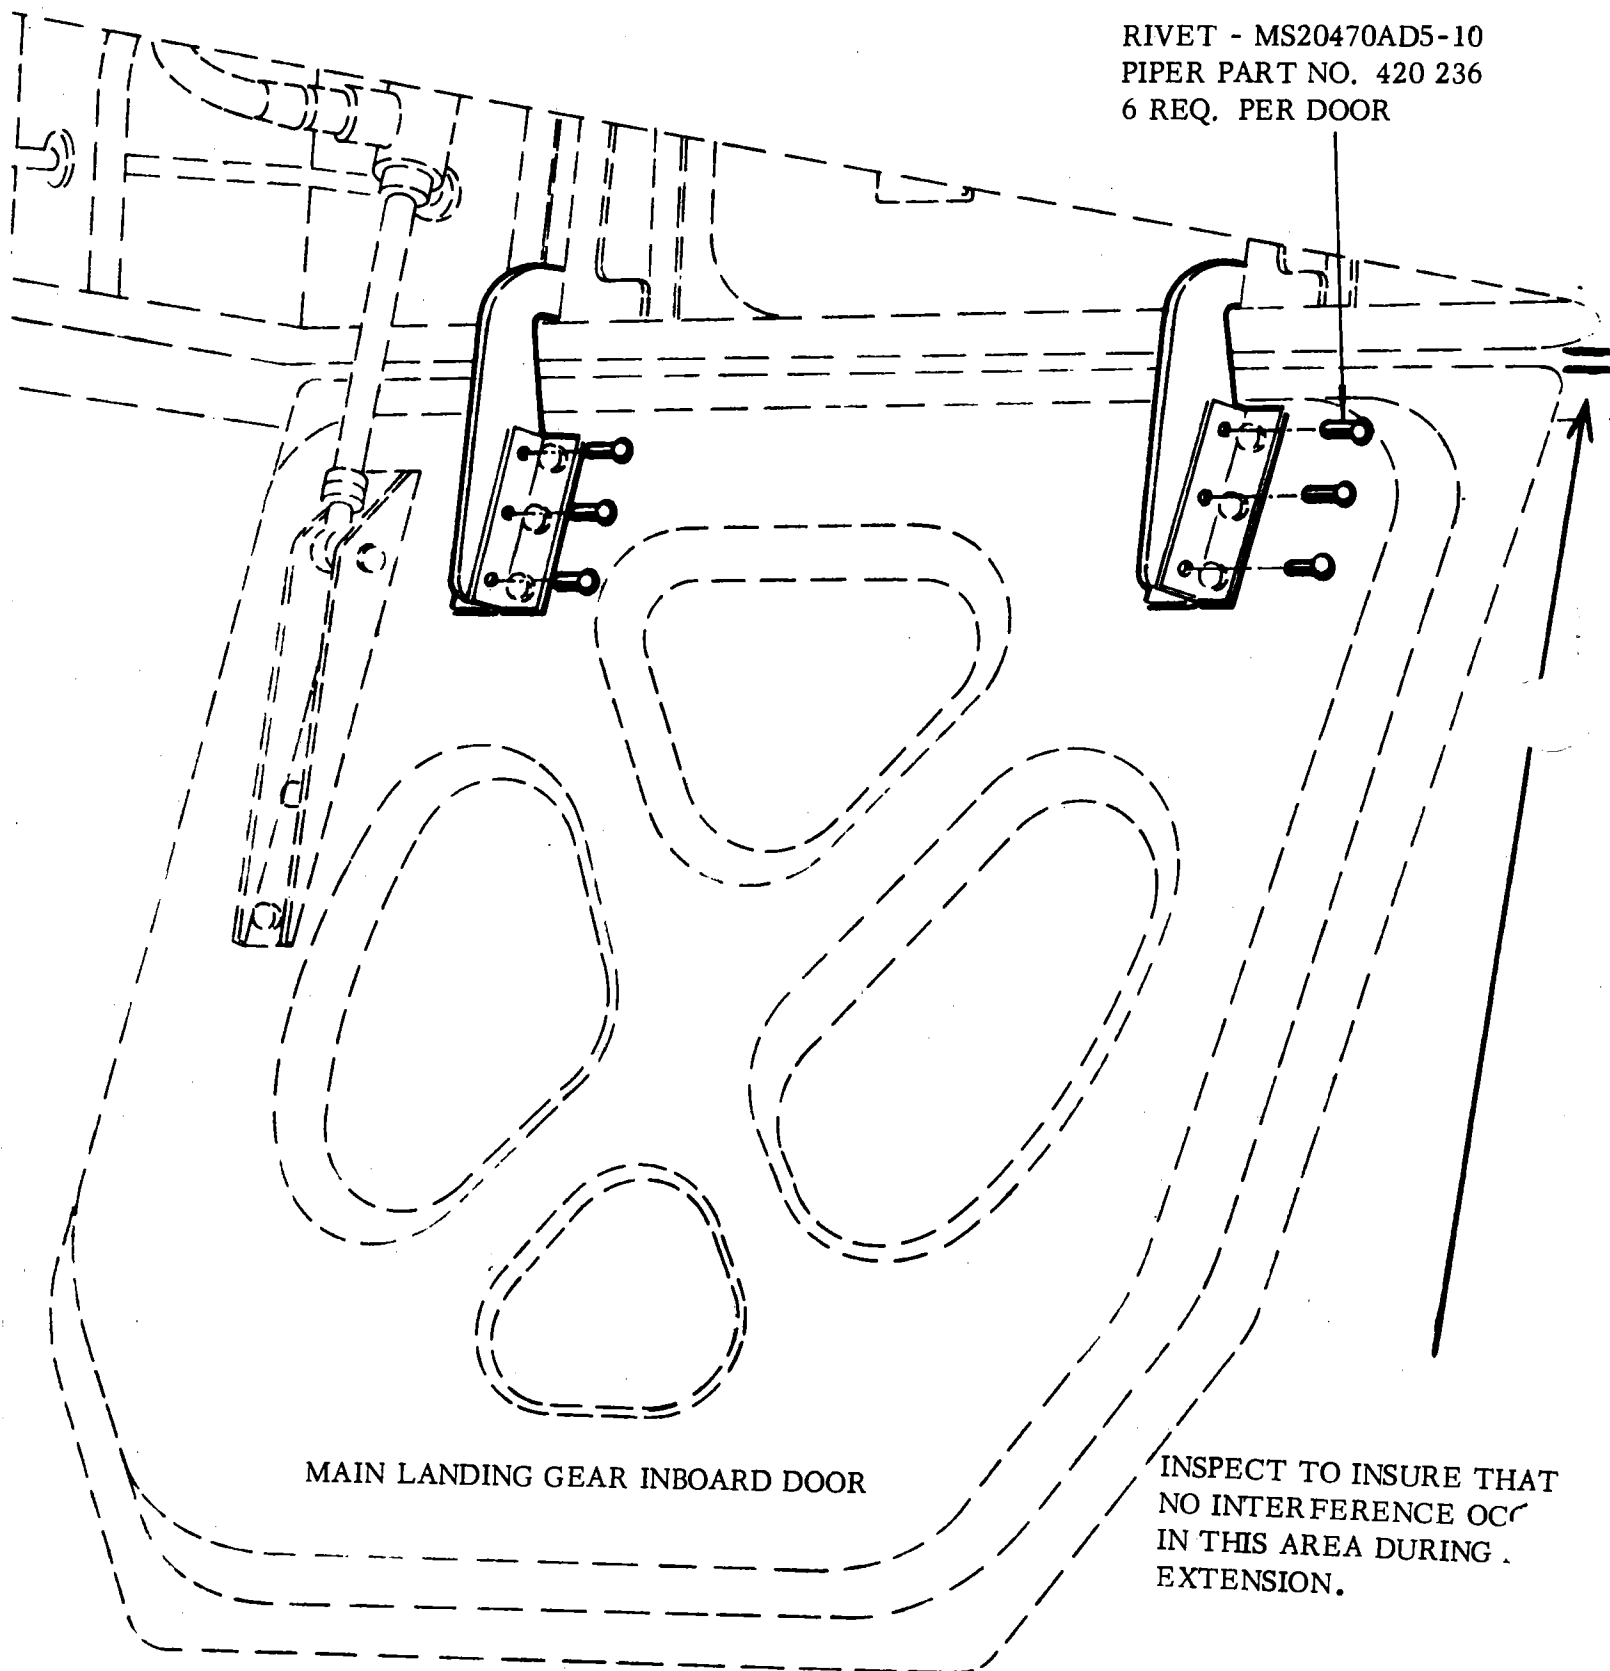
MAIN LANDING GEAR INBOARD DOOR

INSPECT TO INSURE THAT
NO INTERFERENCE OCC
IN THIS AREA DURING
EXTENSION.

Extend the inboard doors, observing that no interference occurs between the inboard landing gear door skin and the wing skin in the butt rib area.

RIVET - MS20470AD5-10
PIPER PART NO. 420 236
6 REQ. PER DOOR
