# SERVICE BULLETIN

No. 344

Piper Aircraft Corporation

Subject: Revised Emergency Gear Extension Operation Information

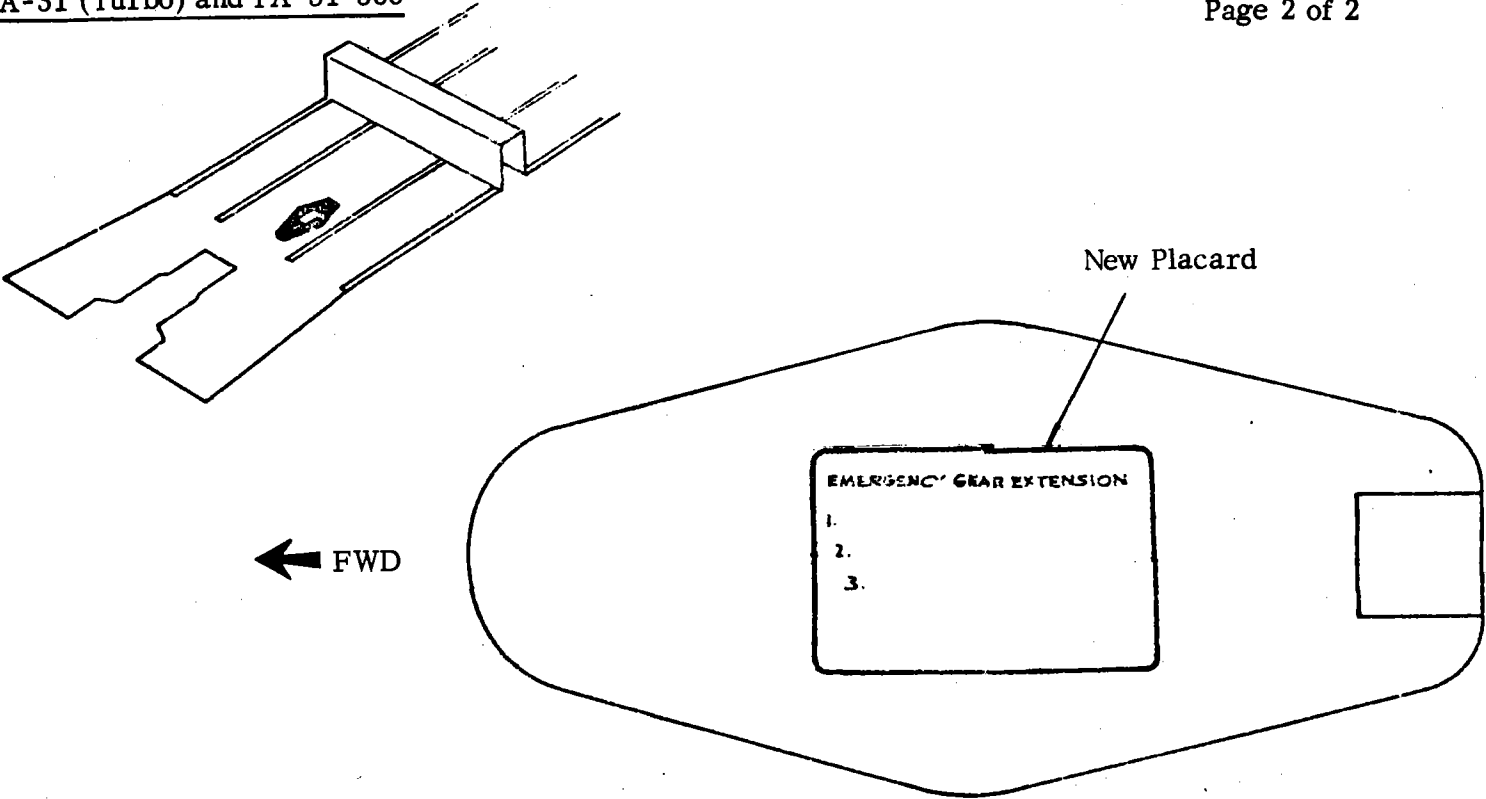
Access Door Assembly (Bottom View)

Purpose: To revise the existing emergency gear extension operation information, which is located on the underside of the emergency gear extension door between the pilot and co-pilot seats and in the appropriate airplane flight manual in the Placards section; Emergency Procedures section. (Sketch on reverse side illustrates the location of the emergency gear extension door on the above referenced aircraft.)

Instructions: Contained in Emergency Gear Extension Placard Replacement Kit, Piper part number 760 570.

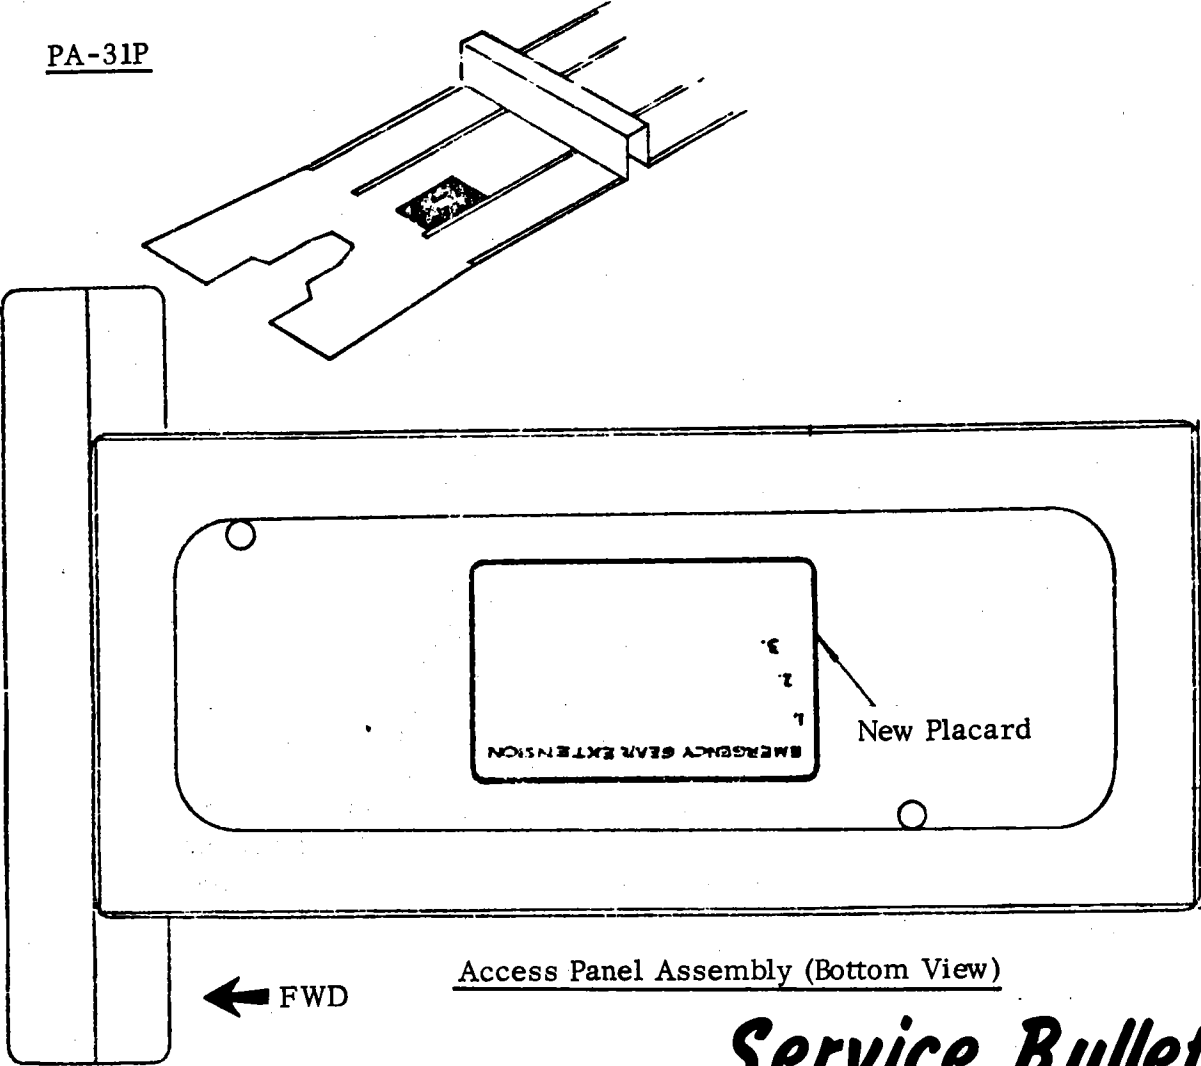
Access Panel Assembly (Bottom View)

PA-31P
