SERVICE No. 361 BULLETIN

Piper Aircraft Corporation

Subject: Inspection of Elevator Hinge Bracket Reinforcement

Models Affected: PA-31 Navajo

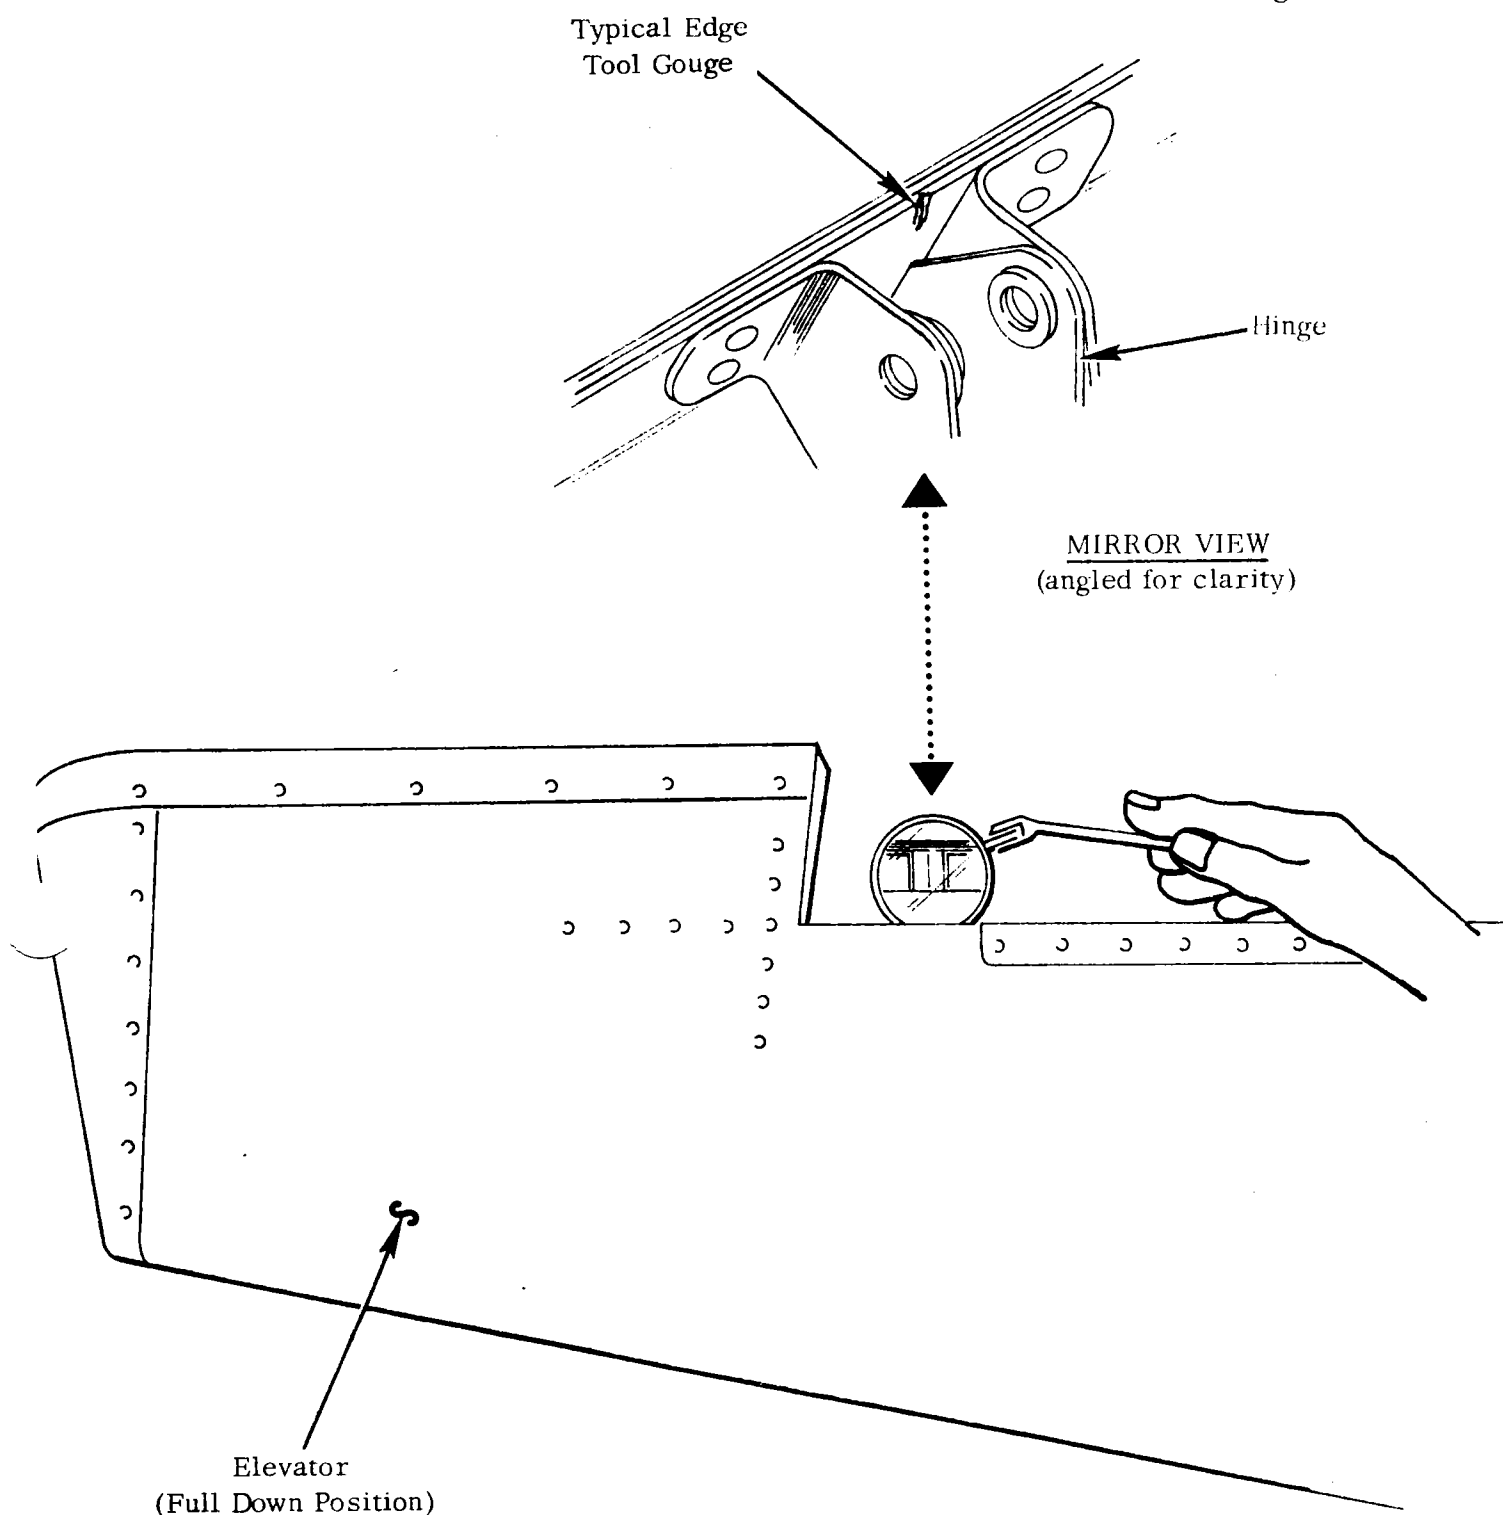
Service Bulletin 361

Purpose: A recent report received from the field described damage to the outboard hinge bracket reinforcement area of an elevator assembly on one of the above referenced aircraft. The damage amounted to a tool mark along the edge surface of the hinge bracket reinforcement.

Stand directly aft of elevator and position mirror as shown for proper view of hinge area.

Therefore, it will be necessary to inspect the elevators on the above referenced aircraft in the areas described above to insure that there are no tool marks in the elevator outboard hinge bracket area and to replace elevators should the inspection reveal tool mark damage -- see attached sketch for a general illustration.

1. Place elevators in "full down" position.
2. Stand directly aft of elevator and position mirror as shown for proper view of outboard hinge bracket reinforcement area.
3. Check for tool marks; a pictorial representation of a tool mark is contained on the attached sketch.
4. If no tool marks are observed, no further action is required. Make appropriate log book entry and return aircraft to service.
5. Should tool marks be observed as denoted on the attached sketch, replace affected elevator assembly (see Material Required, below). Make appropriate log book entry.
