SERVICE BULLETIN

No. 379A

Piper Aircraft Corporation

Subject: Inspection of Rudder Control Cable Routing

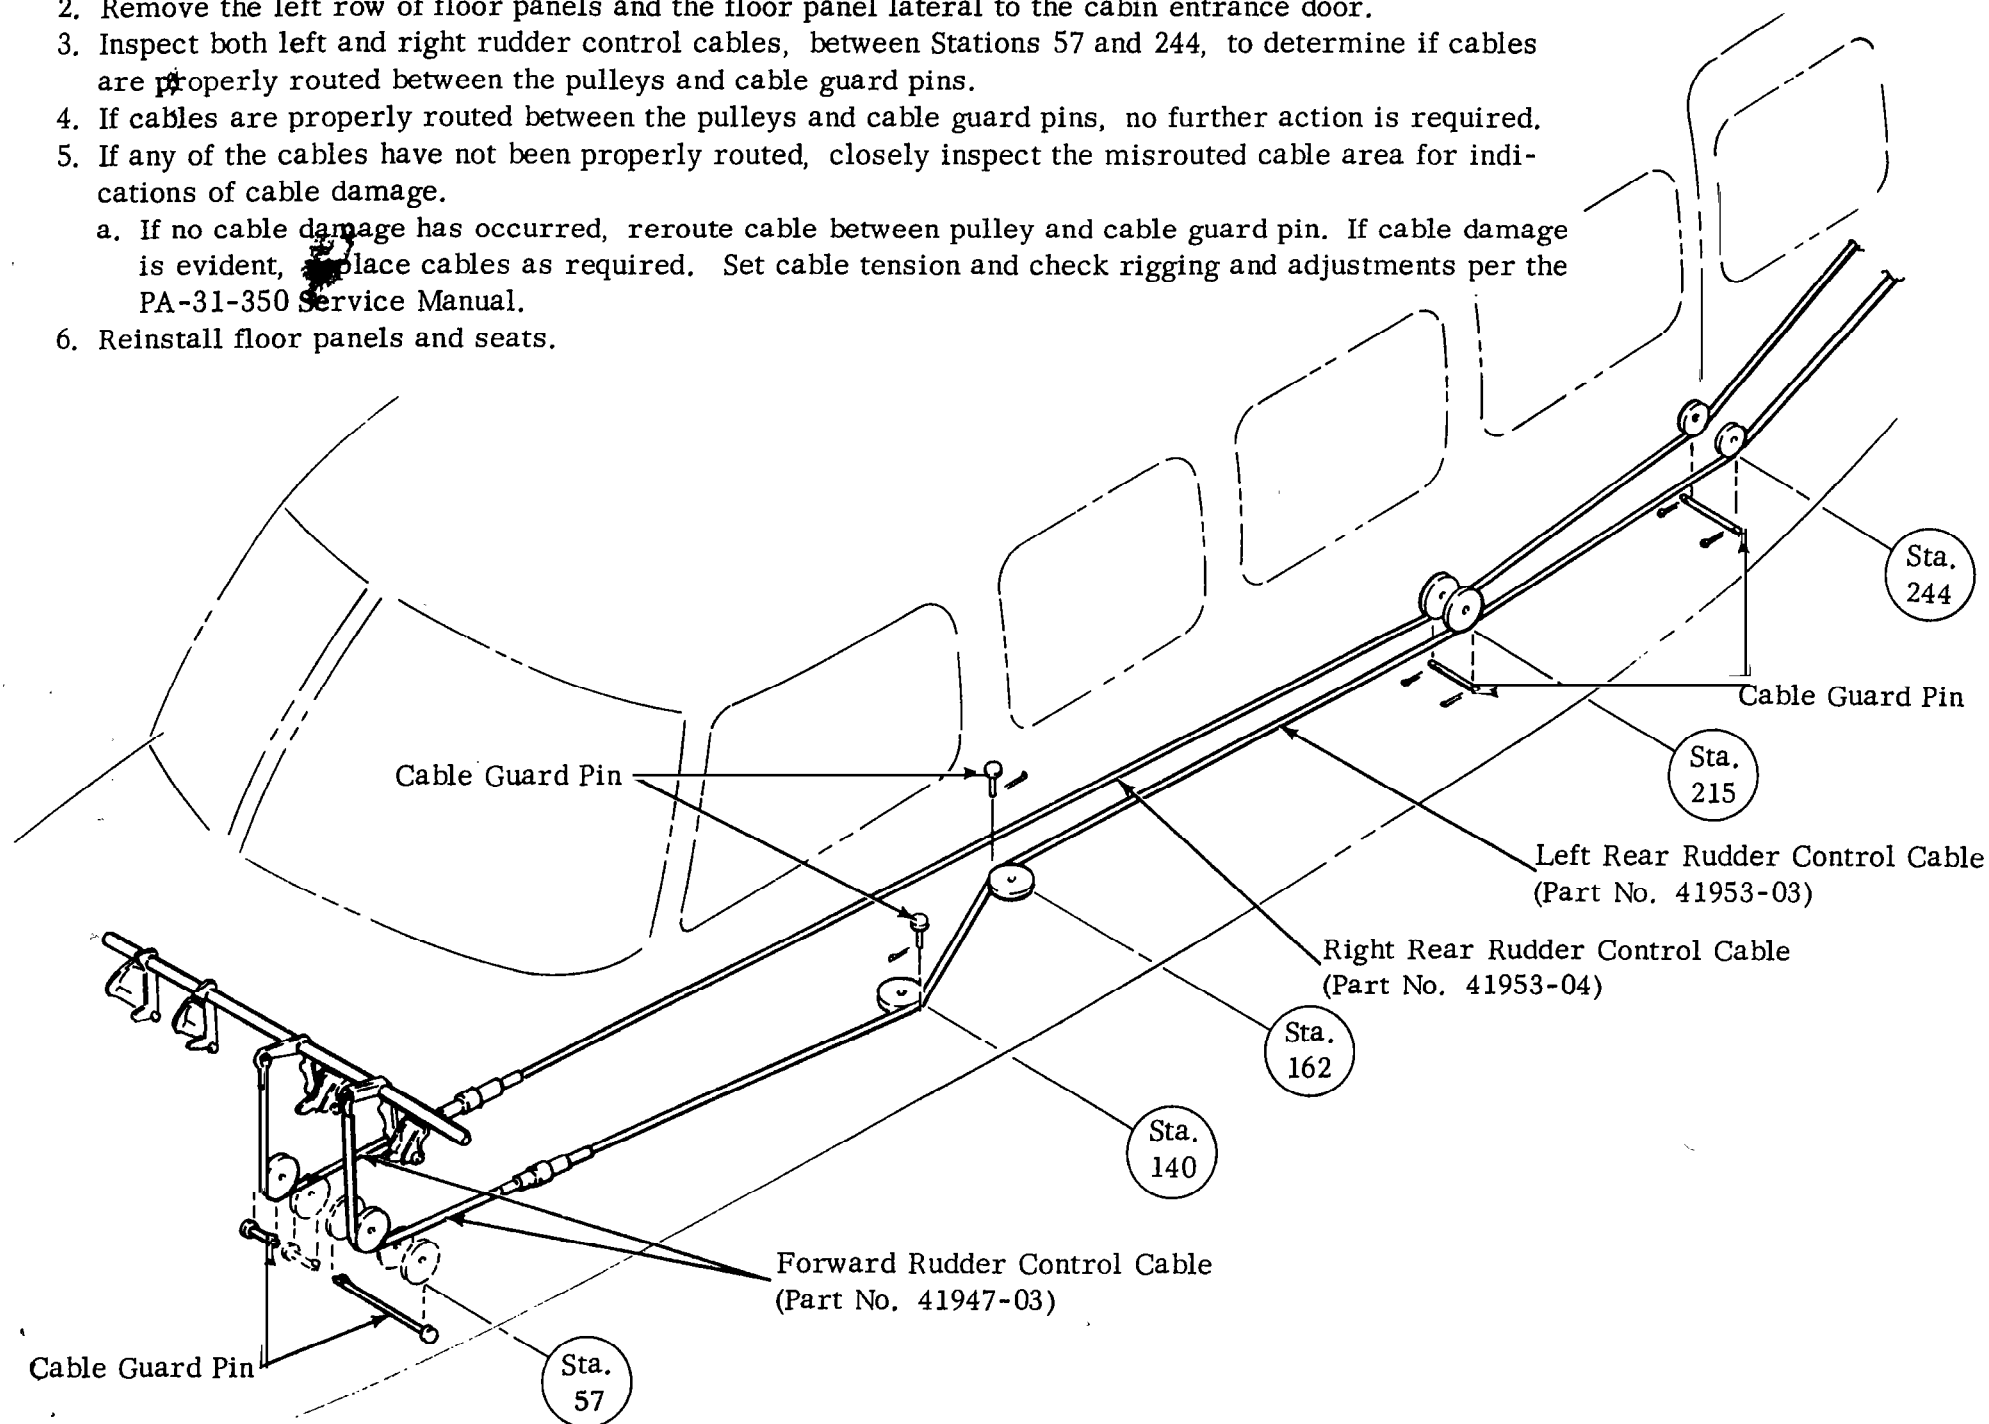
The intent of this service release is to expand the rudder control cable inspection area to insure that both the right and left rudder control cables have been properly routed through appropriate fuselage frame members and between pulleys and cable guard pins (between fuselage stations 57 to 244). The attached sketch/instruction data illustrates the affected areas and describes the inspection procedure.

1. Remove the left pilot's seat and left row of passenger seats.
2. Remove the left row of floor panels and the floor panel lateral to the cabin entrance door.
3. Inspect both left and right rudder control cables, between Stations 57 and 244, to determine if cables are properly routed between the pulleys and cable guard pins.
4. If cables are properly routed between the pulleys and cable guard pins, no further action is required.
5. If any of the cables have not been properly routed, closely inspect the misrouted cable area for indications of cable damage.
 - a. If no cable damage has occurred, reroute cable between pulley and cable guard pin. If cable damage is evident, replace cables as required. Set cable tension and check rigging and adjustments per the PA-31-350 Service Manual.
6. Reinstall floor panels and seats.

Material Required: Forward Rudder Control Cable(s), part number 41947-03 and/or Left and/or Right Rear Rudder Control Cables, part numbers 41953-03 or -04 respectively only if the inspection has revealed evidence of cable damage caused by improper routing (see attached sketch/instruction data).
