# SERVICE BULLETIN

No. 389

Piper Aircraft Corporation

Subject: Bridle Cable and Bridle Cable Clamp Inspection; AltiMatic V and AltiMatic V Flight Director Series Automatic Flight Control Systems

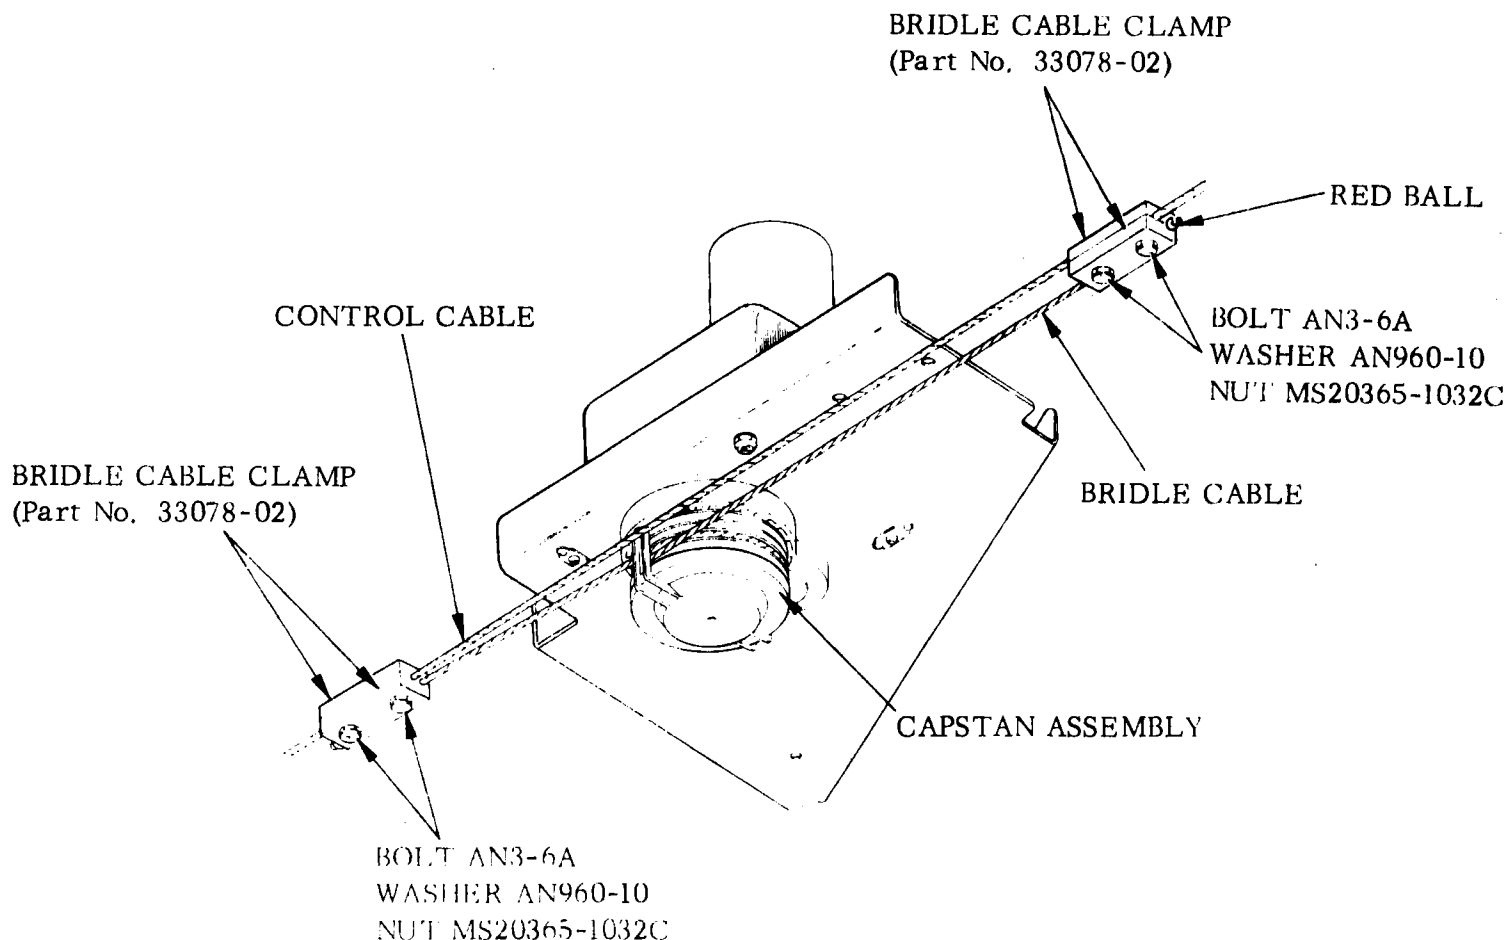
TYPICAL BRIDLE CABLE INSTALLATION  
(PA-31 Series Roll Servo Shown)

Purpose: Two reports have been received which described the slippage of the roll servo bridle cable clamps on the above referenced aircraft. It appears possible that the lock nuts used in the bridle cable clamp assemblies may have loosened, causing subsequent bridle cable clamp slippage. This condition can normally be prevented by routine inspections of the Automatic Flight Control System components as specified in the appropriate Piper periodic inspection forms, airplane service manuals and appropriate Automatic Flight Control System service manuals.

2. Loosen the nuts on the bridle cable clamps - one at a time, then retighten; ascertain that the MS20365-1032C nuts retain their self-locking capabilities. If the nuts run freely on the AN3-6A bolts, replace nuts as required.

3. Check the control cable and bridle cable tension in accordance with the Roll and/or Pitch Servo Capstan Assembly Installation Instructions in the appropriate V Series Service Manual.

4. Torque the bridle cable clamp bolts to  $23 \pm 2$  inch-pounds, above the nut running torque.
5. Check for proper position and security of bridle cable clamps and for proper servo function as outlined in the roll and/or pitch servo installation instruction in the appropriate V Series service manual.
