SERVICE BULLETIN

No. 509

Piper Aircraft Corporation

Replacement of Engine Mount Assembly
Attachment Nuts.

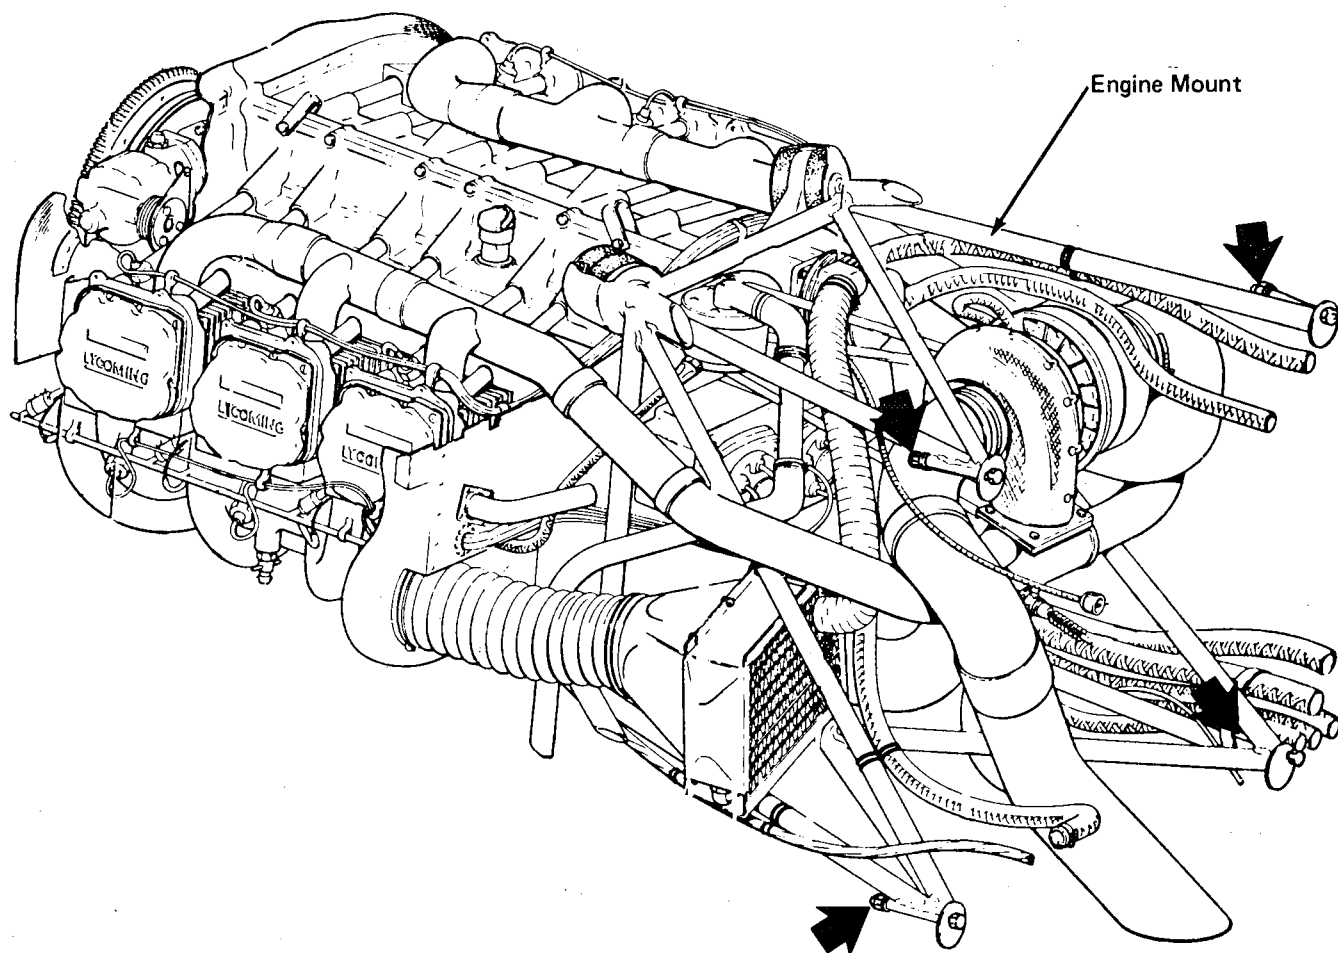
It has been determined that aircraft in the above specified group may have had engine mount assembly attachment nuts installed which were not cadmium-plated. This condition could eventually lead to corrosion of the nuts.

INSTRUCTIONS

Replace existing nuts on engine mount attachment bolts (four per mount) with new cad. plated nuts MS20365-624C (Piper P/N 404 890). Torque nuts to 160 to 190 inch-pounds (13 to 16 foot-pounds).
