SERVICE BULLETIN

No. 521

Piper Aircraft Corporation

<u>Subject:</u>	Inspection of Stabilizer Stringer Attachment
<u>Models Affected:</u>	<u>Serial Numbers Affected:</u>
PA-31 and PA-31-325 Navajo	31-7612060 to 31-7612080 Inclusive, 31-7612082 to 31-7612089 Inclusive, 31-7612091, 31-7612096, and 31-7612099.
PA-31-350 Navajo Chieftain	31-7652105 to 31-7652115 Inclusive, 31-7652117, 31-7652118, 31-7652120 to 31-7652146 Inclusive, 31-7652148 to 31-7652162 Inclusive, 31-7652164, 31-7652165 and 31-7652168.
<u>Compliance Time:</u>	At the next scheduled Programmed Inspection Event, not to exceed the next fifty (50) hours of operation.

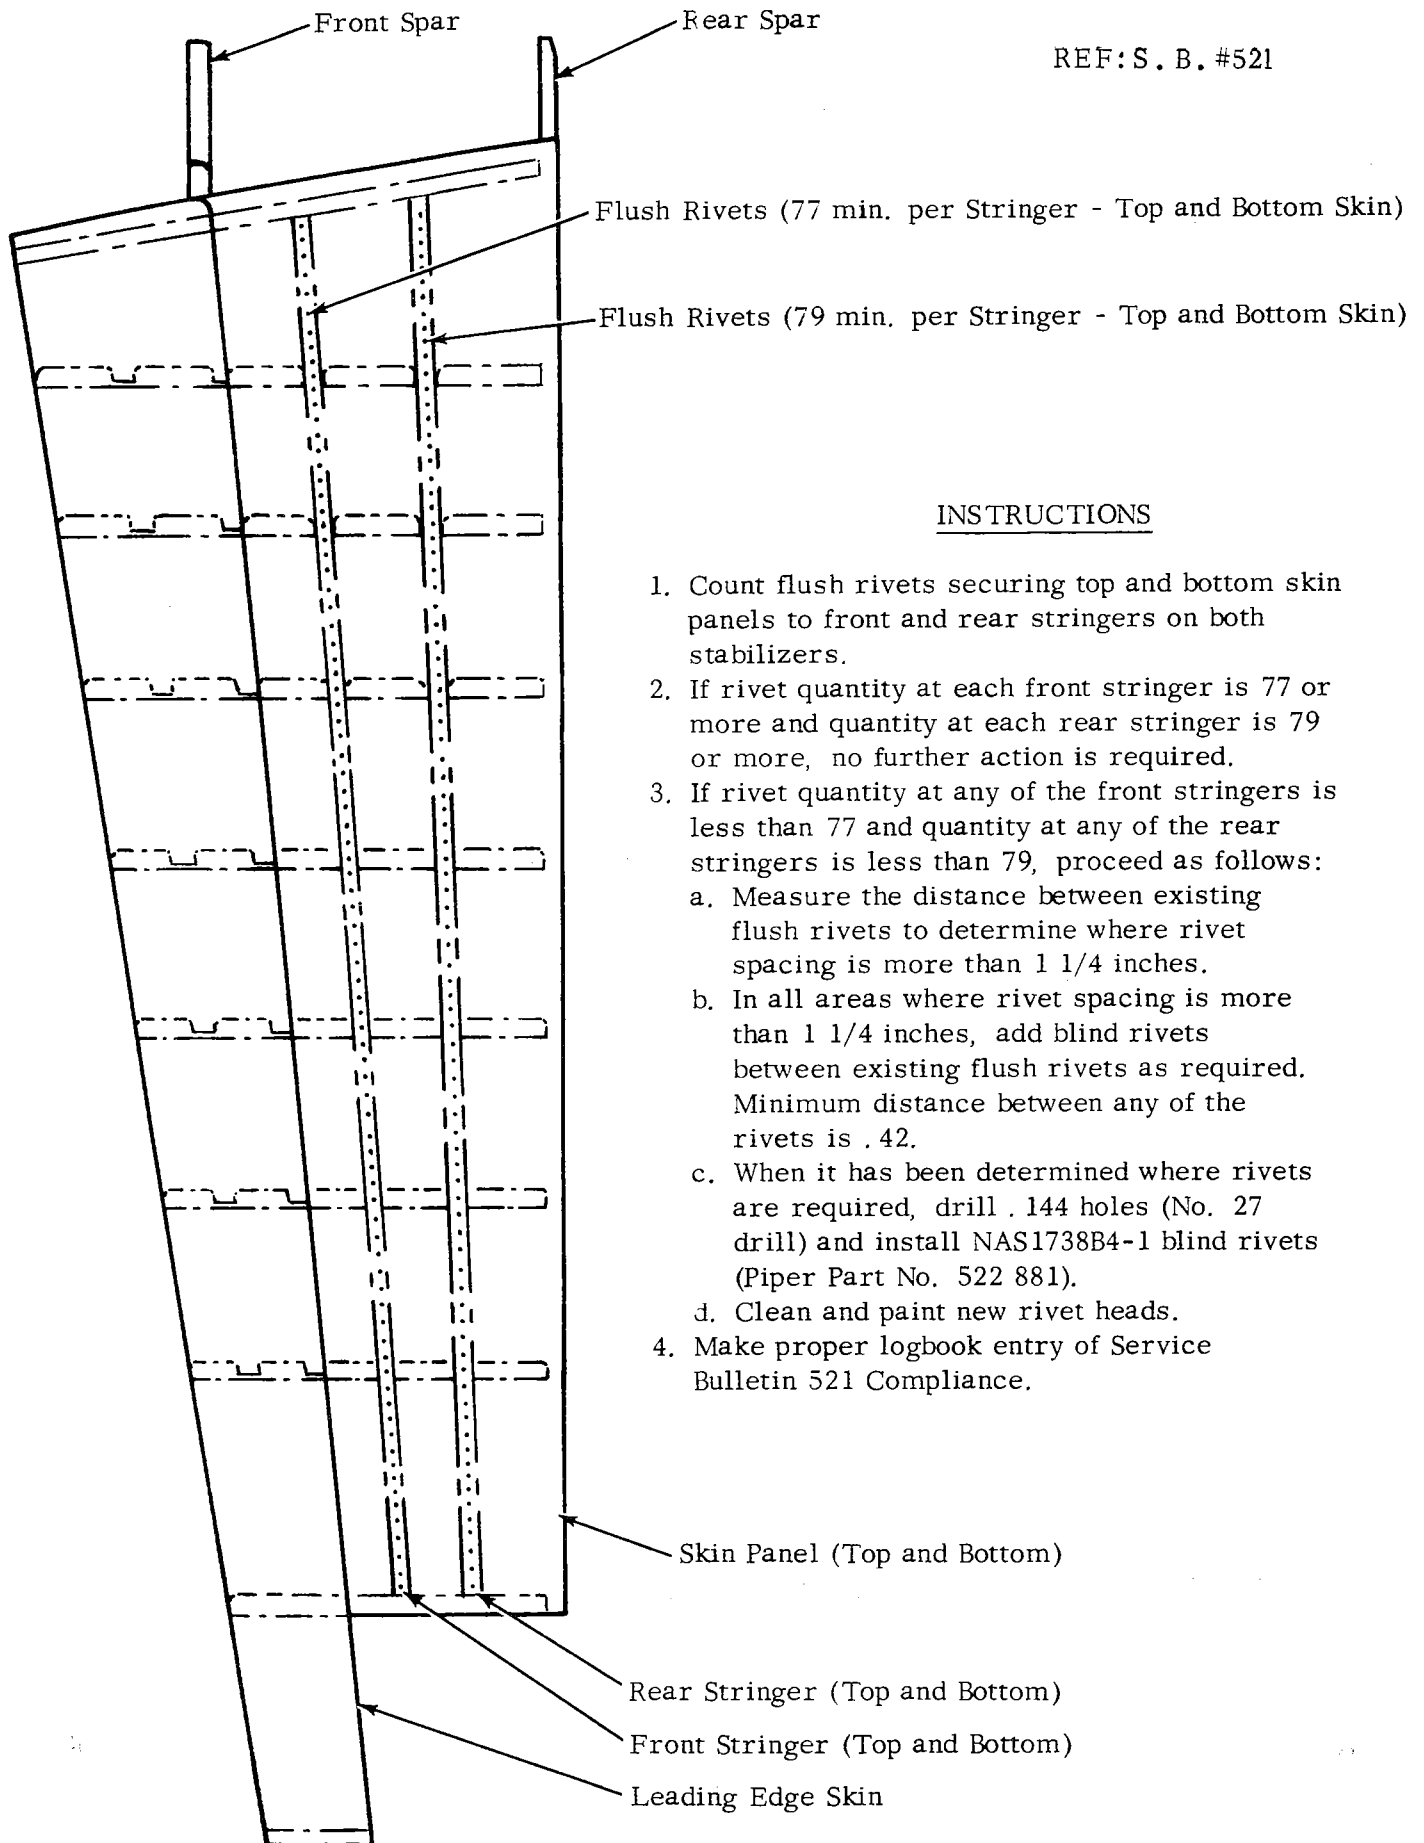
TOP VIEW OF LEFT STABILIZER SHOWN - RIGHT OPPOSITE

It has been found that an inadequate number of rivets may have been used to attach the stringers to the top and bottom skin panels. An inadequate number of rivets may permit local buckling of the skin between rivets. See attached sketch/instruction data for an illustrated view of the subject area.

1. Count flush rivets securing top and bottom skin panels to front and rear stringers on both stabilizers.
2. If rivet quantity at each front stringer is 77 or more and quantity at each rear stringer is 79 or more, no further action is required.

3. If rivet quantity at any of the front stringers is less than 77 and quantity at any of the rear stringers is less than 79, proceed as follows:
 - a. Measure the distance between existing flush rivets to determine where rivet spacing is more than 1 1/4 inches.

- b. In all areas where rivet spacing is more than 1 1/4 inches, add blind rivets between existing flush rivets as required. Minimum distance between any of the rivets is .42.

- c. When it has been determined where rivets are required, drill .144 holes (No. 27 drill) and install NAS1738B4-1 blind rivets (Piper Part No. 522 881).

- d. Clean and paint new rivet heads.
4. Make proper logbook entry of Service Bulletin 521 Compliance.
