SERVICE BULLETIN

No. 525

Piper Aircraft Corporation

Subject: Pilot/CoPilot Seat Latch Mechanism Modification

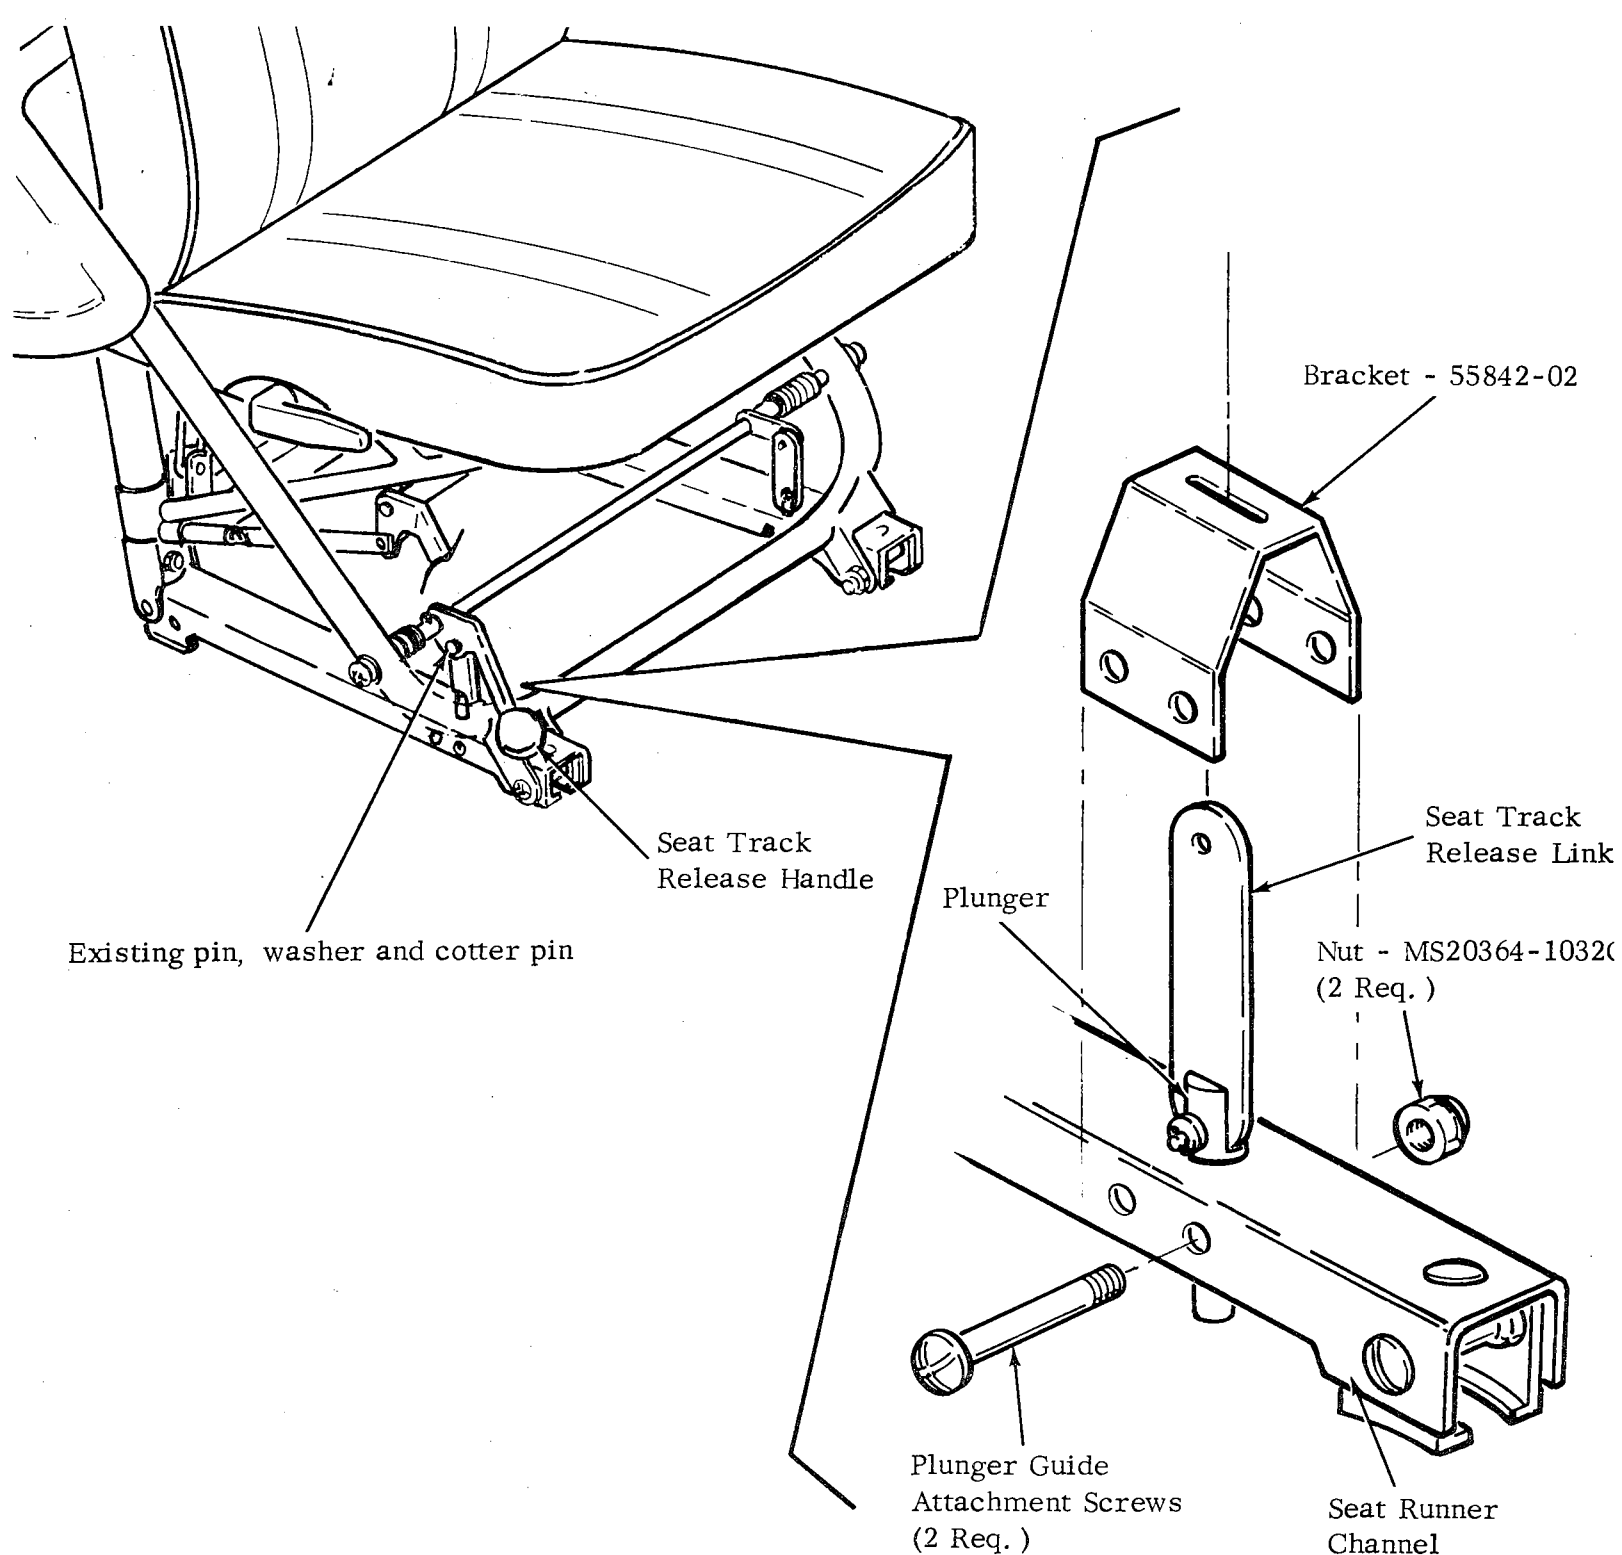
Purpose: A report has been received from the field describing a condition in which the pilot's seat latch mechanism plunger jammed in the "up" position, failing to relock upon release of the seat adjustment lever. This condition could permit inadvertent fore and aft travel of the pilot/copilot seat.

This service release provides material and instructions to install a bracket over the plunger/ seat track release link assembly to prevent excessive upward movement of the plunger, thus insuring relocking of the plunger when the seat adjustment lever is released.

1. Remove the pin, washer and cotter pin attaching the seat track release link to the seat track release handle, as shown above. Retain hardware for reinstallation. Do not remove link and plunger assembly from seat runner channel.
2. Remove the two plunger guide attachment screws as shown above. Retain screws for reinstallation and discard cap nuts.
3. Install bracket 55842-02 to seat runner channel, as shown above, using the two existing screws and two new MS20364-1032C nuts (procure nuts locally).
4. Attach seat track release link to seat track release handle using existing hardware as shown.
5. Make proper logbook entry of Service Bulletin 525 compliance.
