# SERVICE BULLETIN

No. 567

Piper Aircraft Corporation

Subject: Flap Solenoid Repositioning

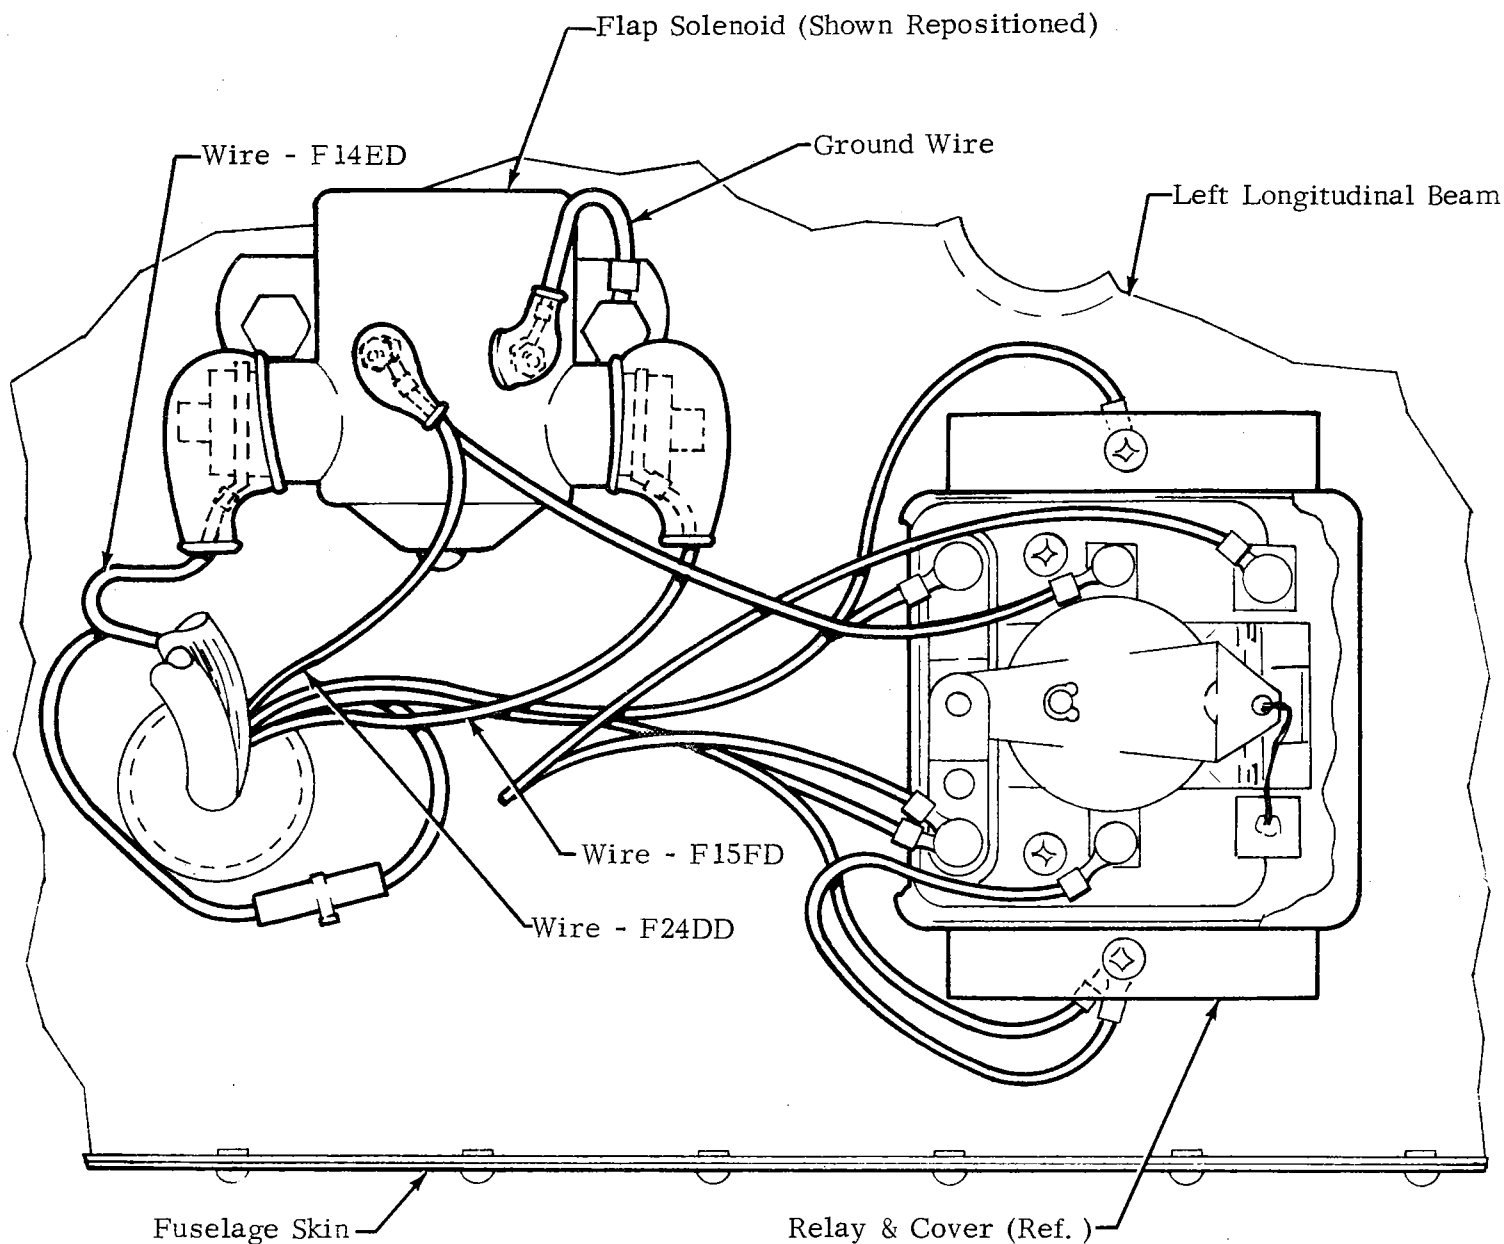
Purpose: The potential exists for the aileron balance cable to contact an electrical terminal on the flap solenoid. If the aileron balance cable should contact an exposed flap solenoid terminal, the flap system may become inoperative and/or the aileron balance cable may be damaged.

1. Refer to attached sketch/instruction data (to invert the solenoid).
2. Visually check aileron balance cable (near solenoid) for indications of damage; replace, if necessary.
3. Adjust position of solenoid terminal insulating boots (if necessary).

1. Remove the center floor panel from the main cabin area to gain access to the flap solenoid. Solenoid is located on the left longitudinal beam between the fuselage bulkheads at stations 162.60 and 174.00.
2. Remove the electrical wires from the solenoid.
3. Remove the solenoid from the beam and reinstall in the inverted position as shown above.
4. Reinstall the electrical wires to the solenoid.
5. Reinstall the center floor panel.
6. Make proper logbook entry of Service Bulletin compliance.
