# SERVICE BULLETIN

No. 595

Piper Aircraft Corporation

Subject: Elevator Outboard Hinge Bracket Rivets Replacement

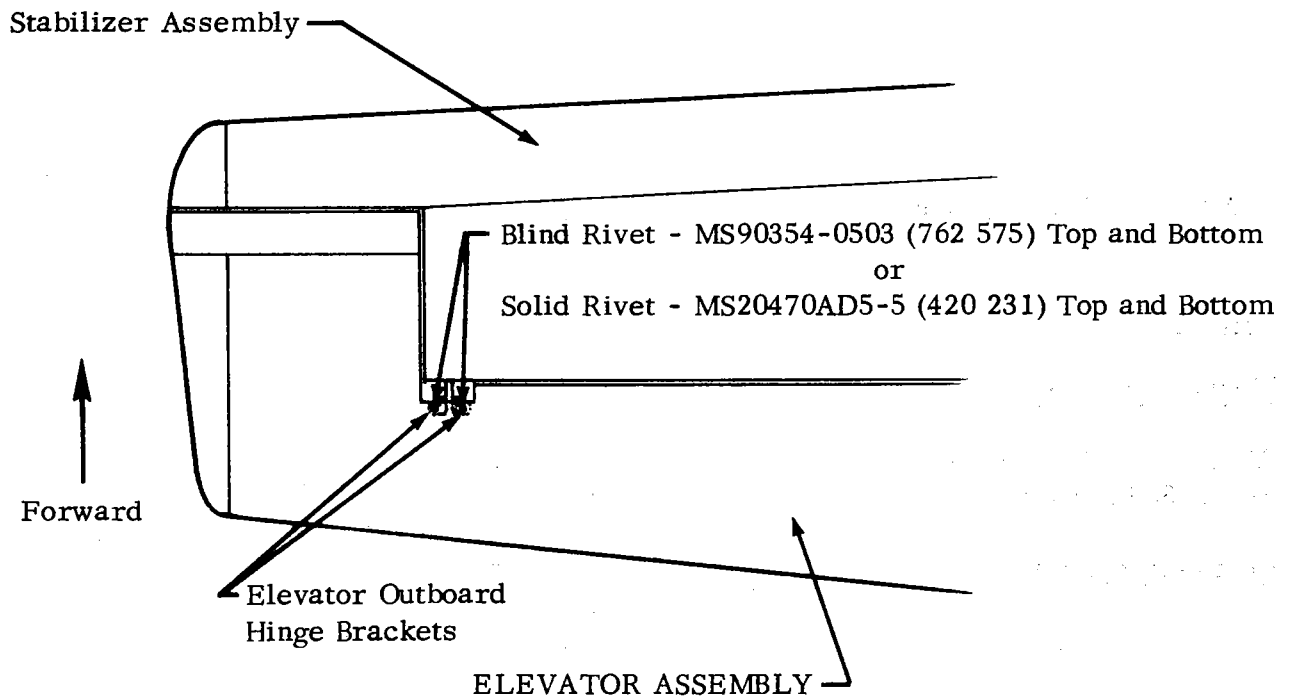
Purpose: It has been determined that in the above referenced aircraft there exists a possibility of the rivets for the upper and lower attach point on the elevator outboard hinge bracket shearing and remaining undetected.

TOP VIEW OF LEFT ELEVATOR SHOWN - RIGHT ELEVATOR OPPOSITE

1. Locate the two outboard elevator hinge brackets, on the left and right elevators, as shown on sketch above.
2. Replace existing MS20470AD4 solid rivets, attaching elevator hinge brackets to spar flange and skin, with MS90354-0503 blind rivets as follows. (If the MS90354-0503 blind rivets cannot be installed, due to lack of equipment etc., proceed to step 3 for alternate MS20470AD5-5 solid rivet installation. ) Accomplish on left and right elevator assemblies.

- a. Remove one of the four (4) existing hinge bracket rivets as shown above. Removing one rivet at a time will prevent misalignment of the outboard elevator hinge brackets.

- b. Enlarge the rivet hole to .166 dia. (#19 drill). Install MS90354-0503 rivet.
  - c. Repeat steps a. and b. above for each of the three (3) remaining rivets.

- d. Make proper logbook entry of Service Bulletin 595 compliance.
3. If MS90354-0503 blind rivets cannot be installed, it will be acceptable to install MS20470AD5-5 solid rivets as follows. Accomplish on left and right elevator assemblies.

- a. Refer to appropriate Navajo Service Manual and remove elevator assembly.
  - b. Remove one of the four (4) existing hinge bracket rivets as shown above. Removing one rivet at a time will prevent misalignment of the elevator hinge brackets.

- c. Enlarge the rivet hole to .166 dia. (#19 drill). Install MS20470AD5-5 rivet.
  - d. Repeat steps b. and c. above for each of the three (3) remaining rivets.

- e. Reinstall elevator assembly per appropriate Navajo Service Manual.
  - f. Make proper logbook entry of Service Bulletin 595 compliance.
