# SERVICE BULLETIN

No. 604A

Piper Aircraft Corporation

PART II: Forward Baggage Door Lock Arm Assembly Inspection

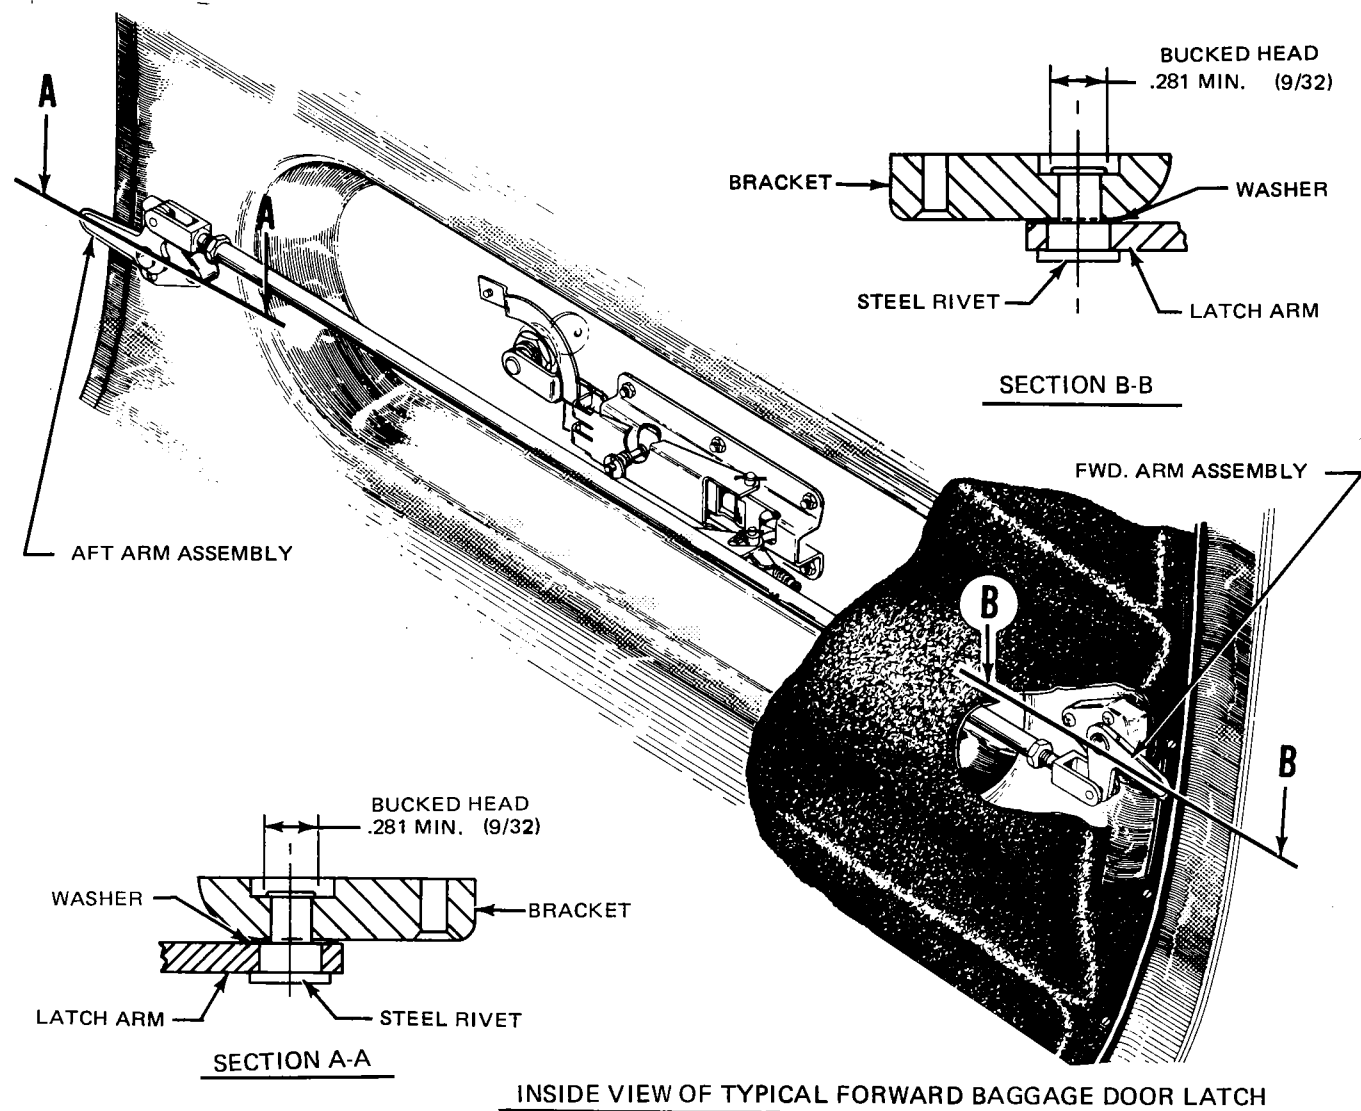
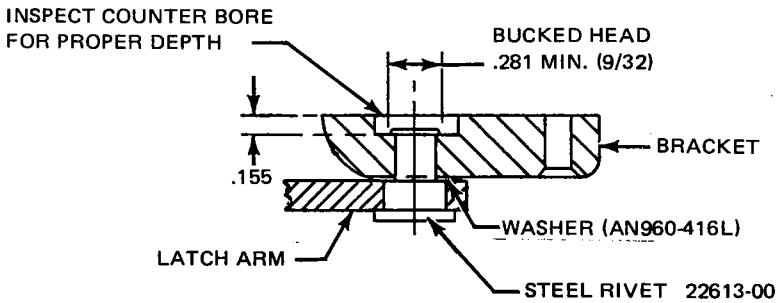
FIGURE 1

The door lock arm assemblies on the forward or nose, baggage door on the above referenced models are secured to brackets by steel rivets. It has been determined that for optimum arm assembly-to-bracket security, the bucked (peened) head of the rivet should have a diameter of .281 inch or greater.

1. Refer to Section IV in the appropriate Service Manual and remove the door latch arm assemblies from the forward baggage door.
2. With the latch arm assemblies removed from the door, inspect as follows.
  - a. Measure the diameter of the bucked head of the steel rivet that secures the latch arm to the bracket (Refer to Section A-A and B-B on Sketch A). This diameter must be .281 (9/32) or greater.
3. Latch arm assemblies with a bucked head diameter of .281 (9/32) or greater may be considered acceptable.
4. Latch arm assemblies with a bucked head diameter of less than .281 (9/32), must either be replaced with a new part as listed in the table below or may be reworked as follows.
  - a. Peen rivet head, in an acceptable manner, to achieve a bucked head diameter of .281 (9/32) or greater, as shown.

NOTE: Latch arm assemblies not retaining freedom of rotational movement, after head of rivet is peened, must be replaced with a new part as listed in Table below or steel rivet may be replaced as follows. (Refer to Sketch "A", Figure 1. )

- (1) Carefully drill out steel rivet. Maximum allowable hole size after drilling is .267.
  - (2) Inspect the .50 diameter counter bore in bracket to determine if counter bore is the proper depth as shown. Counter bore the hole to .155 if it is not the proper depth.
  - (3) Install new rivet Part No. 22613-00 and peen in an acceptable manner to achieve a bucked head diameter of .281 (9/32) or larger.

NOTE: Latch arm assemblies not retaining freedom of rotational movement after rework, must be replaced with a new part as listed in Table below.
5. Install new or reworked latch arm assemblies to forward baggage door. Refer to Section IV in the appropriate Service Manual.
6. Make proper Logbook entry of Service Bulletin 604A "Part II" compliance.
