SERVICE BULLETIN

No. 643A

Piper Aircraft Corporation

Subject: Oil and Manifold Pressure Tubes Inspection

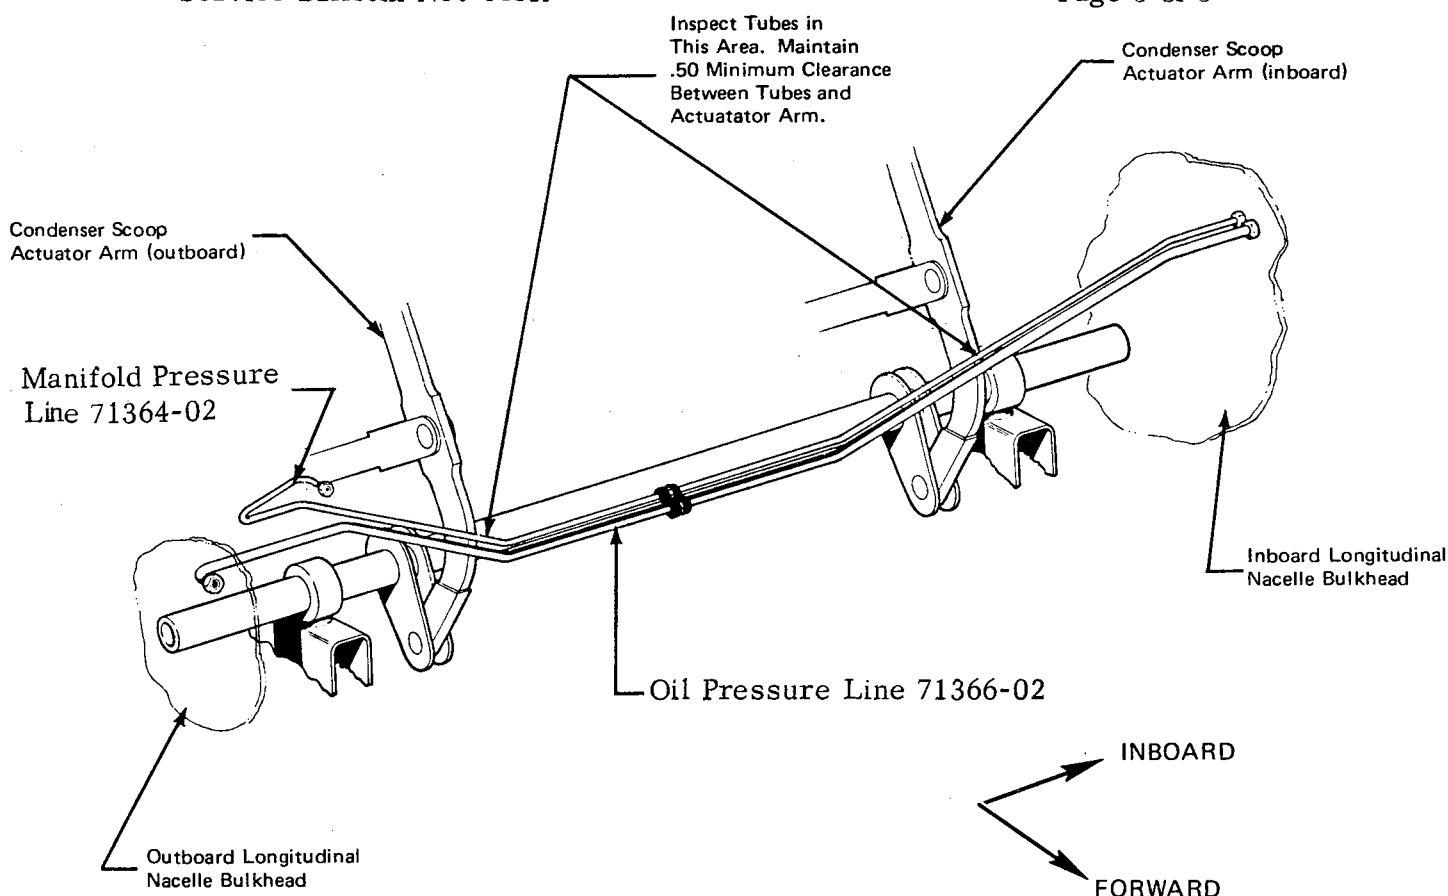
It has been determined that in the aircraft listed above which have air conditioning installed, there exists a possibility of oil pressure and manifold pressure tubes coming into contact with the air conditioner condenser scoop actuator arms. Such contact could cause damage to the oil pressure and manifold pressure tubes and could result in inaccurate indications or in the loss of oil from the affected engine.

1. Remove the top, inboard and outboard access panels from the right engine nacelle to gain access to the oil pressure and manifold pressure tubes.
2. Inspect the oil pressure and manifold pressure tubes for possible chafing or interference with the condenser scoop actuator arms as shown.

3. If the oil pressure and/or manifold pressure tubes are not chafed, proceed to Step 5.
4. If the oil pressure and/or manifold pressure tubes are chafed, at either inboard or outboard actuator arm, tubes must be replaced with new tubes as shown on sketch above.

5. Operate the condenser scoop to the full open position and inspect for proper clearance between the actuator arms and oil pressure, manifold pressure tubes as shown above.

- a. If clearance between actuator arms and tubes is .50 or larger, proceed to Step 6.
 - b. If clearance between actuator arms and tubes is not .50, carefully reposition tubes to gain .50 minimum clearance.

6. Operate condenser scoop to insure .50 minimum clearance, between tubes and actuator arms, during complete cycle.
7. Reinstall access panels removed for this inspection/replacement.
