SERVICE BULLETIN

No. 645A

Piper Aircraft Corporation

<u>Subject:</u>	Crossfeed Valve Inspection
<u>Reason for Revision:</u>	To add Serial Numbers
<u>Models Affected:</u>	<u>Serial Numbers Affected:</u>
PA-31-300/PA-31/ PA-31-325 Navajo	31-2 through 31-7812108, 31-7812116, 31-7812120 through 31-7812123, and 31-7812125
PA-31-350 Chieftain	31-5001 through 31-7852138, 31-7852140 through 31-7852193
<u>Compliance Time:</u>	Within the next one hundred (100) hours of operation or at the next scheduled inspection event, whichever occurs first.

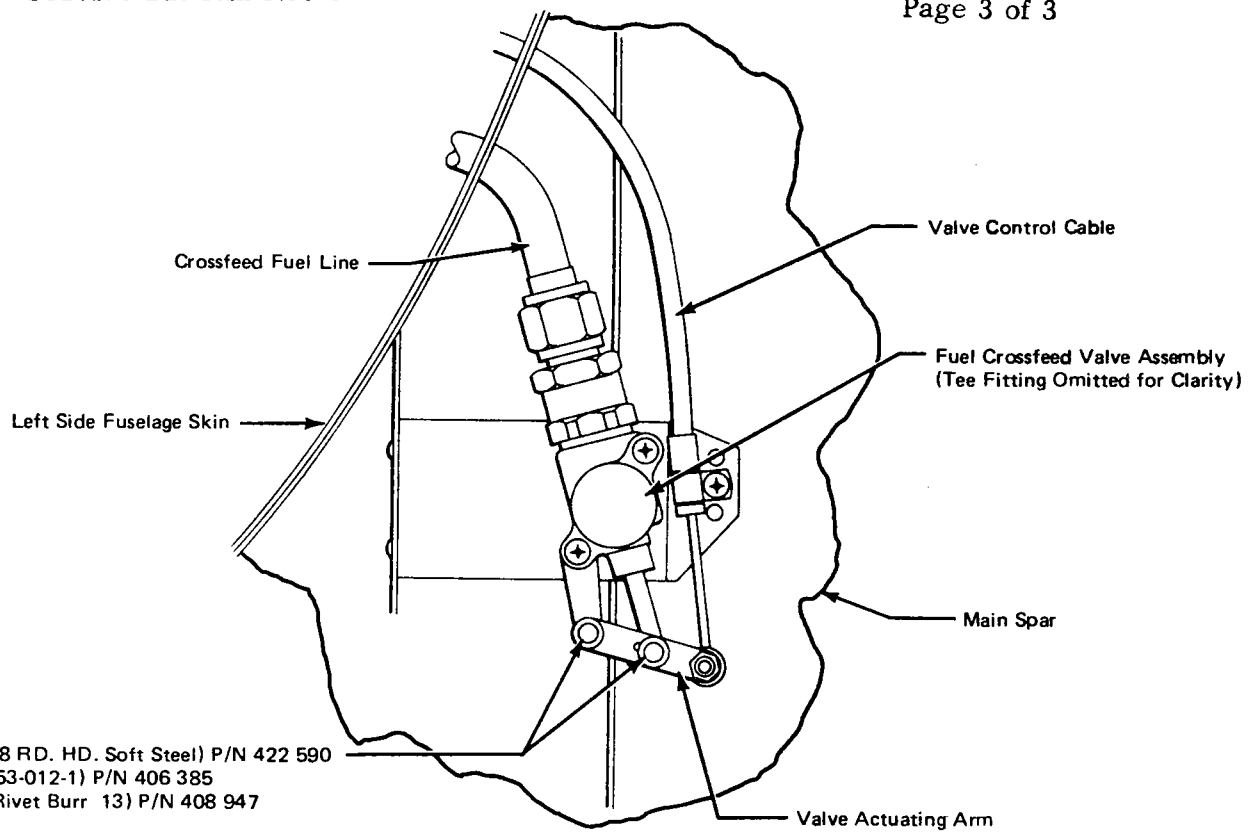
PA-31 & PA-31-325

It has been determined that in some of the above referenced aircraft, the crossfeed valve actuating arm may be connected to the crossfeed valve with aluminum rivets rather than soft steel rivets. This Service Release provides instructions for the inspection of the rivets and the replacement of any aluminum rivets with soft steel rivets to lessen the possibility of a sheared rivet and resulting interference with crossfeed operation.

1. Gain access to the crossfeed valve (Piper Part No. 492 110) by removing the access panel on the lower left wing root.
2. Inspect the two (2) rivets securing the crossfeed actuating arm to the crossfeed valve (Refer to attached Sketch.) The aluminum rivets have a brazier type head and are non-magnetic. Soft steel rivets have a half round head and are magnetic.
3. If the rivets are soft steel (Piper Part No. 422 590), no further action is necessary. Reinstall access panel and make appropriate logbook entry of compliance.

4. If the rivets are aluminum (Piper Part No. 420 189), remove and replace Tinnermann nuts, and remove and replace any aluminum rivets (420 189) with soft steel rivets (422 590).
5. Check valve for secure attachments and proper action.
6. Reinstall access panel and make appropriate Logbook entry of compliance.
