SERVICE BULLETIN

No. 664

Piper Aircraft Corporation

Subject: Elevator Torque Tube Attachment Inspection

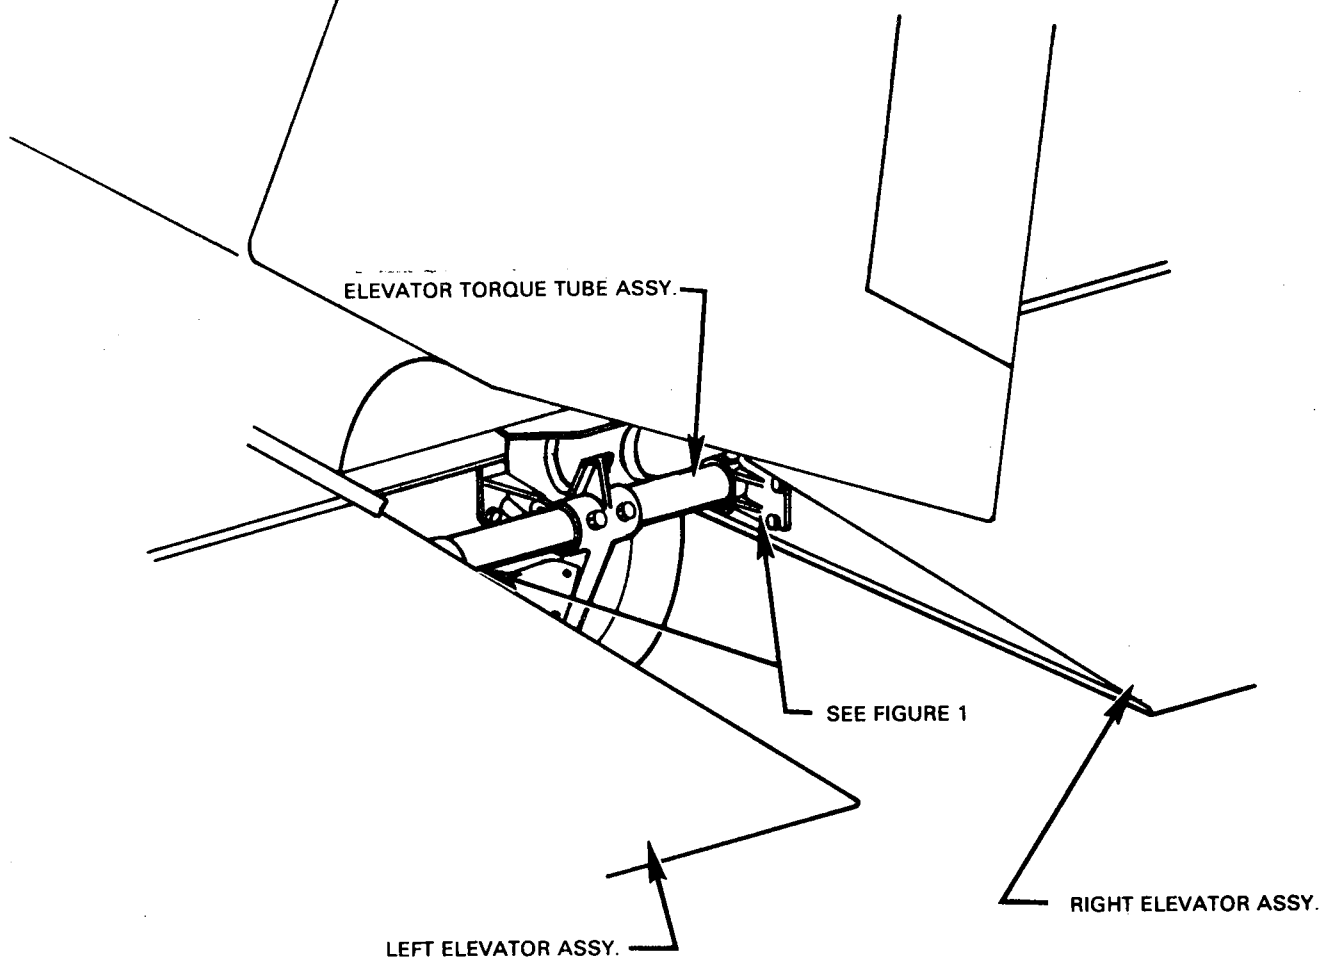
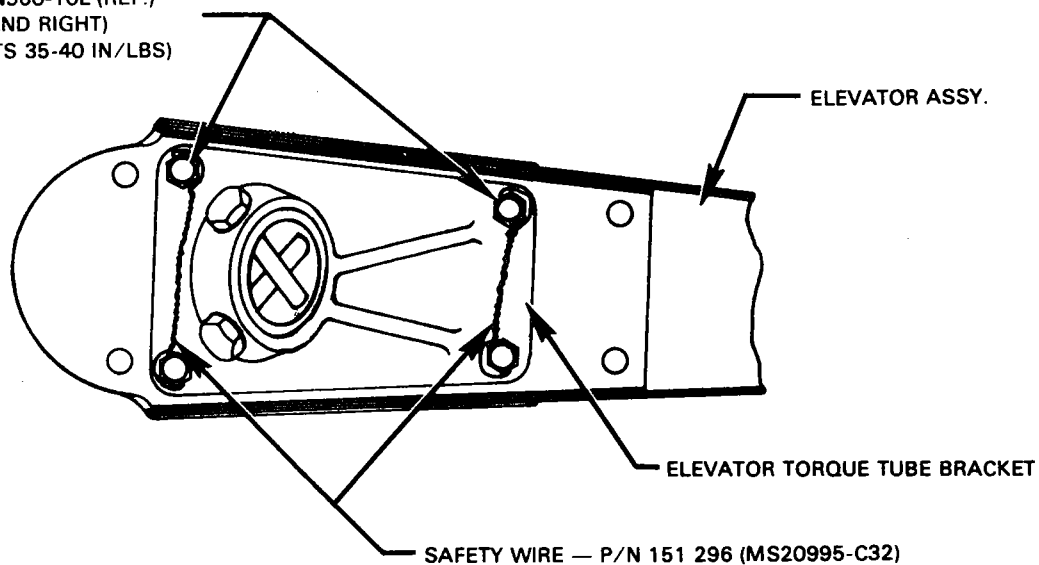
FIGURE 1

On the above-listed aircraft, a possibility exists of the elevator torque tube attachment to the elevator butt ribs having anchor nuts which do not meet the self-locking requirement. Should the bolts back out of the anchor nuts, impairment of elevator operation or loss of elevator control could result.

BOLT — P/N 401 267 (AN3H-5A)
 WASHER — AN960-10L (REF.)
 4 REQ. (LEFT AND RIGHT)
 (TORQUE BOLTS 35-40 IN/LBS)

RIGHT ELEVATOR BRACKET SHOWN - LEFT ELEVATOR BRACKET OPPOSITE

1. Remove tail fairing to gain access to the elevator torque tube assembly (see attached sketch).
2. Remove one of the bolts that attach the torque tube to the elevator.
3. Reinstall the bolt using just the fingers. If using just the fingers to tighten, the head of the bolt contacts the forging, loss of the self-locking feature of the anchor nut is indicated.
4. Repeat steps 2 and 3 above on each of the eight (8) affected bolts.

5. If all eight (8) anchor nuts prove to be self-locking, torque bolts to 35-40 inch-pounds, replace tail fairing, and make appropriate logbook entry of compliance with this service release.
6. If one (1) or more of the anchor nuts are not self-locking, then all eight (8) of the affected bolts must be replaced as follows:
 - a. Refer to attached Sketch, Figure 1.
 - b. Replace the eight (8) bolts with drilled head AN3H-5A bolts (Piper Part Number 401 267). Use existing AN960-10L washers.
 - c. Torque bolts to 35-40 inch-pounds.
 - d. Safety wire the forward two (2) bolts and the aft two (2) bolts together with MS20995-C32 Safety Wire (Piper Part Number 151 296).
 - e. Reinstall tail fairing and make appropriate logbook entry of compliance with this Service Release.
