SERVICE BULLETIN

No. 739

Piper Aircraft Corporation

Restriction of Flap Travel and Inspection
of Wing Flap Flexible Drive Shaft

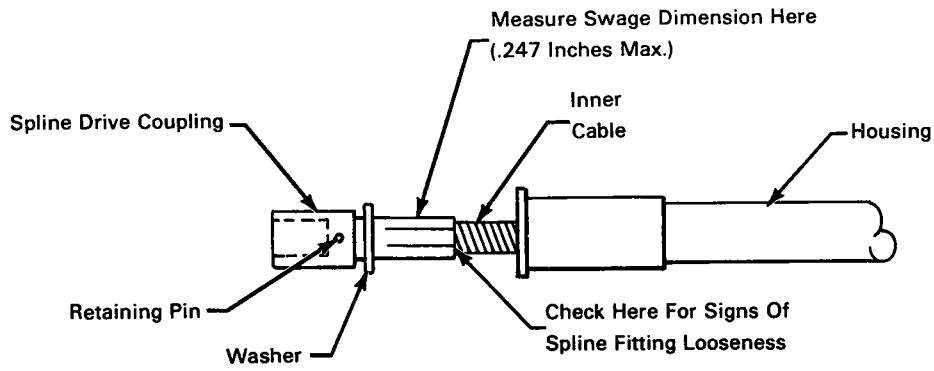
FIGURE 2

4. Visually inspect the flexible shaft splined drive coupling and retaining pin for evidence of looseness on the cable swage fitting. (Ref Sketch D, Figure 2.) If any looseness is apparent, replace the flexible shaft assembly.

5. Inspect the swaged fittings at both ends of the flexible shaft as follows:
 - a. Expose the swaged portion of the inner cable at the motor end by twisting the outer housing two (2) turns clockwise. The swaged portion of the cable should have eight (8) flats clearly visible and free from deep scratches or wear marks. (Ref Sketch D, Figure 2.)

- b. Using a micrometer, or dial caliper, measure the diameter of the swage for each of the flats at the middle of the swaged portion of the cable. A total of four (4) measurements should be taken. If any of the measurements exceed .247 inches, replace the drive shaft

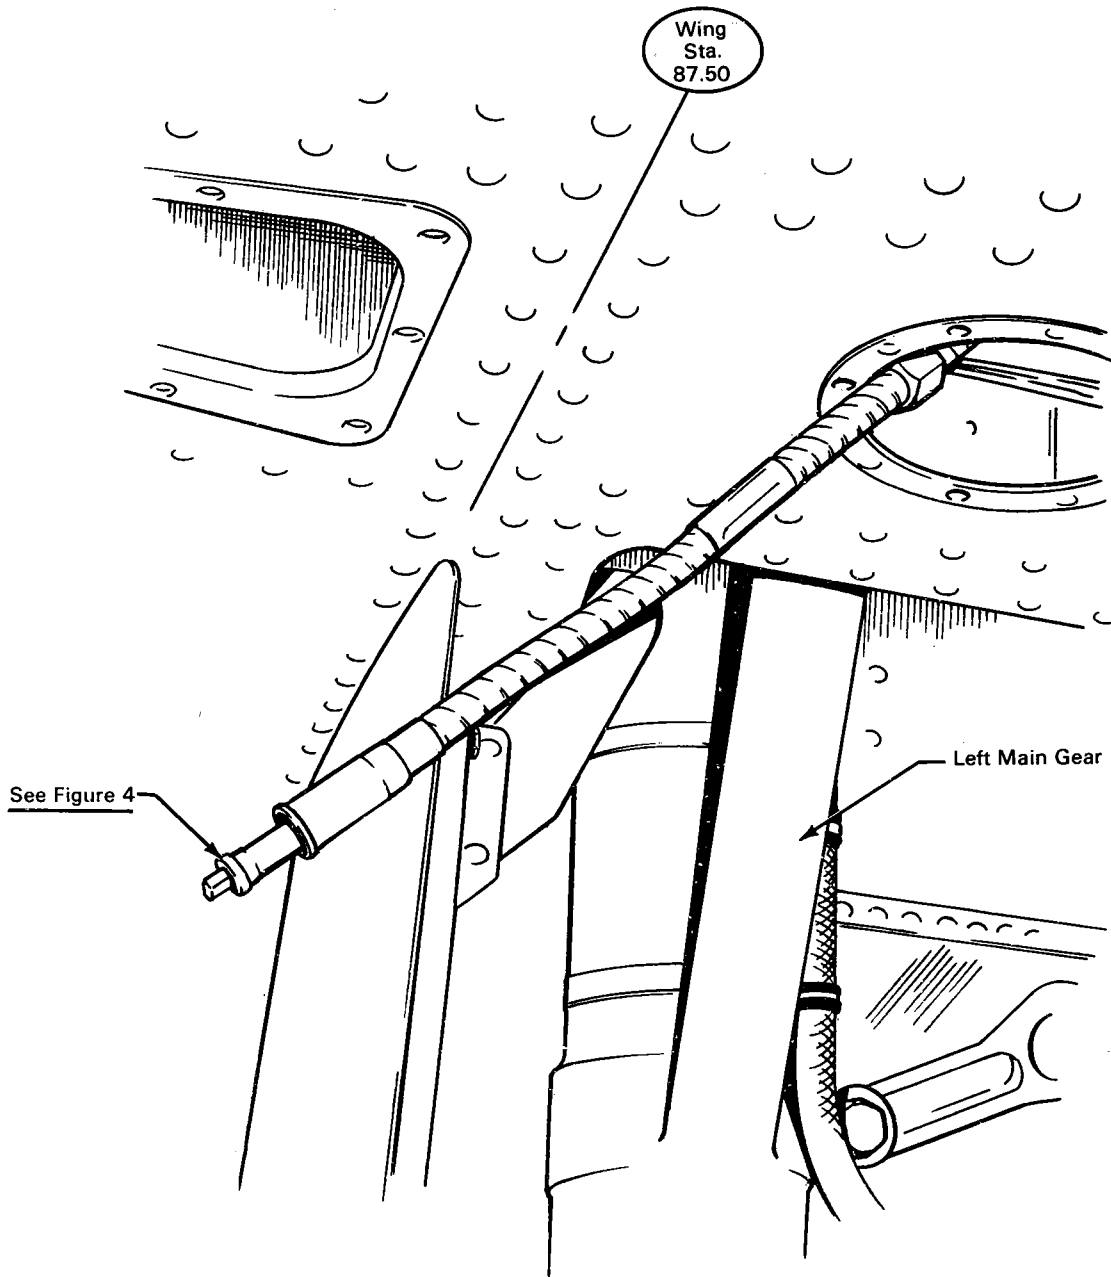
SKETCH E

- c. Disconnect drive shaft from the flap transmission. Using caution not to damage the shaft housing, route inboard through the Sta. 87.50 bulkhead. (ref Sketch E.) Inspect the swaged portion of the drive blade fitting end as described in "a" and "b" above.

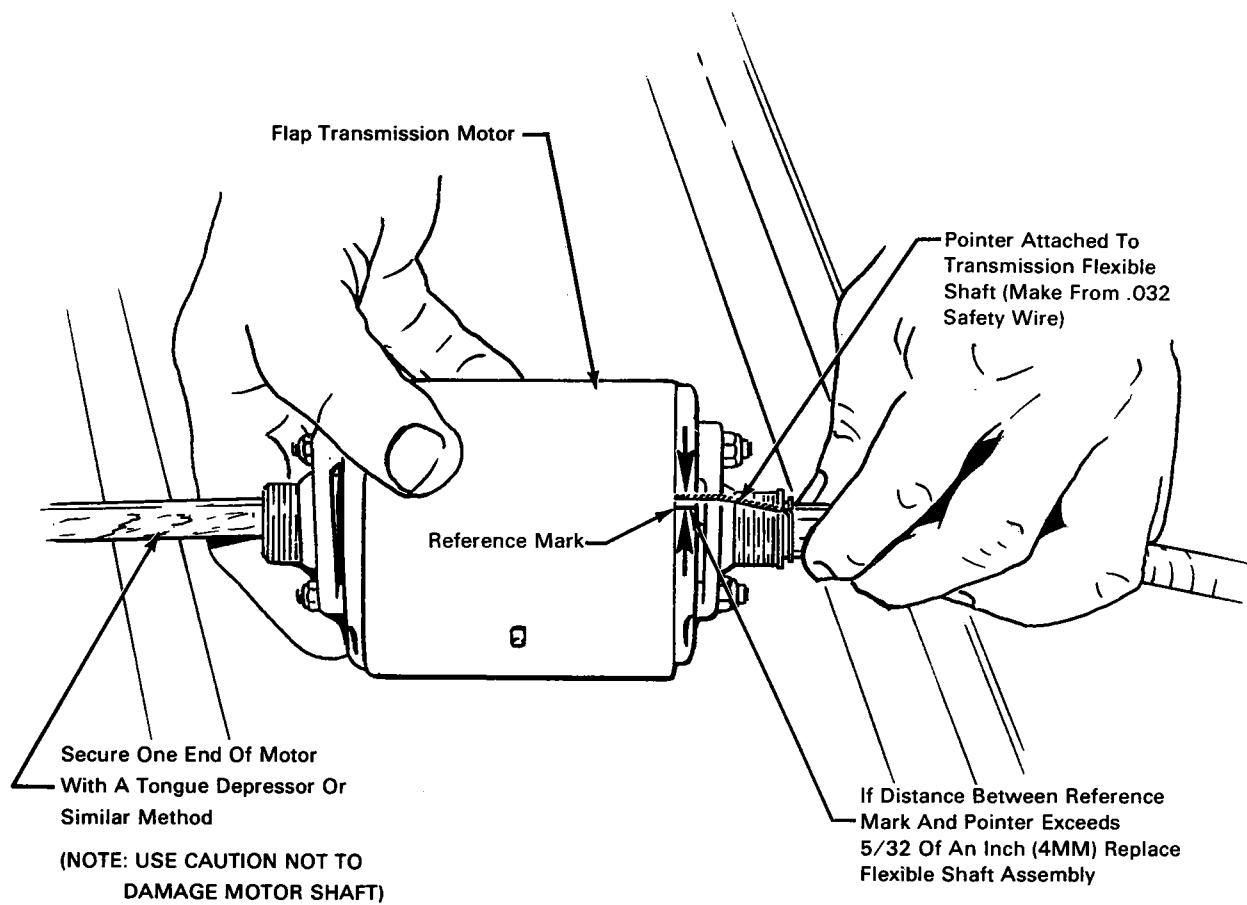
**FIGURE 5****SKETCH F**

6. Inspect the internal splines of the drive coupling for evidence of wear. If splines are distorted or significantly worn, replace the drive shaft. Use the following method to determine if the amount of spline wear is acceptable.

- b. Hold the spline end of the flexible shaft securely with one hand, and gently turn the flap motor to remove rotational play in the splines. Place a reference mark on the motor housing adjacent to the wire pointer (Ref Sketch F, Figure 5). Turn the flap motor gently in the opposite direction to remove rotational play and place another reference mark on the motor housing. If any distance between these two marks exceed 5/32 of an inch (4 mm) replace the flexible shaft assembly (Ref Sketch F, Figure 5).
