Piper Aircraft Corporation
Vero Beach, Florida, U.S.A.

SERVICE *No. 779B* BULLETIN

Date **October 12, 1987** **M**

SUBJECT: Landing Gear Upper Bearing
Retaining Pin Replacement and Strut
Assembly Inspection.

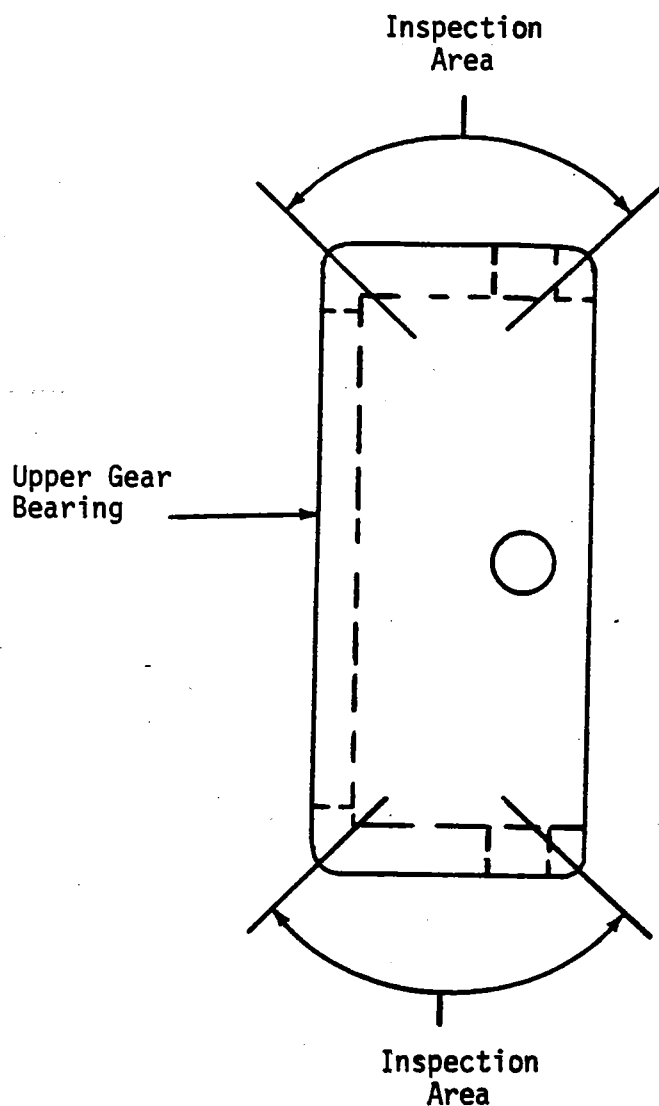
SKETCH "A"

Additionally, some aircraft may have landing gear upper bearings with rough surfaces or ridges which could score strut housing walls, generate aluminum dust, and cause premature wear of strut components. This could result in leakage, loss of strut pressure, and loss of shock-absorbing.

Note: For All PA-31/31T/31P Series Aircraft, Upper Main Gear Bearing, Piper Part Number 40247-00 and/or Upper Nose Gear Bearing, Piper Part Number 31779-00. Inspection Area Must Be Chrome Plated And Have a Smooth Surface (No Ridges Allowed) Between Indicated Points on Entire Outside Surface.

For All PA-42 Cheyenne III Aircraft, Upper Main Gear Bearing, Piper Part Number 57470-02 and/or Upper Nose Gear Bearing, Piper Part Number 31779-02 are Manufactured of Bronze Alloy And Are Not Plated. Inspection Area Should Have a Smooth Surface (No Ridges Allowed) Between Indicated Points on Entire Outside Surface.

Remove the upper bearing and inspect the area shown in Sketch A.
If ridges are found in the designated inspection area, replace the bearing.
Any replacement bearing should also be inspected per Sketch A prior to installation.
