## Piper Aircraft Corporation

# SERVICE *No. 822* BULLETIN

Special Inspection of Hydraulic Hose,  
Piper Part Number 17766-02 (465-138)

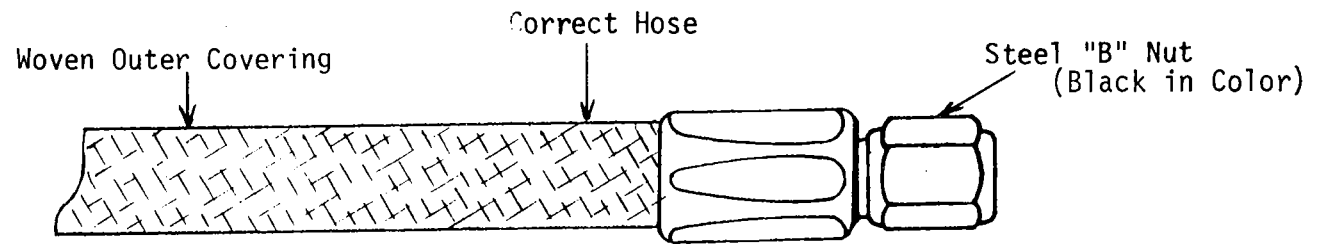
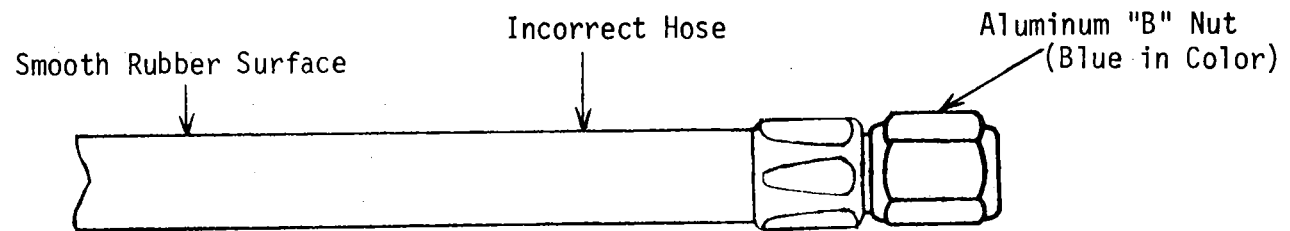
SKETCH "A"

It has been determined that a group of hydraulic  
hoses, Piper Part Number 17766-02 (465-138), were manufactured using material  
that does not meet the pressure requirements for operation in the aircraft  
hydraulic system. If an installation has been made using these hydraulic hoses,  
premature failure will result in a loss of hydraulic capabilities.

1. Refer to the appropriate aircraft parts catalog and maintenance manual for location and quantity requirements for specific model application.
2. Gain access as required by model for visual inspection of each affected hose. See Sketch "A" attached.
3. Replace any hose found to be of incorrect material prior to further flight.
4. If replacement is required by inspection, perform a hydraulic systems function check per the appropriate maintenance manual.
5. Make appropriate logbook entry of compliance with this Service Bulletin.
