Piper Aircraft Corporation
Vero Beach, Florida, U.S.A.

SERVICE *No.* 923 BULLETIN

Date August 16, 1989 M

Main Landing Gear Actuator
Reinforcement Bracket Replacement

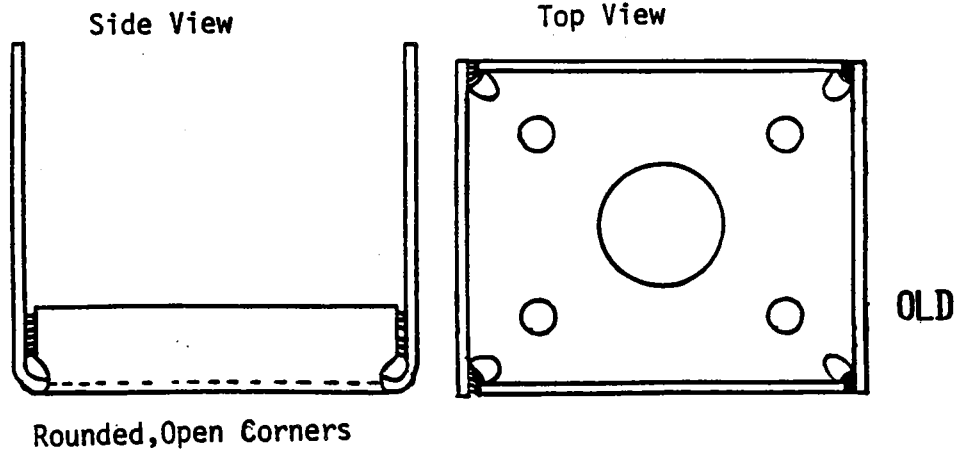
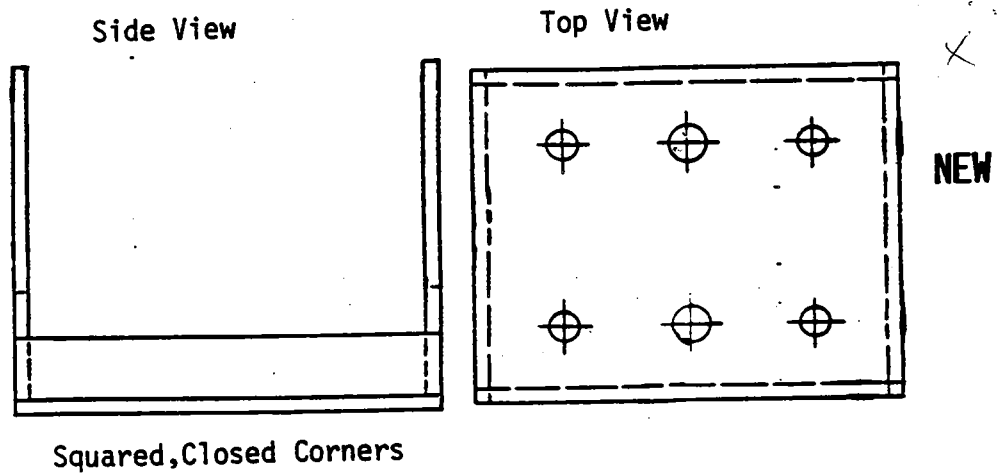
PURPOSE: Field reports have been received of cracks developing in the Main Landing Gear Actuator Reinforcement Bracket(s). If this condition exists and is left uncorrected, failure of the bracket(s) could occur disabling the main landing gear actuator on the affected side(s).

Some aircraft may have the new actuator reinforcement brackets (Piper Part Number 73786-02) installed as replacement parts. Refer to Sketch "A" for identification of Piper Part Numbers 40776-00 (old) and 73786-02 (new). Aircraft with Piper Part Number 73786-02 installed on both sides are in compliance with this Service Bulletin.
