SERVICE *No. 926A* BULLETIN

Hartzell Service Bulletin No. 165 E,
Inspection for Cracks in Certain
Three Blade "Y" Shank Aluminum
Propeller Hubs

SERVICE BULLETIN 165E

Inspection for Cracks in Certain Three Blade "Y" Shank Aluminum Hubs

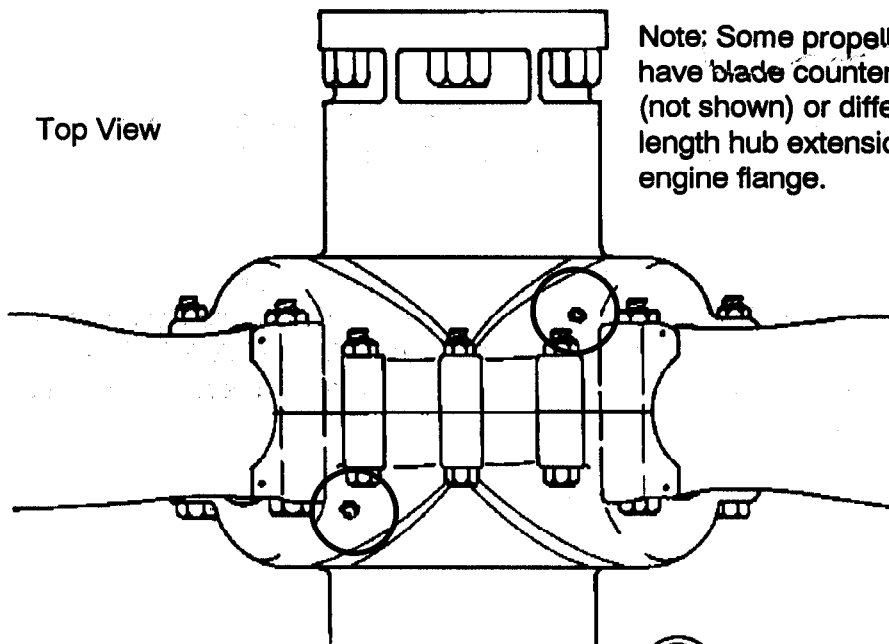
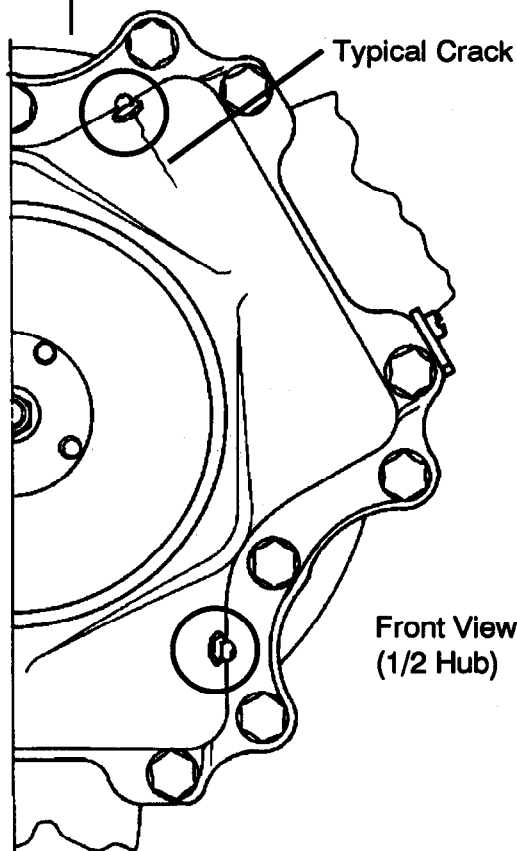
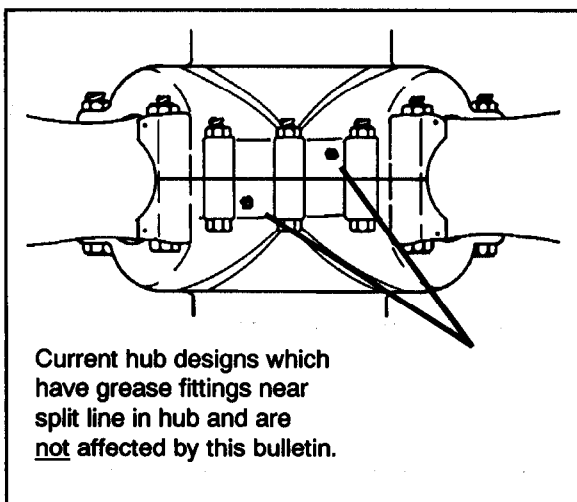
Figure 1. Hub Grease Fittings

In Hartzell three blade "compact" aluminum hub propellers, cracks typically originate in the threads of a grease fitting hole on the inside of the hub. As the cracks propagate around the blade arm of the hub, their progression accelerates and results in failure of one hub half. Several incidents have continued to progress to blade separation.

NOTE: Typically, cracks begin at the grease fitting and propagate perpendicular to blade around the blade arm barrel. Cracks may initiate on either hub half from any of the six (6) grease fittings.

Circled areas encompass grease fittings to be inspected at two points on each blade socket

Current hub designs which have grease fittings near split line in hub and are not affected by this bulletin.

3. Use 10X magnifying glass and light source to perform careful visual inspection of the hub for hairline cracks in the general vicinity of blade retention bearings, but primarily inspect the grease fitting areas as shown in Figure 1. Perform inspections with grease fittings installed.

- 2) Scan probe gradually around each of the six grease fittings on the propeller hub. See Figure 1, scan probe in a manner to cross typical crack indications (rather than scanning in strokes that may be parallel to typical crack indications). The center of the probe tip must pass within 1/4 inch of the grease fittings and outward from the fitting as far as practical (up to 2 inches). The initial scanning around the grease fitting should consist of a circle with the probe as close to the grease fitting hole as possible. Perform subsequent scans of concentric circles around the grease fitting with no more than 1/10 inch spacing between circles.
