SERVICE No. 927 BULLETIN

Hartzell Service Bulletin No. 164,
Inspection for Cracks in Certain
Two Blade "Y" Shank Aluminum
Propeller Hubs

HARTZELL**SERVICE BULLETIN**SERVICE BULLETIN 164
CODE: C

SUBJECT:**Inspection for Cracks in Certain Two Blade "Y" Shank Aluminum Hubs
EFFECTIVITY:**

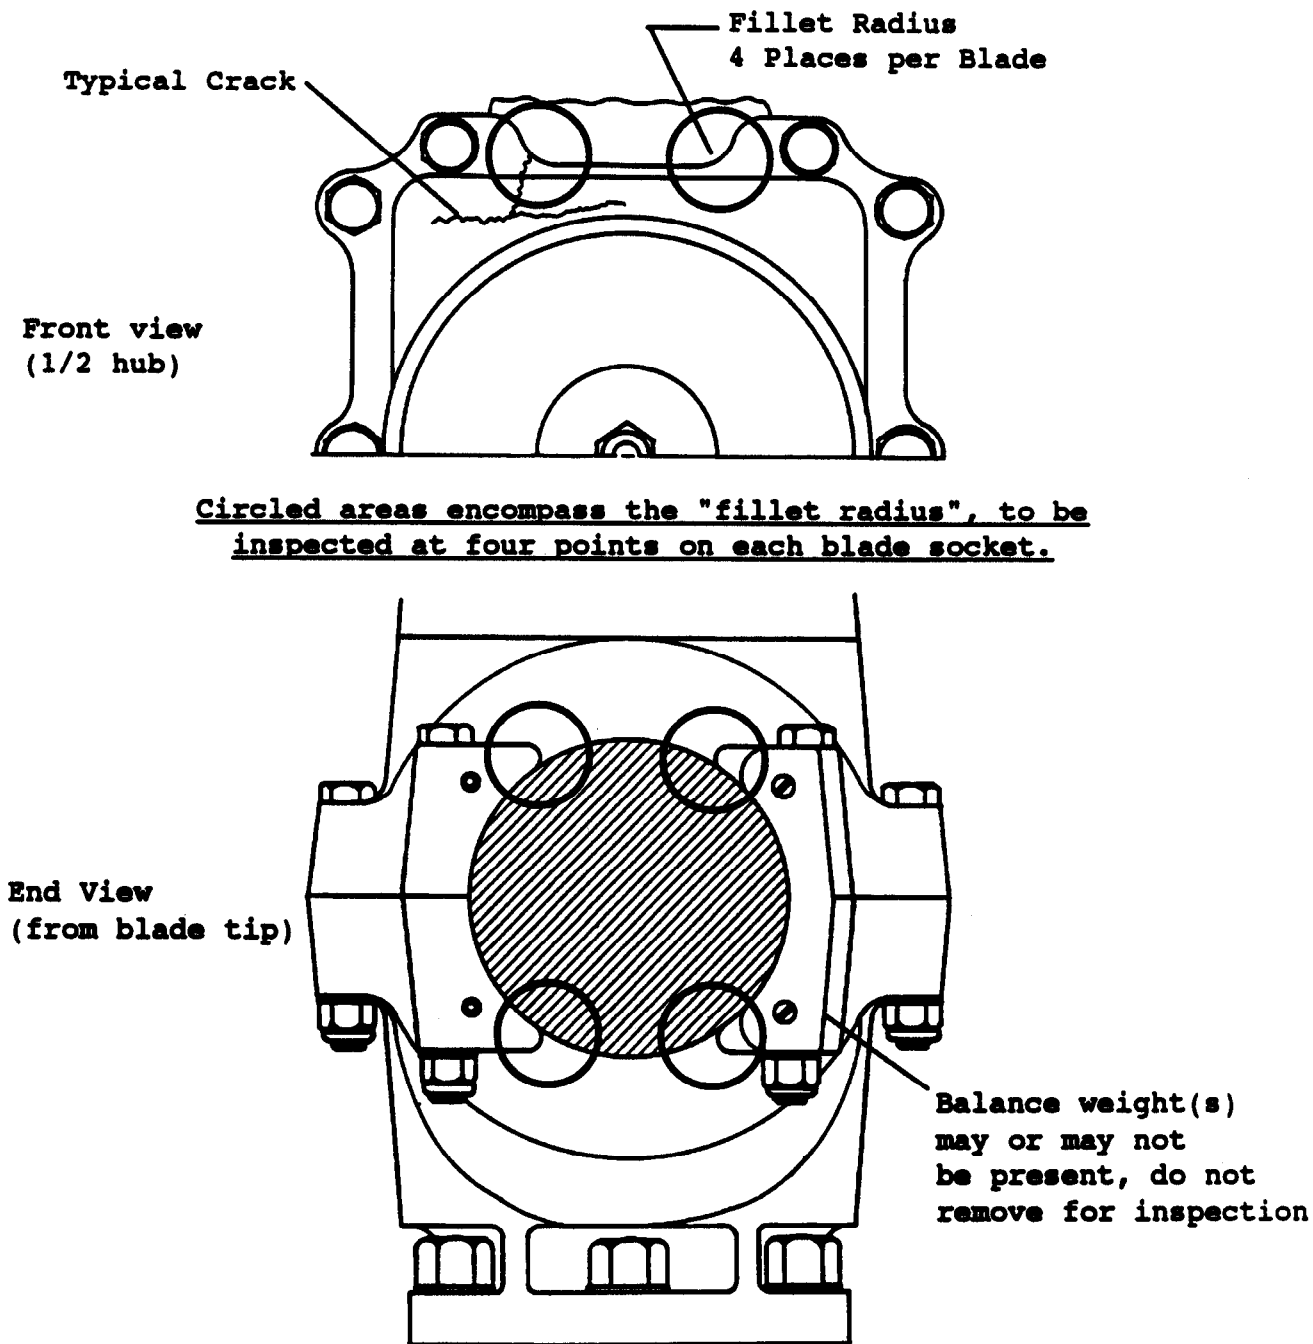
Figure 1. Hub Fillet Radius

Cracks typically initiate at the same point on the hub. The cracks are external and believed to be observable with careful visual examination. The cracks originate at a point adjacent to the blade called the "fillet radius". As the cracks propagate toward the center of the hub, their progression accelerates and results in failure of one hub half which can then, potentially, progress to blade separation.

1. Remove spinner dome.
2. If present, remove any paint*, grease or other matter which may hinder visual examination.
3. Use 10X magnifying glass to perform careful visual inspection for hairline cracks in the fillet radius area as shown in Figure 1.

NOTE: Typically, cracks begin at the outermost point and propagate inboard to a point where the crack divides and progresses in two directions around the blade arm barrel. Cracks typically initiate on the forward hub half (opposite side from the engine flange) in the fillet radius closest to the blade leading edge.

4. If no cracks are found, re-install spinner dome and make logbook entry indicating compliance.
5. If there are any indications of a crack, hub replacement (by an approved propeller repair station) must be accomplished prior to further flight.
