Service Letter No. 504

B. F. Goodrich Service Bulletin No. E-67-34  
(Prop De-Icer and Strap Restrainer Installation.)

PA-23-250, PA-E23-250 Aztecs  
PA-31 Navajos

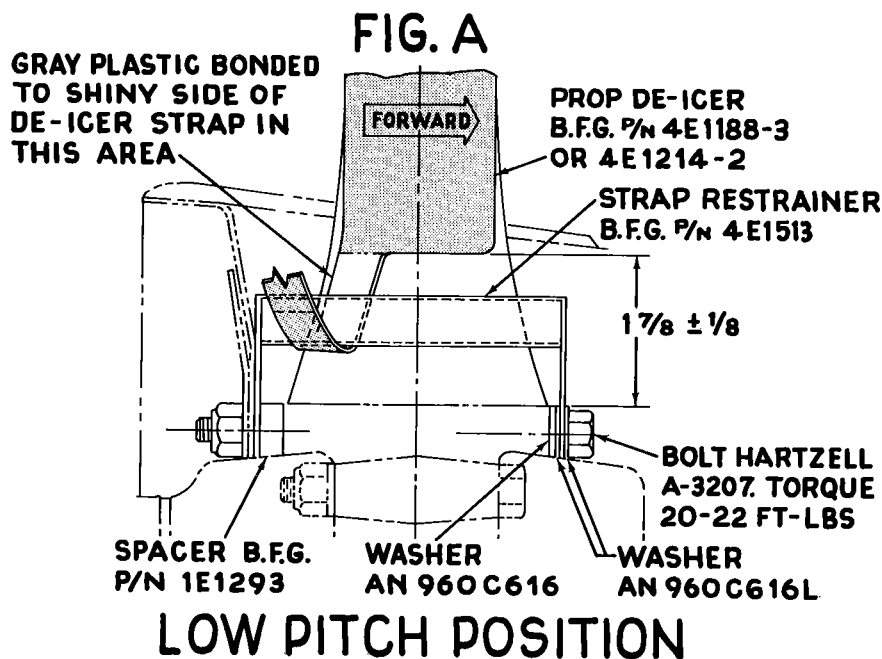
1. B.F. Goodrich De-Icers, P/N 4E1188-3 for Piper PA-31's and P/N 4E1214-2 for Piper PA-23 & E23-250's should have gray plastic bonded to the shiny side of De-Icer strap. See Fig. A.
2. Strap restrainers, B.F. Goodrich P/N 4E1513, should be positioned as shown in Fig. B when propeller blades are in full feather position.

- Procedure:**
1. Remove aircraft spinner domes.
  2. The propeller De-Icer, B.F. Goodrich P/N 4E1188-3 or 4E1214-2, should have the gray plastic bonded to shiny side of De-Icer strap. For removal and installation procedures, consult B.F. Goodrich De-Icer Installation Manual, Report No. 59-728C.
  3. If strap restrainers, B.F. Goodrich P/N 4E1513, are not positioned as shown in Fig. B, proceed as follows:
    - a. Loosen propeller hub bolts. Do Not Remove.
    - b. Rotate strap restrainers into correct clearance position as shown in Fig. B.
    - c. Tighten propeller hub bolts to 20-22 ft. lbs. torque.
  4. Replace aircraft spinner domes.
