# SERVICE LETTER

**No. 538**

<u>Subject:</u>	Inspection of Propeller Blade Shank (Reference attached Hartzell Bulletin No. 94, dated October 3, 1969)
<u>Models Affected:</u>	PA-31 Navajo (reference attached Hartzell Bulletin No. 94; <u>Effectivity</u> )
<u>Serial Numbers Affected:</u>	Reference attached Hartzell Bulletin No. 94; <u>Effectivity</u> .
<u>Compliance Time:</u>	Reference attached Hartzell Bulletin No. 94; <u>Required Action</u> .
<u>Purpose:</u>	To provide distribution and insure compliance with the attached Hartzell Bulletin No. 94.
<u>Instructions:</u>	Reference attached Hartzell Bulletin No. 94; <u>Required Action</u> .
<u>Material Required:</u>	Not applicable.
<u>Availability of Parts:</u>	Not applicable.
<u>Material Allowance:</u>	Not applicable.
<u>Labor Allowance:</u>	Not applicable.
<u>Material/Labor Allowance Termination Date:</u>	Not applicable.
<u>Disposition of Parts in Stock:</u>	Not applicable.
<u>Disposition of Replaced Parts:</u>	Not applicable.

Bulletin No. 94

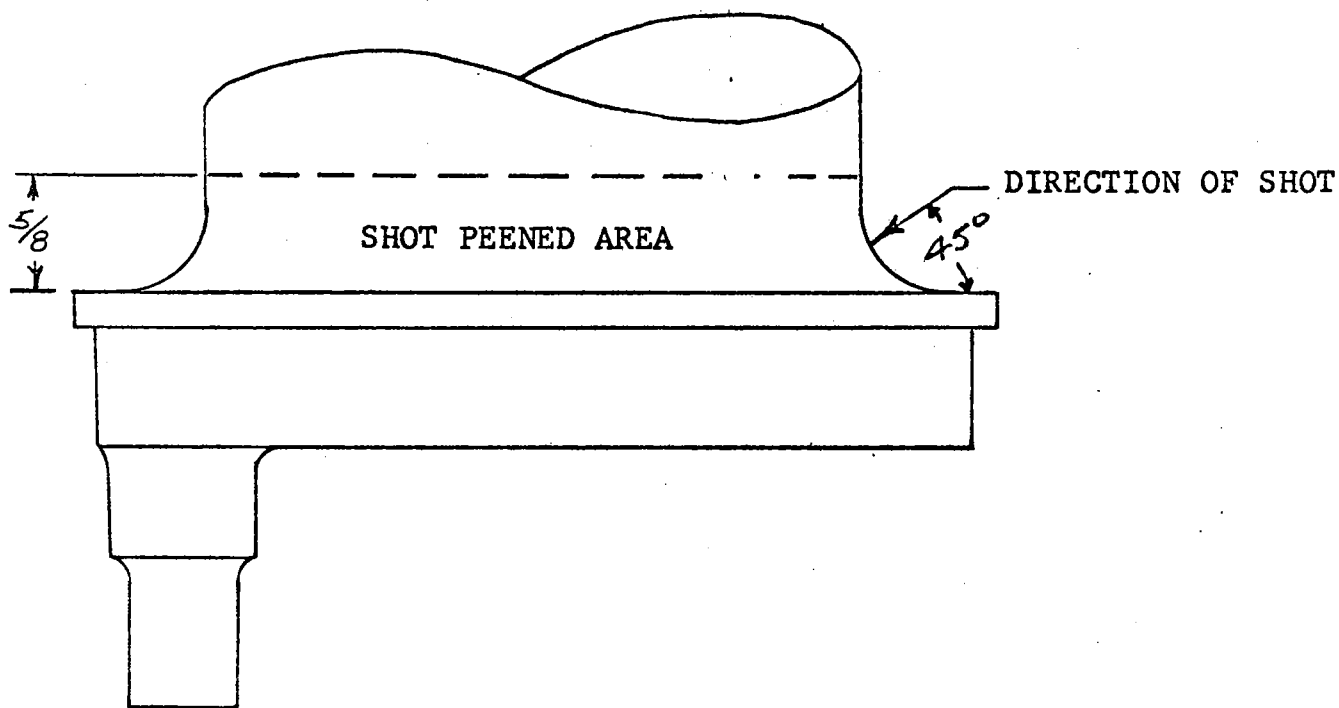
Discussion: After 1240 hours operation the cause of extreme vibration of one engine-propeller combination was found to be a cracked blade shank. This crack was due to fatigue, resulting from vibration of the system, and occurred at the outer edge of the ball bearing race which supports the blade within the hub.

1. For propellers which have been in service for 1000 hours or more, inspect the blade shanks within the next 100 hours, by the dye penetrant method, for cracks in the radius adjacent to the retention flange.
2. If no indications are found, re-shot peen the radius and return the propeller to service.
3. This inspection should be repeated at intervals of 500 hours, after the first 1000 hour inspection. Shot peening need not be repeated unless there is evidence that the bearing race has worn the surface smooth, or below the pebble grain; particularly in the area where the edge of the bearing race contacts the surface of the retention shoulder. If the propeller has been overhauled and at that time properly inspected, it is not necessary to repeat the inspection and re-shot peen until 500 hours has elapsed after that overhaul.

4. Disassembly and assembly of the propeller is described in Hartzell Manual No. 117( ).
5. Shot peen with S-390 shot, .007 to .010 inch arc height on C-2 Almen gage. Limit the shot peened area as shown below.
