PIPER

SERVICE
LETTER

No. 548

<u>Subject:</u>	Inspection of the Right Engine Control System Installation
<u>Models Affected:</u>	PA-31 and PA-31-300 Navajo
<u>Serial Numbers Affected:</u>	31-2, 31-4 to 31-526 incl., 31-528 to 31-536 incl., 31-538 to 31-561 incl., 31-563 to 31-578 incl., 31-580 to 31-584 incl., 31-586 to 31-596 incl., 31-598, 31-599, 31-602, 31-604 to 31-606 incl., 31-614, 31-619, 31-621, 31-623 to 31-626 incl., 31-629 to 31-632 incl., 31-637 and 31-641.
<u>Compliance Time:</u>	Recommended at the next 100 hour inspection.
<u>Purpose:</u>	To inspect the engine control system installation in the right engine nacelle area to insure the existance of proper clearance between the engine controls and engine fuel line.
<u>Instructions:</u>	Reference the sketch on reverse side of this letter for required clearance dimensions and instructions for re-positioning the engine controls, if necessary.
<u>Material Required:</u>	Not applicable.

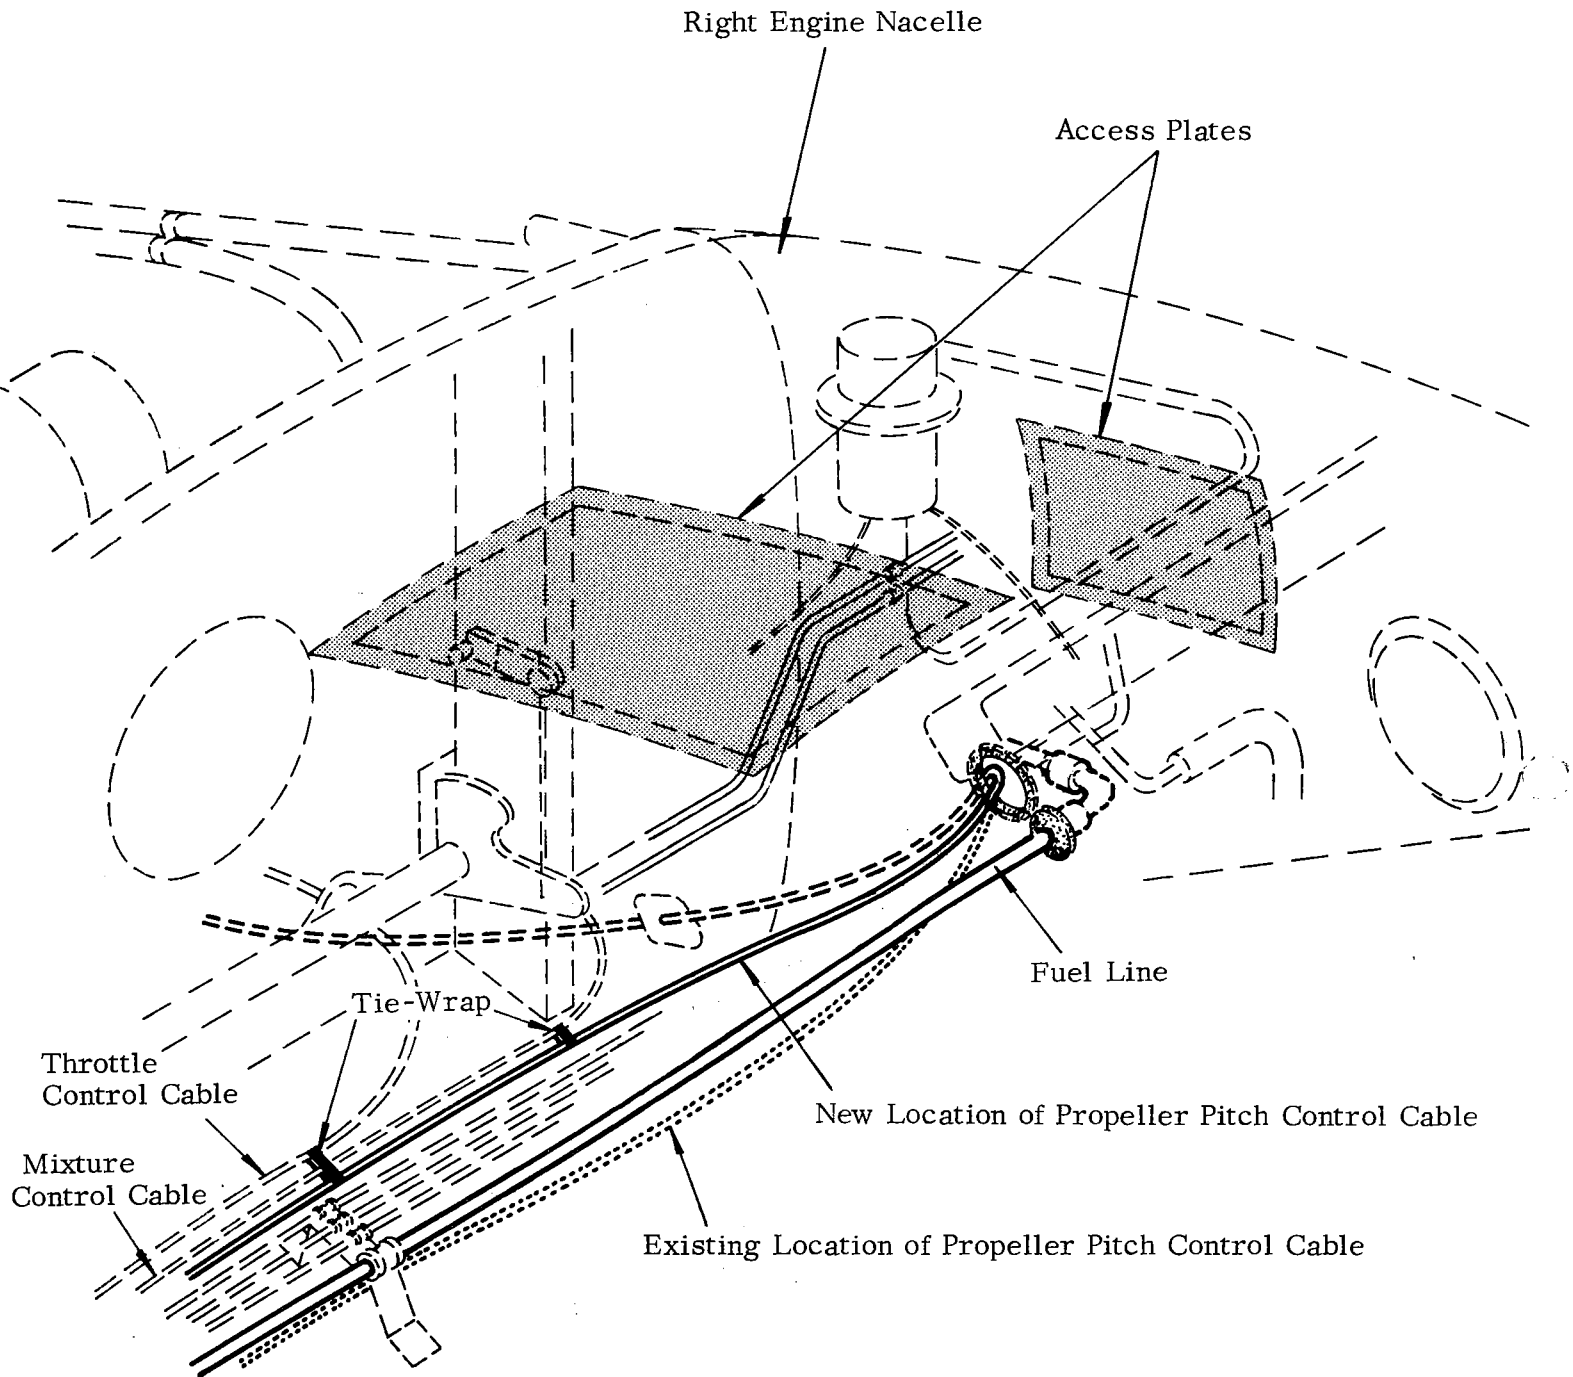
Remove the right engine nacelle access plates and inspect to insure that positive clearance exists between the engine control cables and the various lines behind the firewall. Particular attention should be paid to any interference or chafing between the fuel line and propeller pitch control cable in this area. Reposition the flexible cable, if necessary, per the above sketch. When positive clearance of at least 1/2" is assured, the cable must be secured in position with Tie-Wraps so that clearance will be maintained.
