SERVICE LETTER

No. 555

Subject: Inspection of Nose Gear Idler Link Assembly

Models Affected: PA-31 and PA-31-300 Navajo

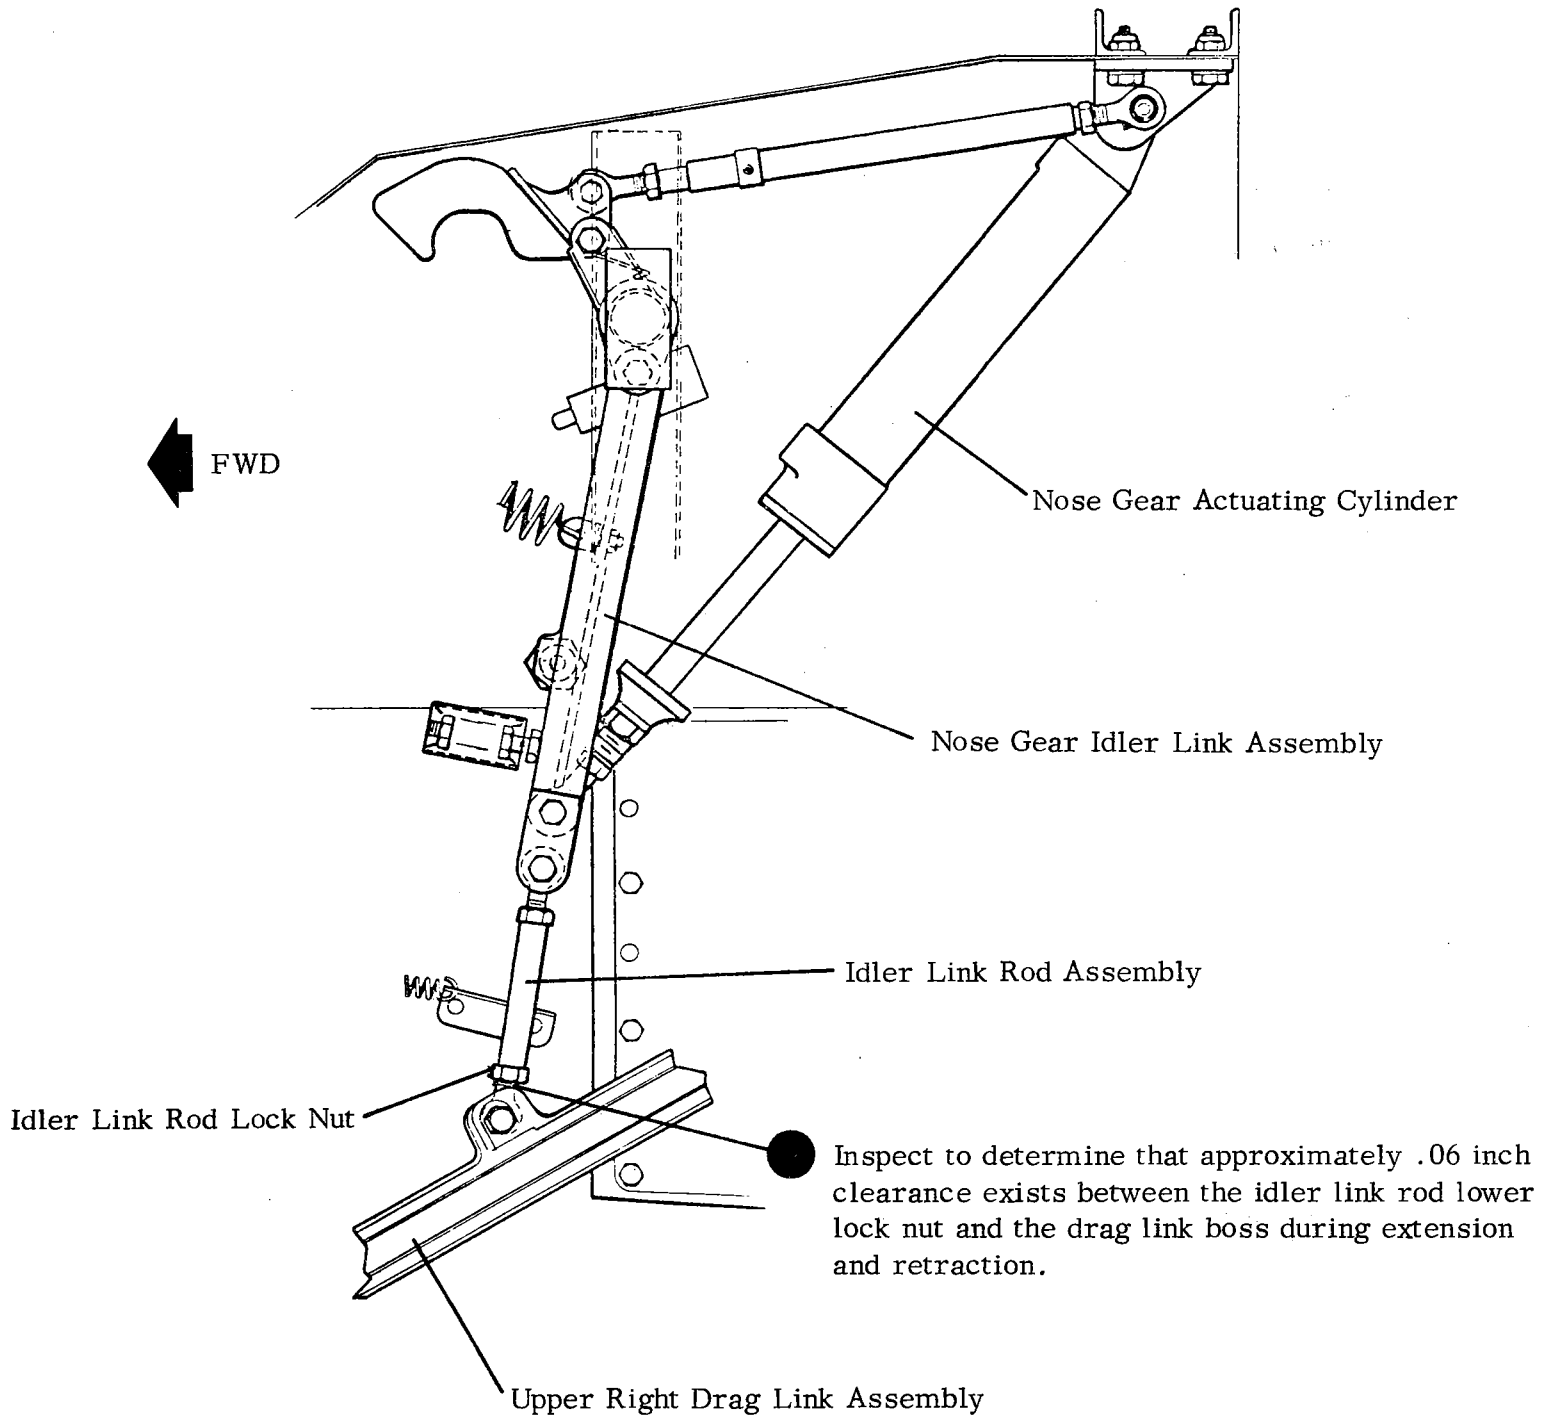
Purpose: To preclude possible interference between the nose gear idler link rod assembly lower lock nut and the drag link boss.

1. Inspect the nose gear idler link rod assembly to determine that approximately .06 inch clearance exists between the idler link rod lower lock nut and the drag link boss during landing gear retraction and extension (reference sketch on reverse side of this letter for additional information).
2. If the above referenced clearance exists, loosen the lower lock nut, clean threads thoroughly, apply "Loc-tite" to threads and retighten lock nut.
3. If clearance between the idler link rod lock nut and the drag link boss does not exist, adjust per information contained in Navajo Service Manual, Section VII. Then, accomplish Step No. 2 (above).
4. Subsequent to completion of Step No. 2, above, place a red dot (indelible ink) on the idler link rod lock nut.
