SERVICE LETTER

No. 593

Subject: Harness Connector Plug Strain Relief Hood Installation

Models Affected: PA-23-250 (Six Place) Aztec and PA-31 Navajo with AltiMatic V or AltiMatic V / FD Installations only.

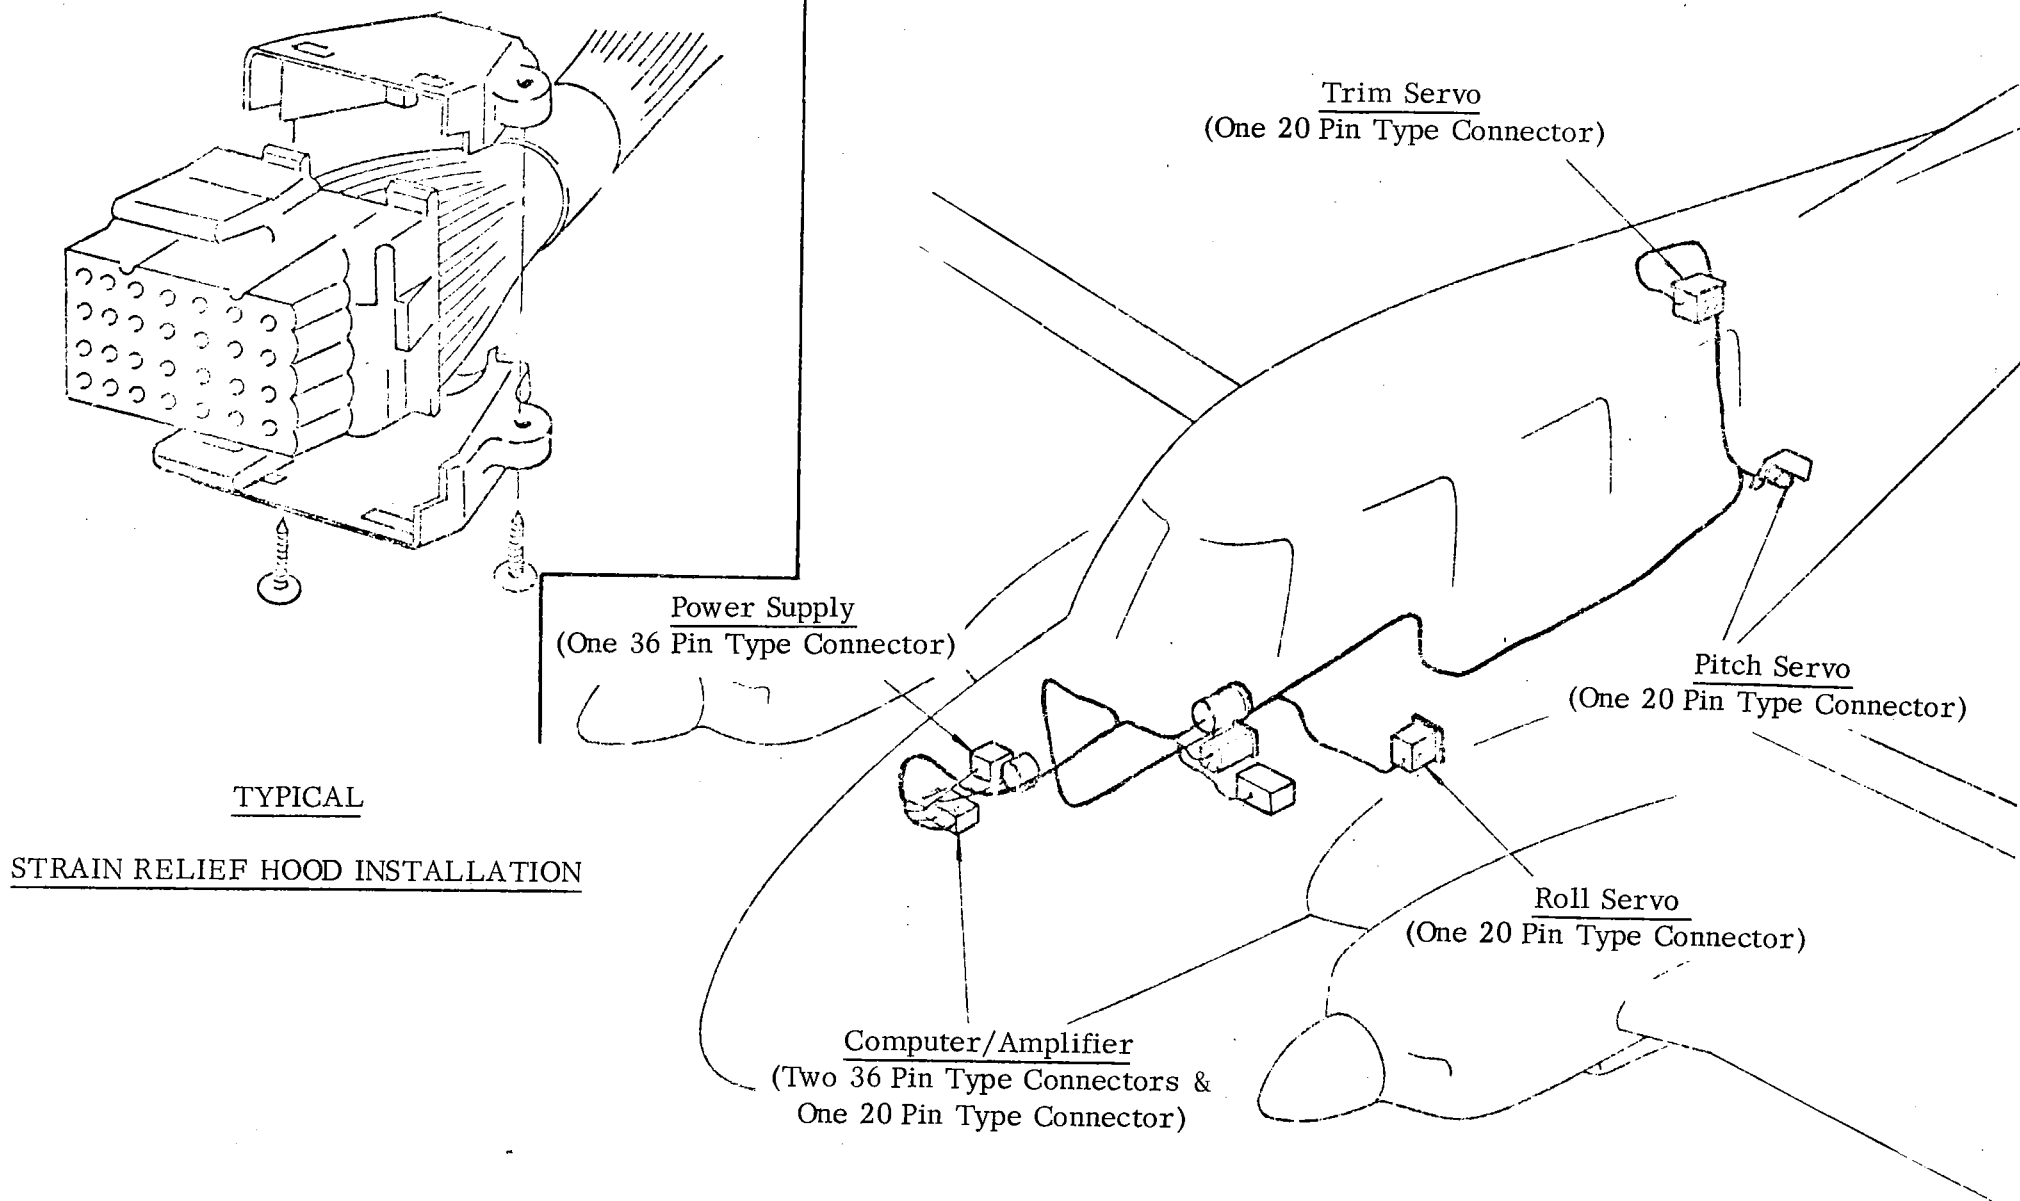
General Illustration of Affected Alt. V and
Alt. V F/D System Components (Typical PA-23-250 - 6 place)

Purpose: Recent reports relative to the AltiMatic V series automated flight control systems have indicated the need for strain relief at connector plugs.

1. Main harness junction (PA-31 only-located at upper left rear of pedestal).
2. Power supply.
3. Computer Amplifier.
4. Trim Servo.
5. Pitch Servo.
6. Roll Servo.

This Service Letter provides material and instructions to install connector plug strain relief hoods on the harness/connector plug assemblies at the following system component locations:

Instructions: Contained in the following AltiMatic V and AltiMatic V / FD Connector Plug Relief Hood Installation Kits;
PA-23-250 (Six Place) Aztec-Piper Kit No. 760 555
PA-31 Navajo-Piper Kit No. 760 556
