# SERVICE LETTER

No. 594

Subject: Inspection of Flap Track and Rudder Tip Rib Assemblies

Models Affected: PA-31 and PA-31-300 Navajo

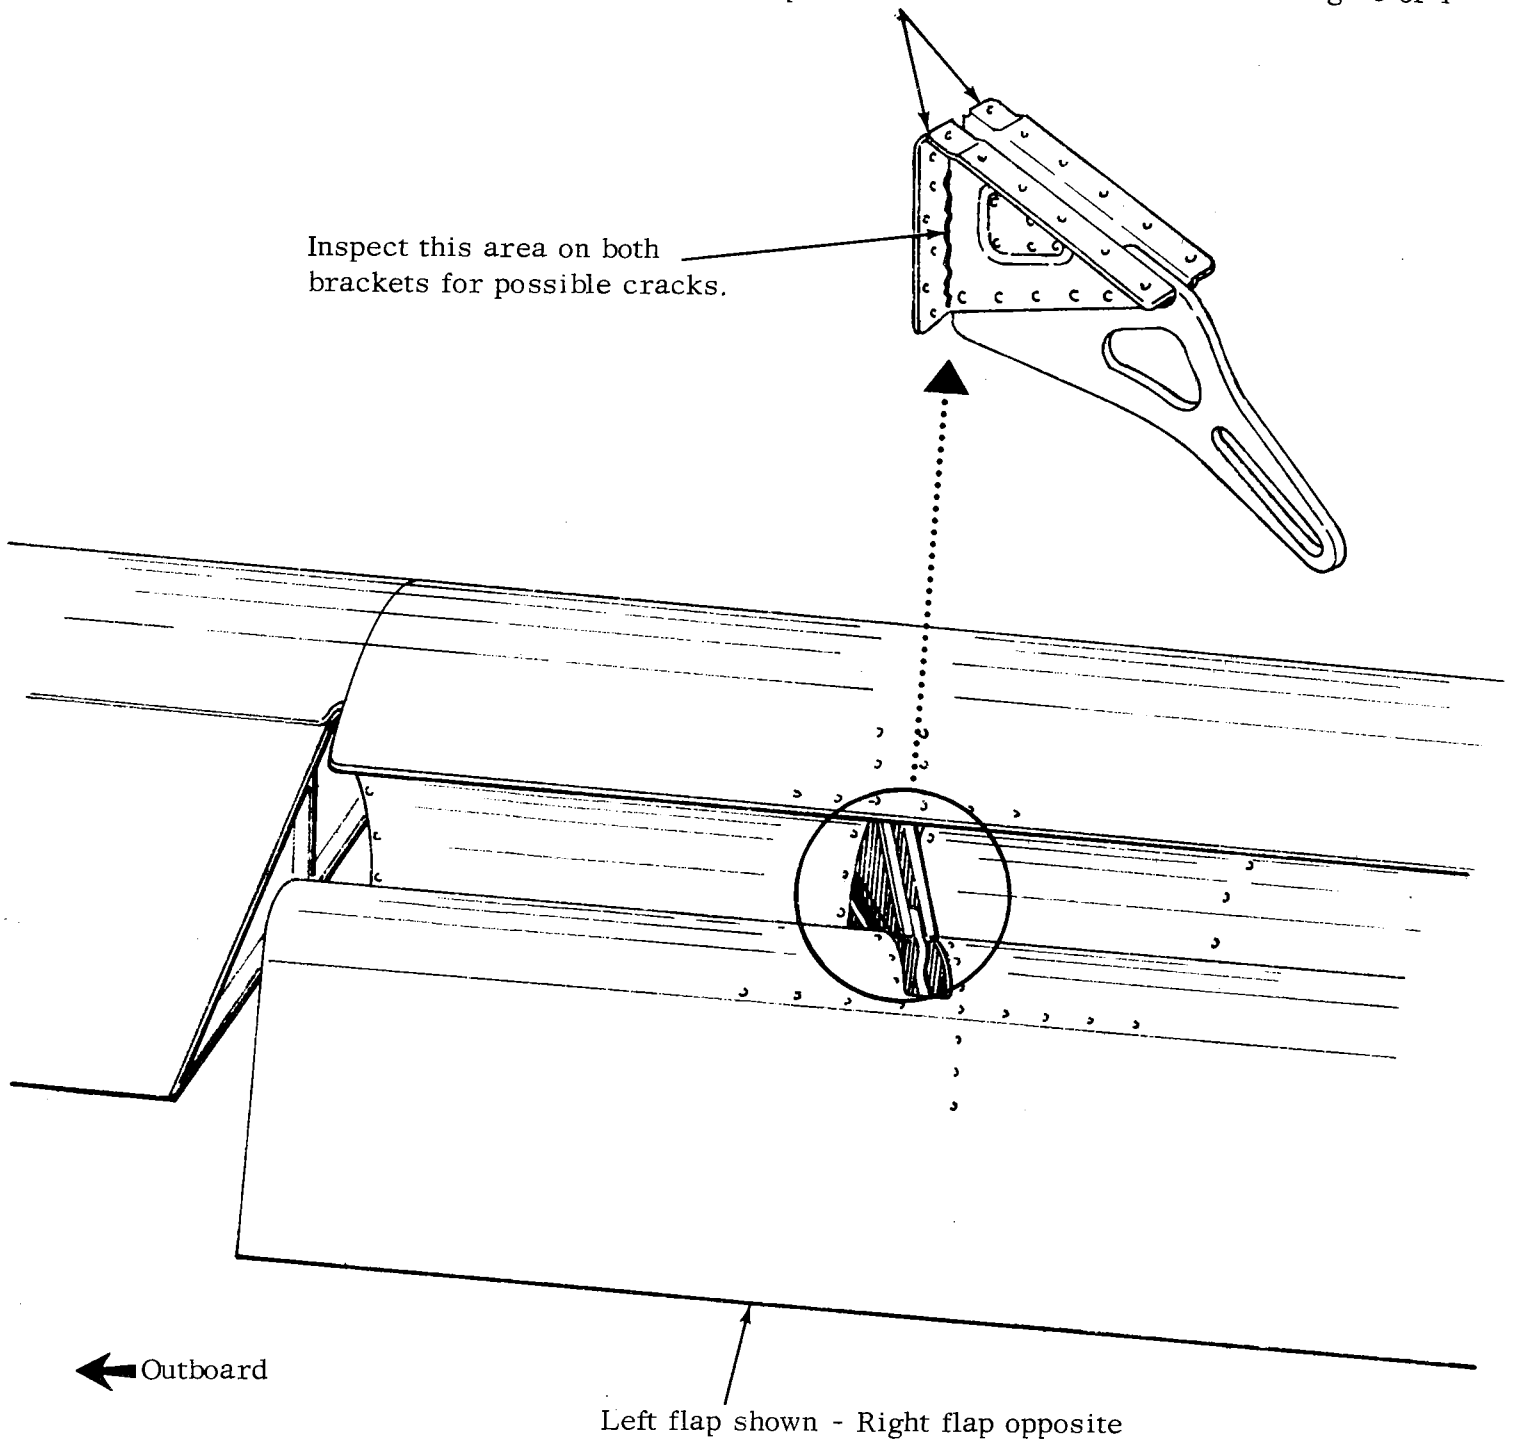
I. PA-31, Serial Nos. 31-1 to 31-172 incl.  
Product condition information indicates that the outboard flap track assemblies on the above referenced aircraft are susceptible to cracks appearing along the inside angle of the flap track bracket. A change was made in production to the flap track assembly effective on serial numbers 31-173 and up.

Inspect this area on both brackets for possible cracks.

Material Required: Reference Purpose No. I; one (1) each (per aircraft) Outboard Flap Track Assembly Piper part number 43764-00 (Left) and/or 43764-01 (Right), if inspection requires material replacement.

1. Lower the flaps and inspect the outboard flap track brackets for possible cracks.
2. If cracks are found, replace with new reinforced Flap Track Assembly, P/N 43764-00 for left wing or P/N 43764-01 for right wing.

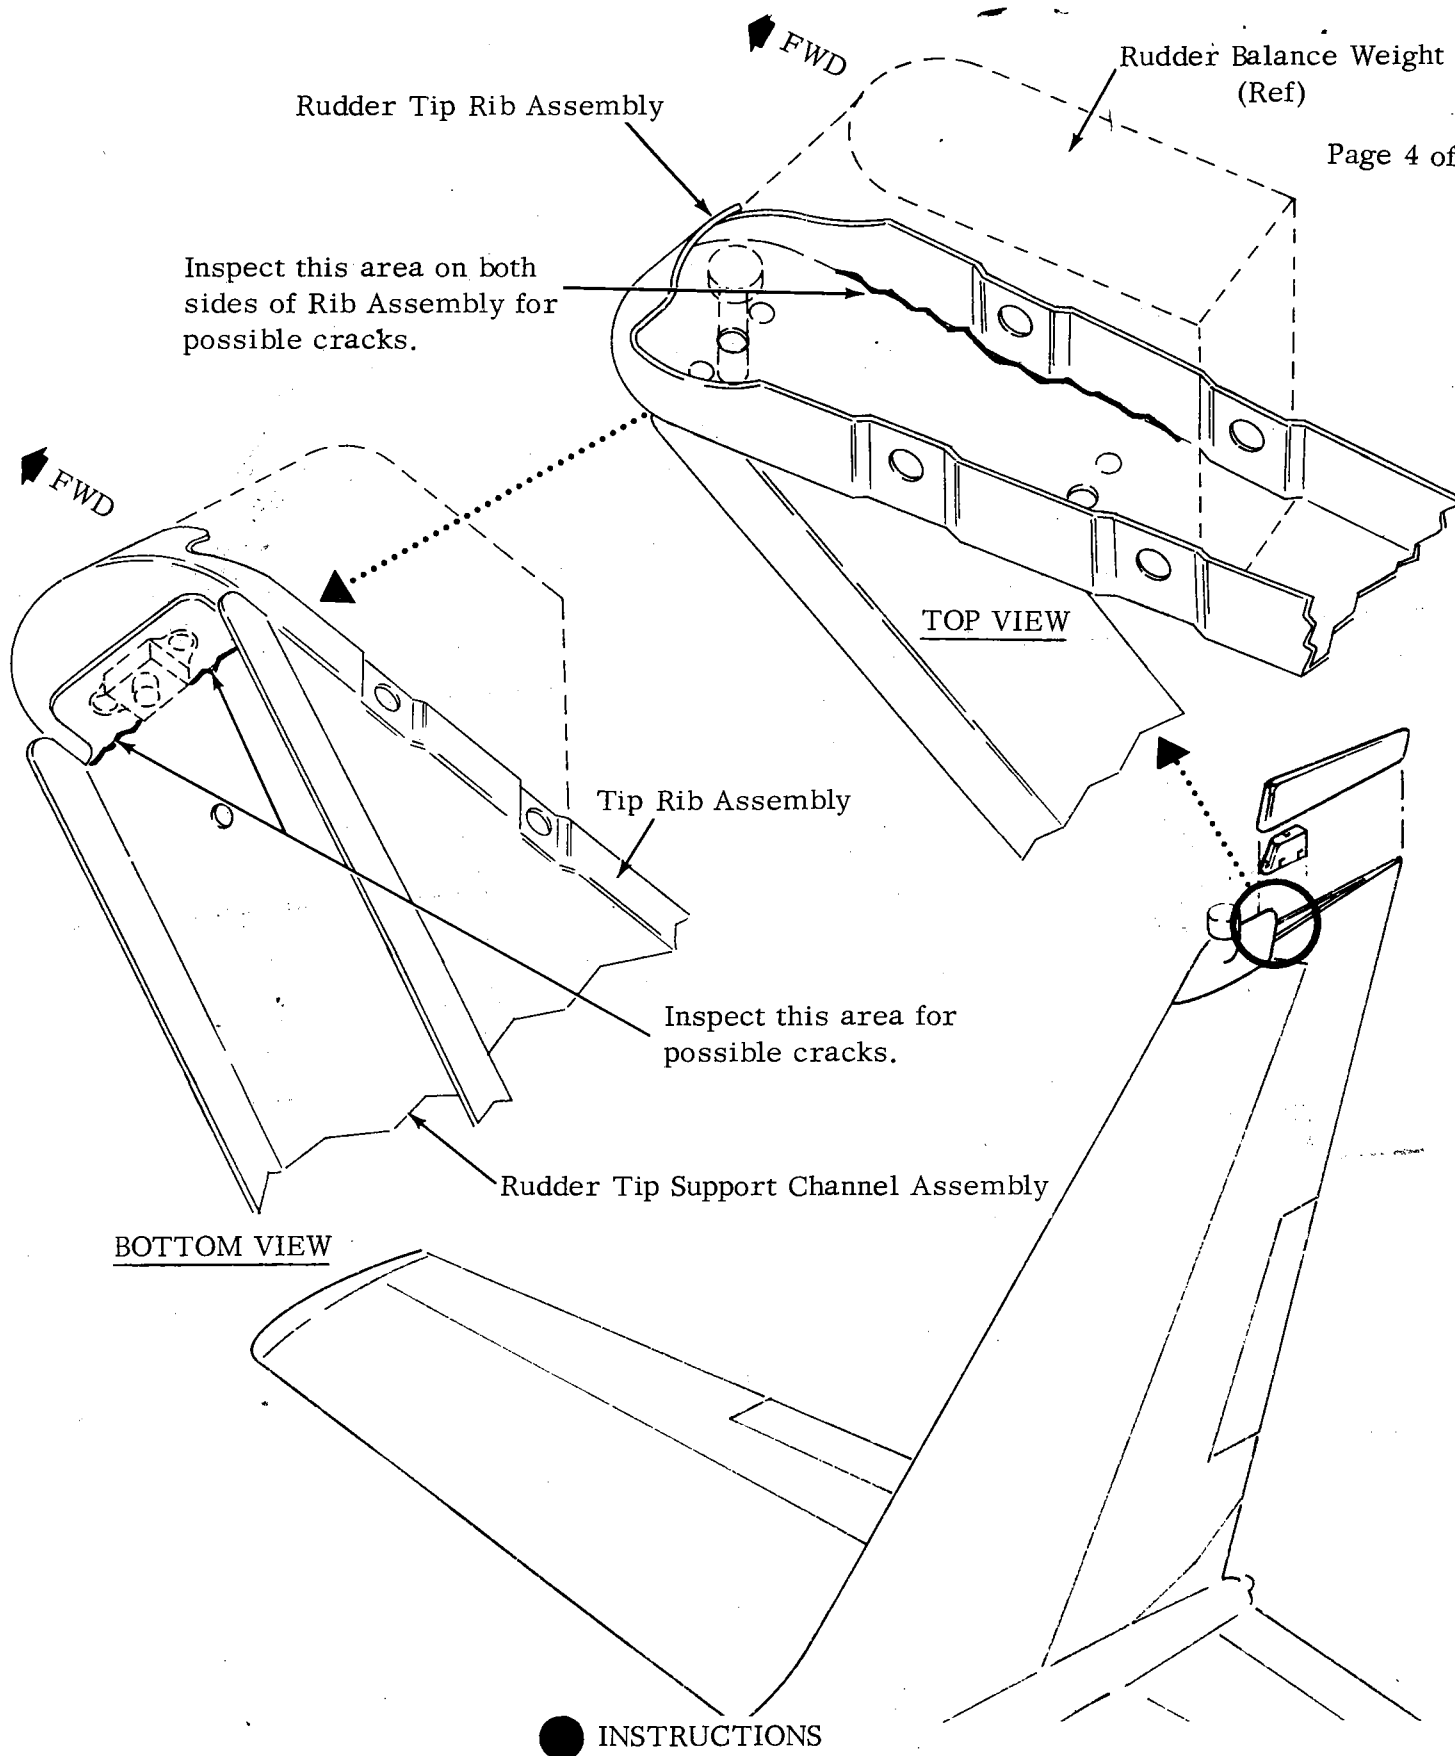
**SKETCH "B"**

II. PA-31 and PA-31-300, Serial Nos. 31-1 to 31-460 incl.  
A recent product serviceability report described the appearance of cracks along the inside angle of the rudder tip rib (supporting the rudder balance weight) and the underside of the rudder tip support channel assembly. This Service Letter provides instructions to inspect this area for possible cracks. Attached sketch "B" contains inspection illustrations and instructions, with material replacement (if required) recommendations.

Reference Purpose No. II; one (1) each (per aircraft)  
Rudder Tip Rib Assembly Piper part number 40044-00  
and/or Rudder Tip Support Channel Assembly Piper part  
number 40045-00, if inspection requires material  
replacement.

1. Remove rudder tip and balance weight from rudder and inspect rib for possible cracks.
2. If cracks are found, replace with new reinforced Rib Assembly, Part No. 40044-00.
3. If Rib Assembly must be replaced, also inspect underside of Rudder Tip Support Channel Assembly for possible cracks. If cracks are found, replace with new Channel Assembly, Part No. 40045-00
