SERVICE LETTER

No-643

Control Shaft Collar Restraining Strap

PA-31 and PA-31-300 Navajo
PA-31P Navajo

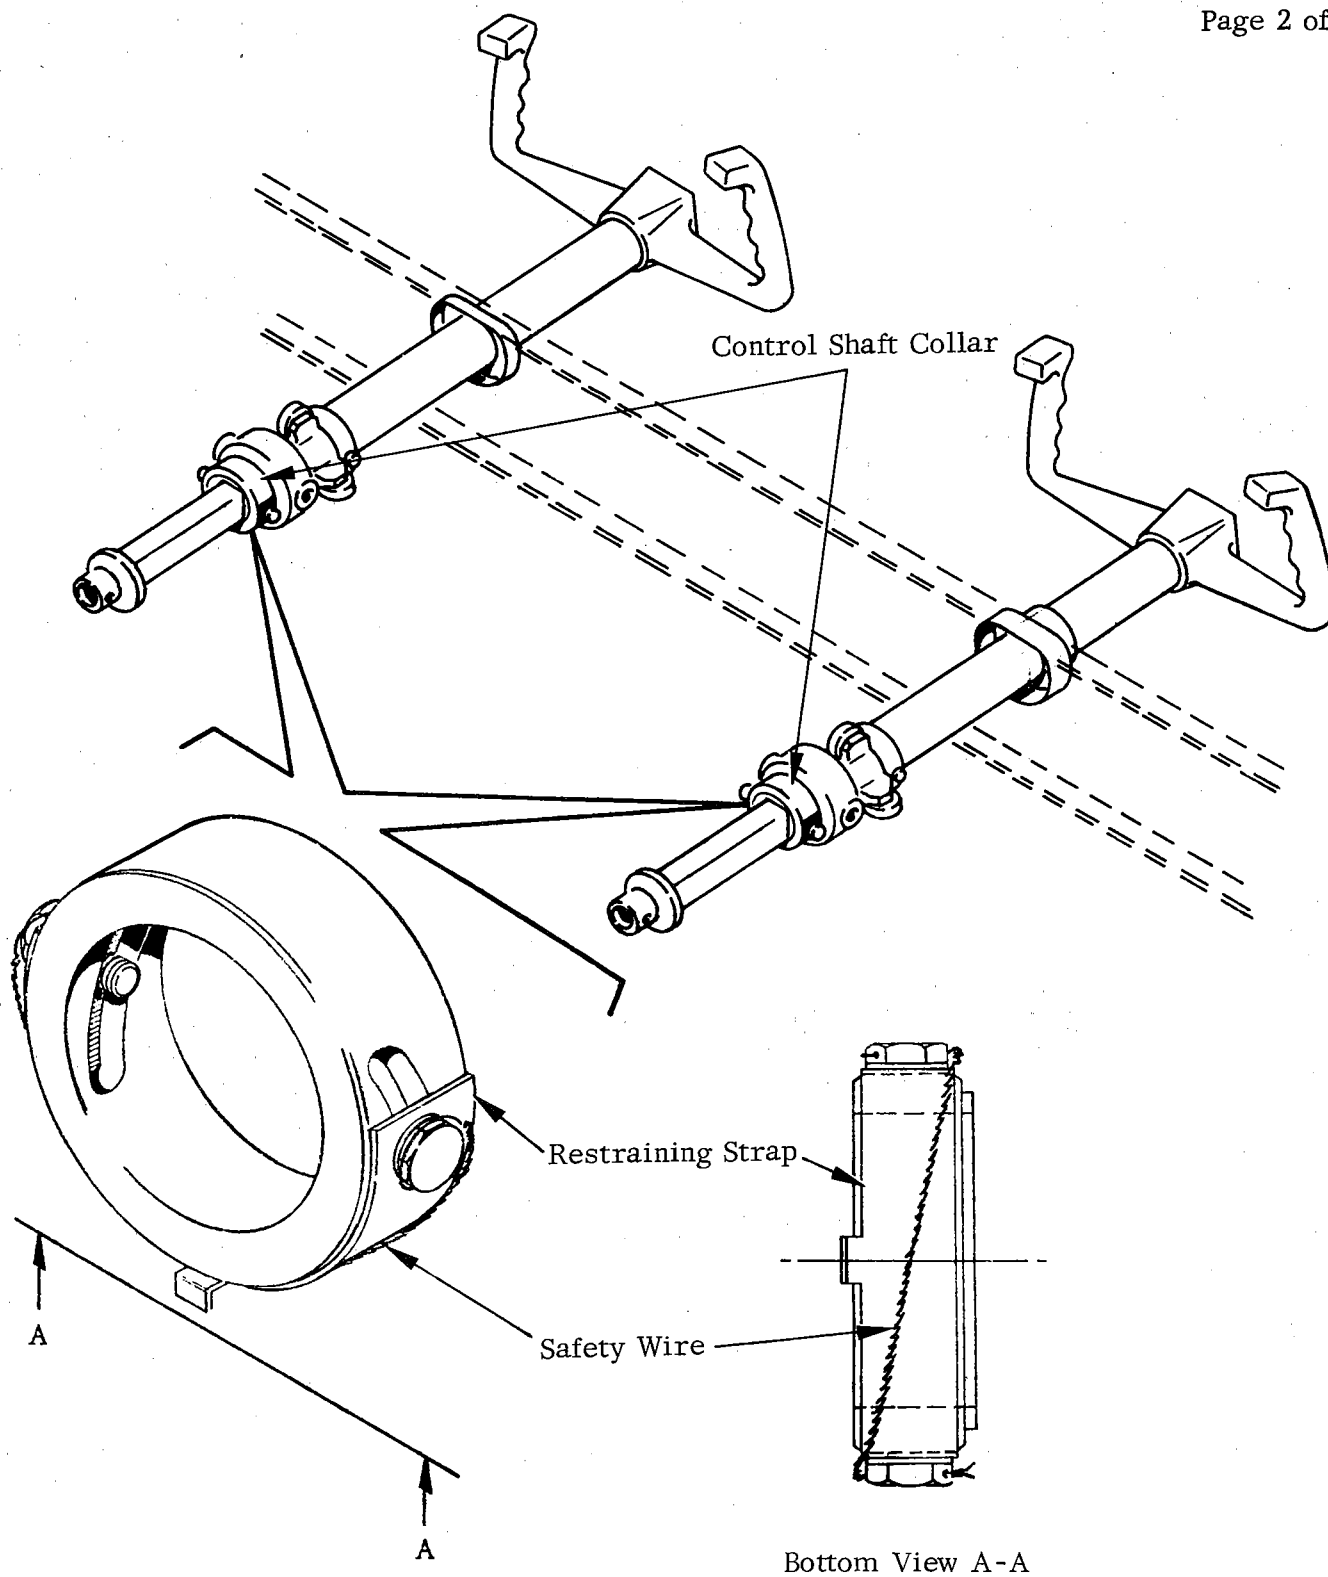
Service Letter No. 643

A recent field report has indicated the need for the addition of a safety wire restraining strap and a revised safety wiring method regarding the attachment of the control shaft collar to the control shaft tube assembly.

This service release provides material and instructions for the installation of a safety wire restraining strap and to revise the control shaft collar safety wiring (refer to sketch on reverse side of this Service Letter for a general illustration).
