SERVICE LETTER

No. 681

Piper Aircraft Corporation

Subject: Inspection of Elevator Balance Weight Bolts

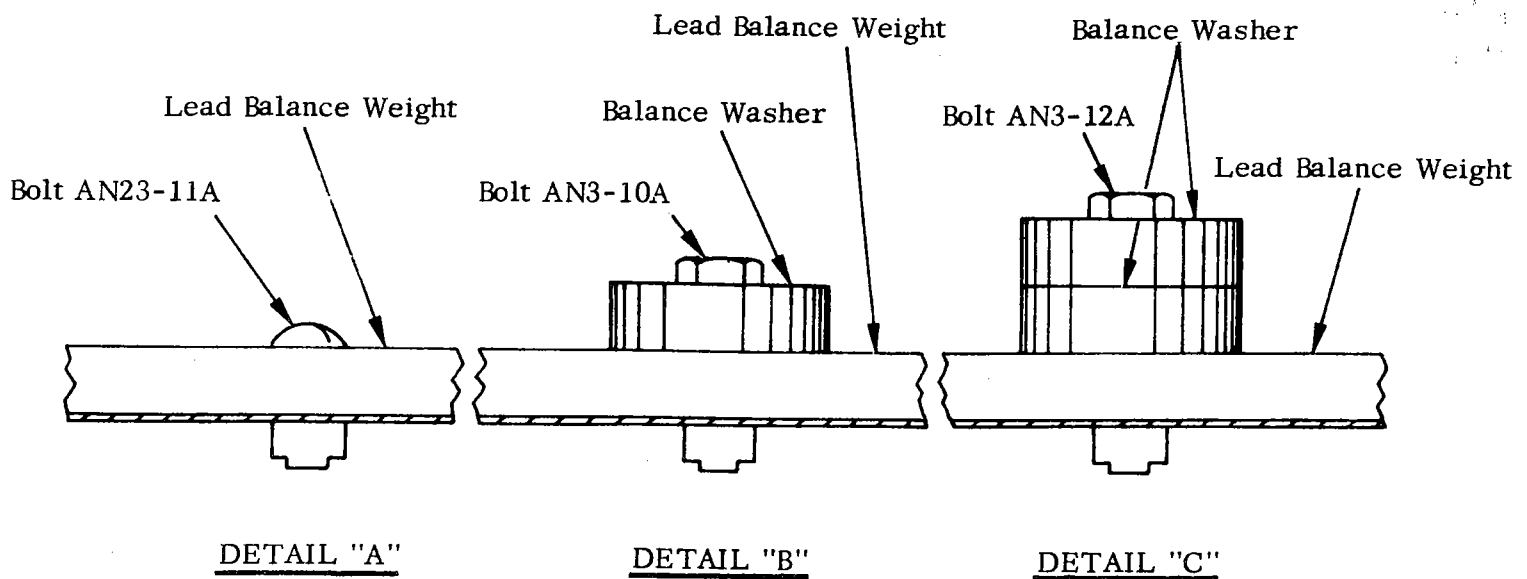
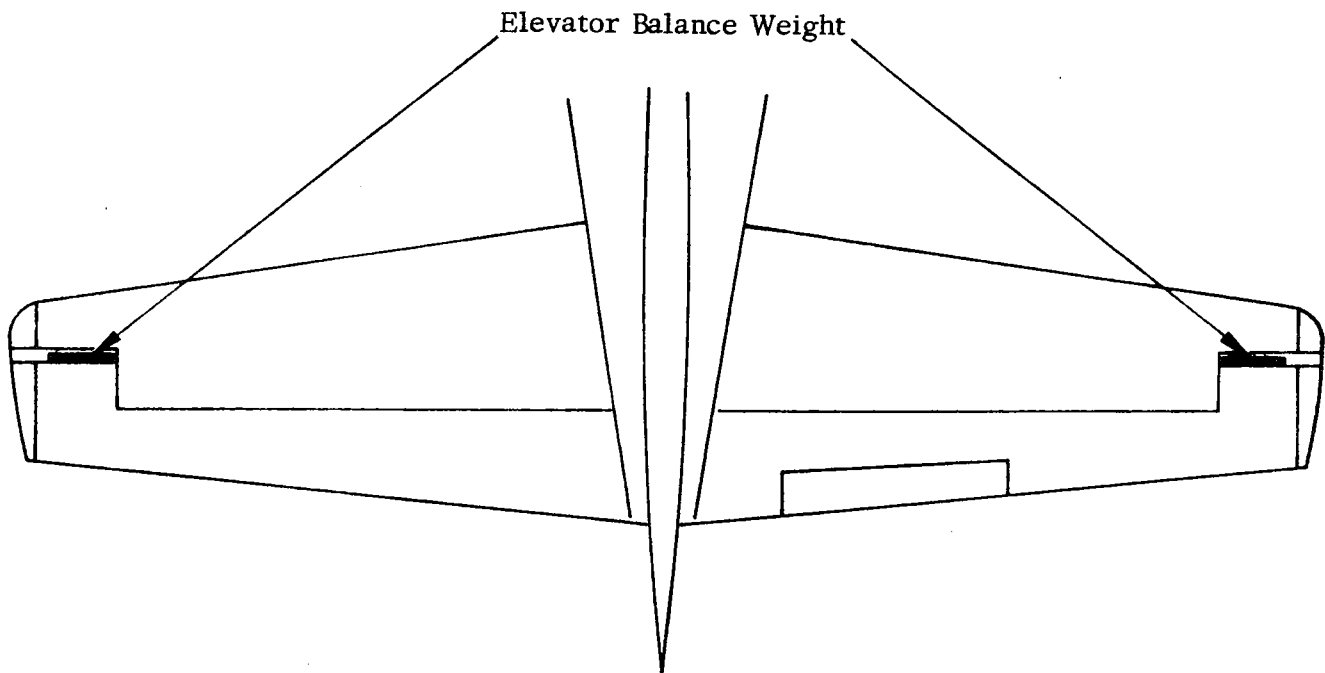
1. Remove tip assembly from leading edge of both elevators.
2. Inspect balance weight attachment bolts (three per elevator) to insure the proper length bolts are installed.
 - a. If no balance washer is installed, (refer to Detail "A") the correct bolt is AN23-11A (Part No. 400 863).
 - b. If one balance washer is installed, (refer to Detail "B") the correct bolt is AN3-10A (Part No. 401 269).
 - c. If two balance washers are installed, (refer to Detail "C") the correct bolt is AN3-12A (Part No. 400 443).
