SERVICE LETTER

No. 718

Subject: Bendix Magneto Bulletin No. 566 -- reference attached Avco Lycoming Service Bulletin No. 373, dated March 22, 1974.

SUBJECT: S-1200 Distributor Block and Gear Change

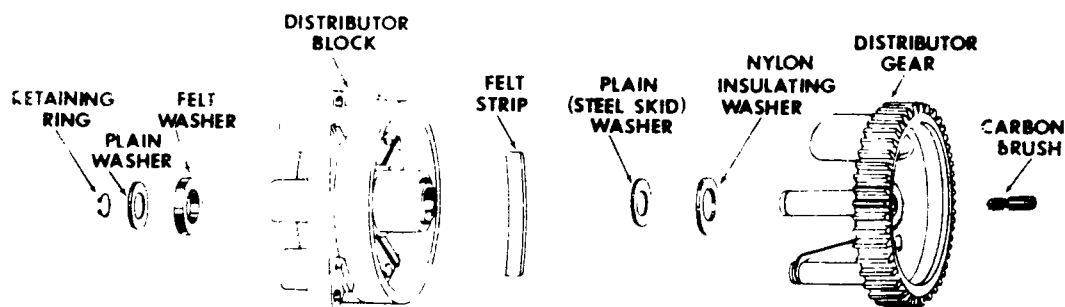
Figure 1.

It has been found that the addition of a nylon insulating washer and steel skid washer between the distributor gear electrode and the block bushing, as shown in figure 1, reduces the possibility of deterioration of the lubricant and possible seizure of the parts.

Assemble large distributor gear, nylon and steel washers to new or reworked block as follows using figure 1 as a guide.

Once modified, the distributor block can be used only with a gear having the nylon and steel washer installed over the shaft as shown in figure 1.

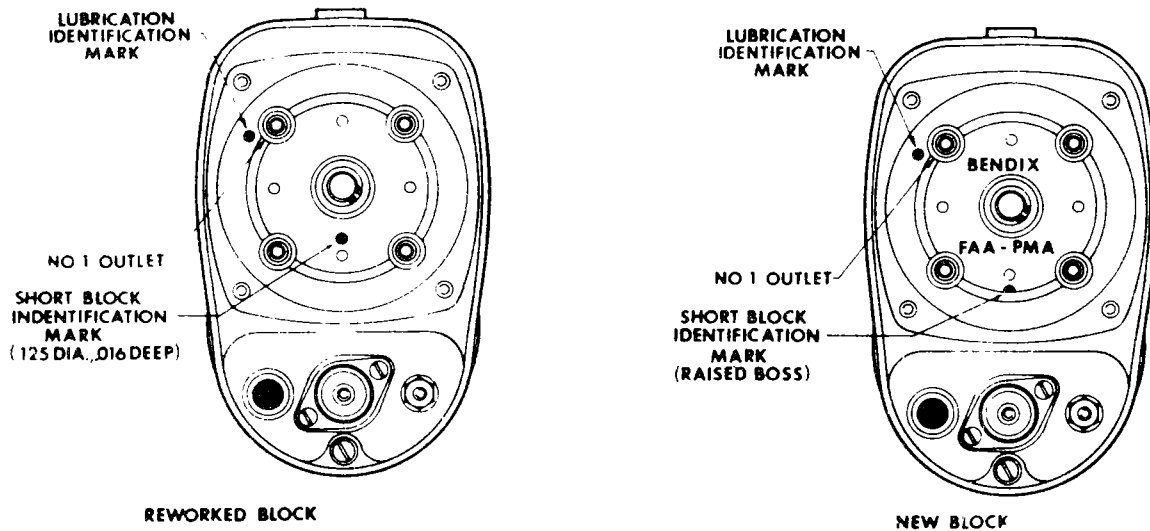
Figure 2

The addition of the washers make it necessary to shorten the gear end of the bushing and block. New production blocks incorporating the change are identified by a raised

boss between the high tension towers at the six o'clock position and molded in letters as shown in figure 2.

Reworked blocks are identified by a drill point indentation in the same location. New and reworked blocks both have different part numbers from the current (old) block. See Table 1.

7. Identify reworked blocks by drilling a flat bottomed hole .125" diameter and .016" deep in the six o'clock position as shown in figure 2.

a. If distributor block is not marked with a raised boss or drill point indentation to the left and adjacent to the No. 1 high tension tower (see figure 2), remove old lubricant from bushing as follows.

(3) Identify distributor block by drilling flat bottomed indentation 0.125 inch diameter and 0.016 inch deep located as shown in figure 2.
