# SERVICE LETTER

No. 764A

Piper Aircraft Corporation

Subject: Wing Flap System Maintenance Procedure

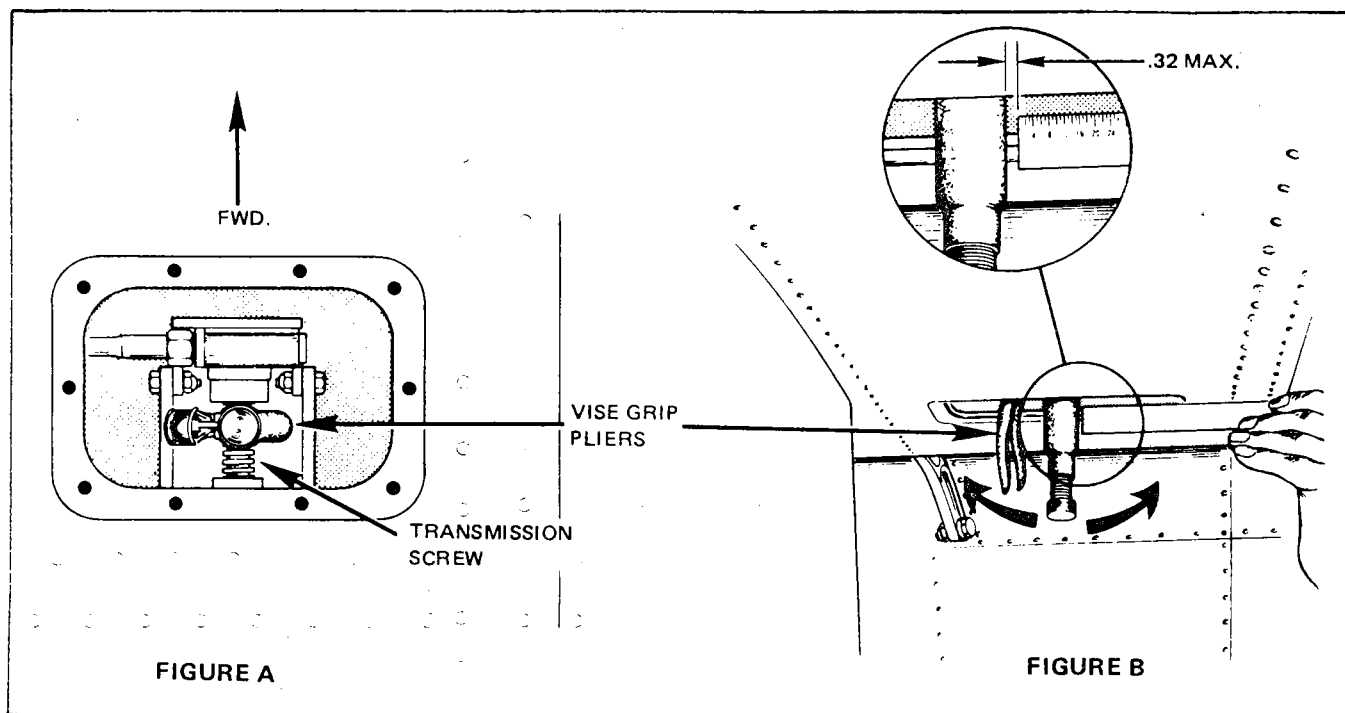
Figure 1. Wing Flap Transmission Inspection

1. INSPECTION OF WING FLAP TRANSMISSION, (Refer to Figure 1.) The flap transmissions are inspected at every 100 hour inspection cycle of the aircraft. This is accomplished without removal of the transmissions, by the following procedures:

- c. With the use of vise grip pliers and exerting light pressure, grasp the exposed portion of the screw close to the transmission as shown. (Refer to Figure 1, views A and B).

- e. Place a six inch ruler along the skin surface as shown in Figure 1, view B, and measure the overall distance the pliers move.

- f. Should this dimension exceed .32 (5/16) of an inch, replace the transmission assembly or obtain Gear Transmission Overhaul Kit 755 051 for 20:1 ratio transmissions, part numbers 4268-00 and 4268-00-1, or Kit 755 050 for 40:1 ratio transmissions, part numbers 1049-00-1 and 1049-00-3. (See parts catalog for serial numbers affected.) (Refer to appropriate service manual for transmission removal and installation.)
- g. Reinstall the access panels and make appropriate logbook entry.
- h. Repeat inspection at 100 hour intervals.

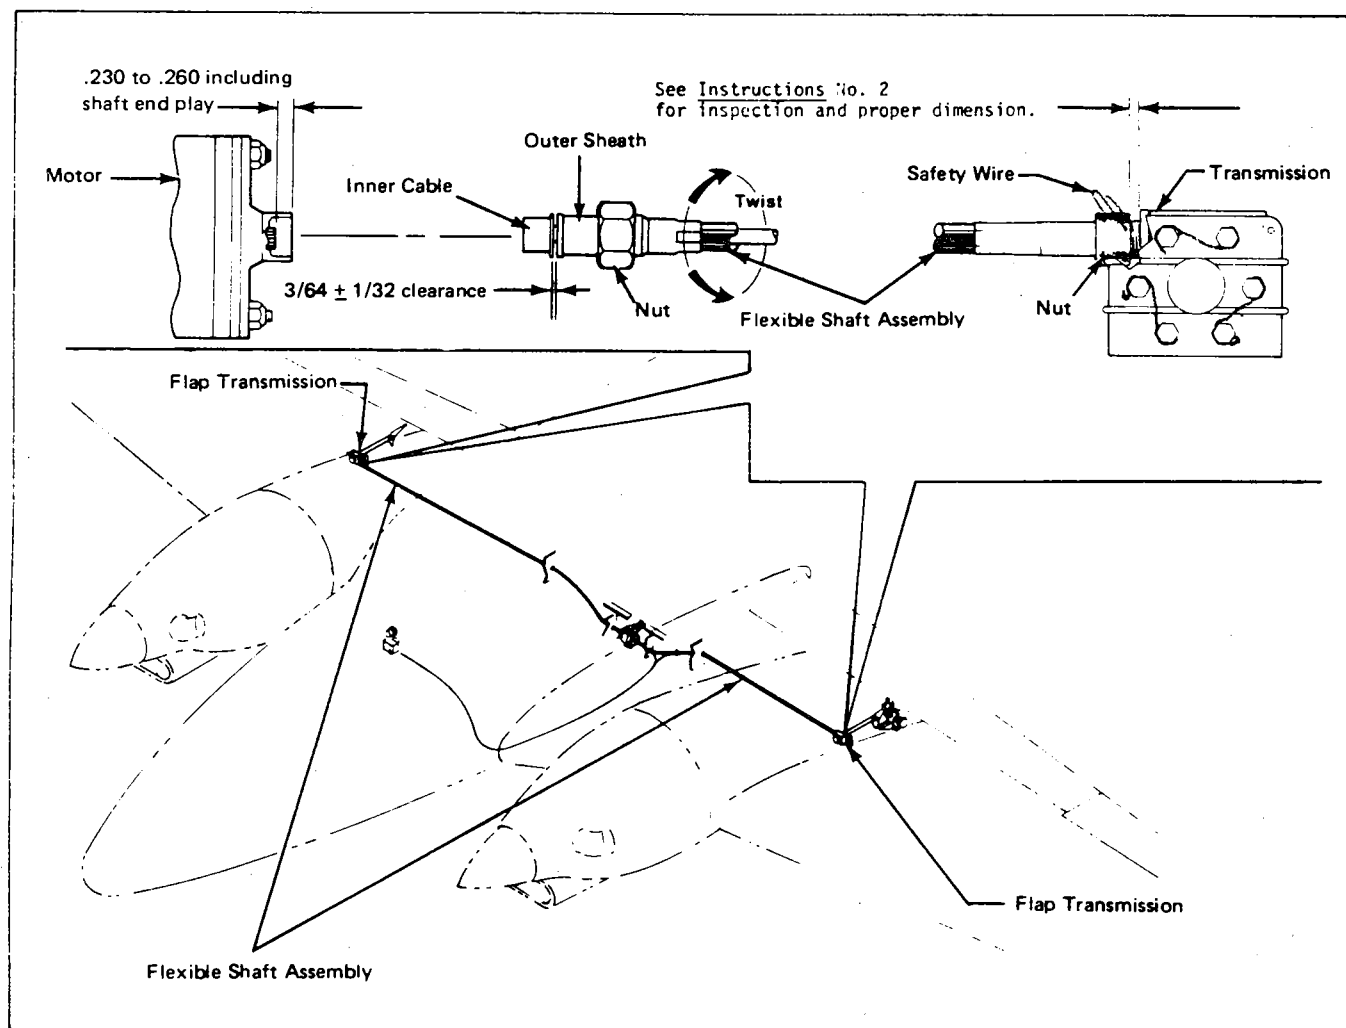
Figure 2. Wing Flap Actuator Cable

2. INSPECTION OF WING FLAP TRANSMISSION ACTUATOR SHAFT. (Refer to Figure 2.)

- c. When properly installed, the nut on flexible shaft will bottom or be within 3/16 of an inch of bottoming against transmission.
- d. If inspection reveals that either of the shaft assemblies are not properly installed, it will be necessary to correct as follows:

- 1. Cut safety wire from nut and disconnect shaft assembly from transmission.
  - 2. Align and insert tang on shaft assembly into slot in transmission. Tighten nut per Steps b and c requirements. (A specific torque is not required; however, nut must be drawn up snug to insure that end of shaft housing is firmly seated against transmission). Safety nut with .040 wire.

- 2. Observe the clearance between the outer sheath and inner cable.
  - 3. Twist outer sheath in proper direction (to lengthen or shorten), bringing clearance to  $3/64 \pm 1/32$  of an inch. It may be necessary to loosen clamp on fuselage bulkhead in order to twist outer sheath. (See Figure 2.)

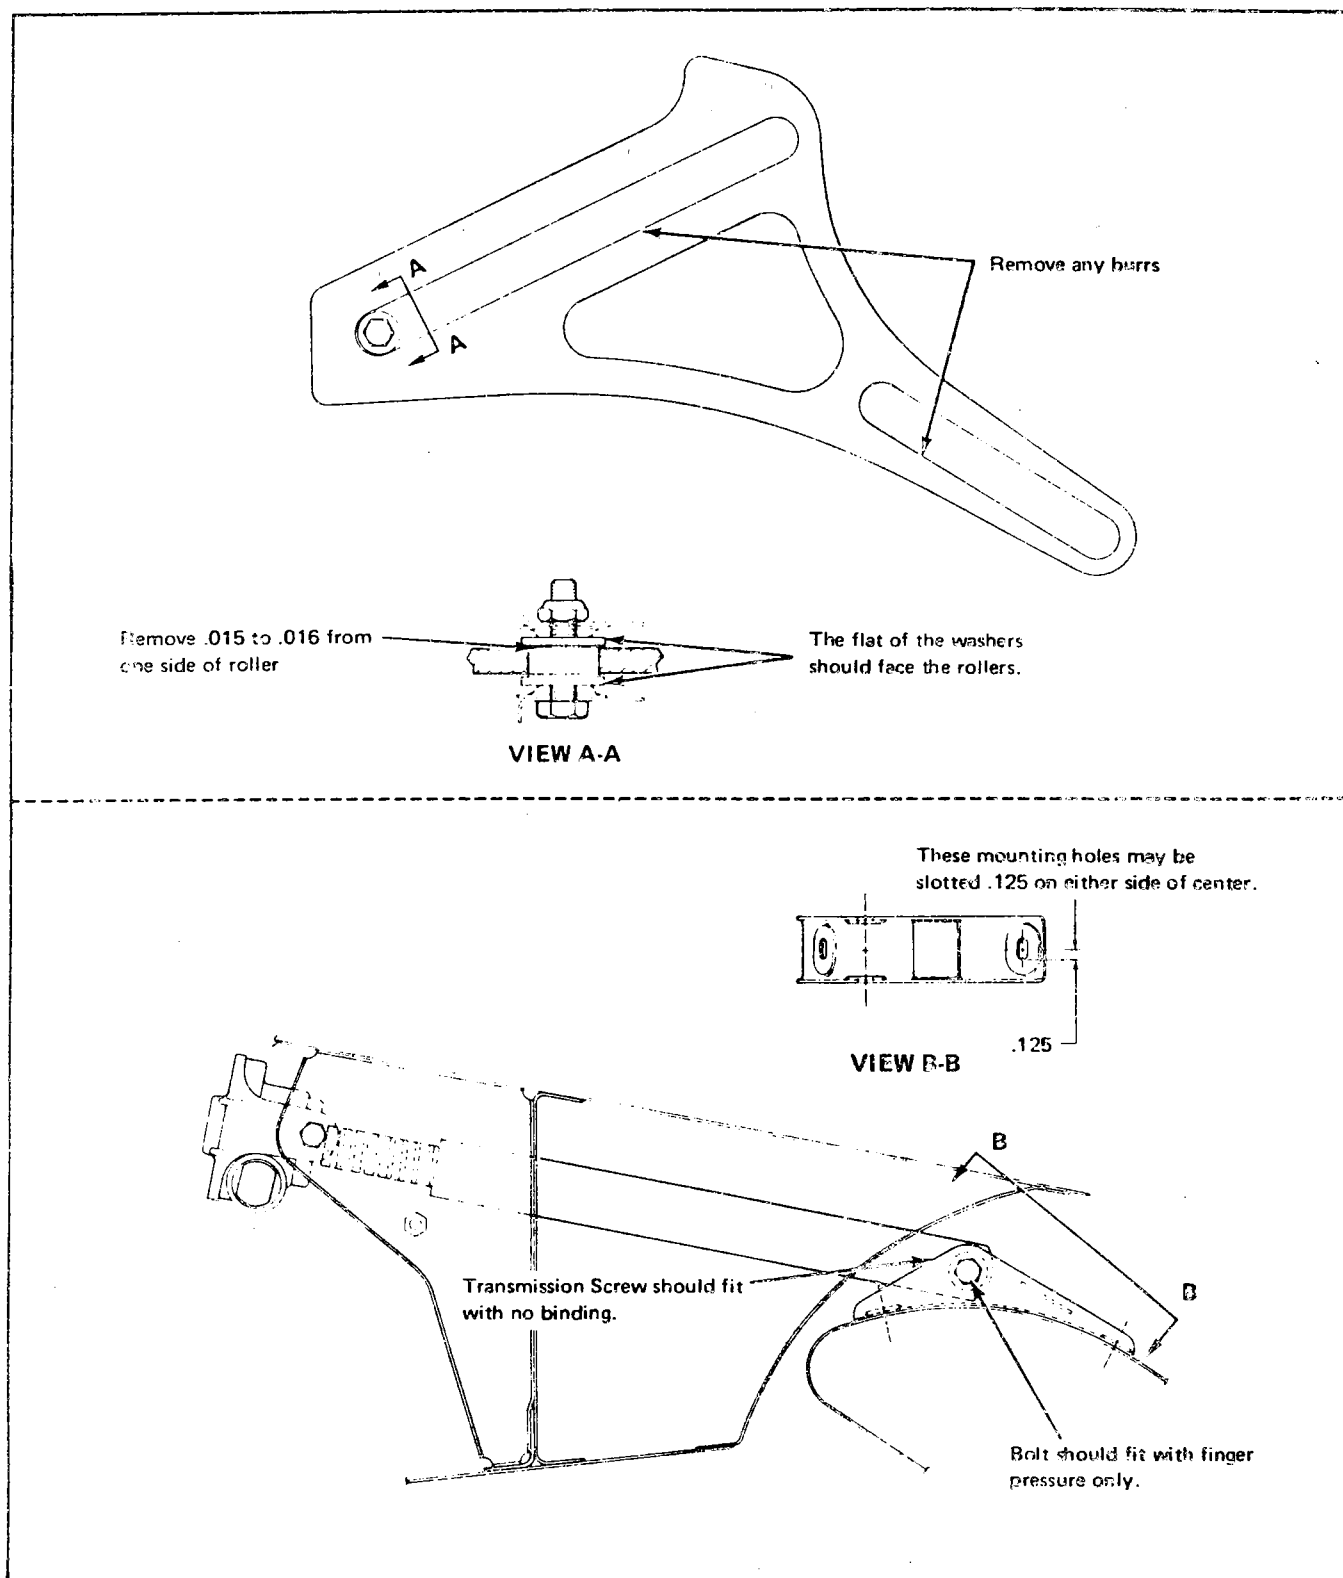
Figure 3. Friction Reduction in Wing Flap System

3. REDUCTION OF FRICTION IN WING FLAP SYSTEM. (Refer to Figure 3.) To insure proper flap system operation and reduce friction on the flap motor, the following inspection and repairs are only required should operational problems exist in the flap system.

- c. Inspect the flap tracks for any burrs along the track edges. If any are found, remove them with a fine file. Insure that no noticeable depressions are evident at the ends of the track areas.

- e. Clean all dirt and paint from the flap rollers.
  - f. On each flap roller remove 1/64 or .016 of an inch from one side of each roller. (Refer to Figure 3, View A-A.)

- g. Polish all flap rollers and lubricate with light oil, MIL-L-7870.
  - h. Insure that the washers used on both sides of the rollers are flat. (Refer to Figure 3, View A-A.)

It may be necessary to move the horn assembly to obtain this no binding fit. The mounting holes on the horn assembly may be slotted to gain some adjustment if needed. (Refer to Figure 3, View B-B for dimensions of slots.)

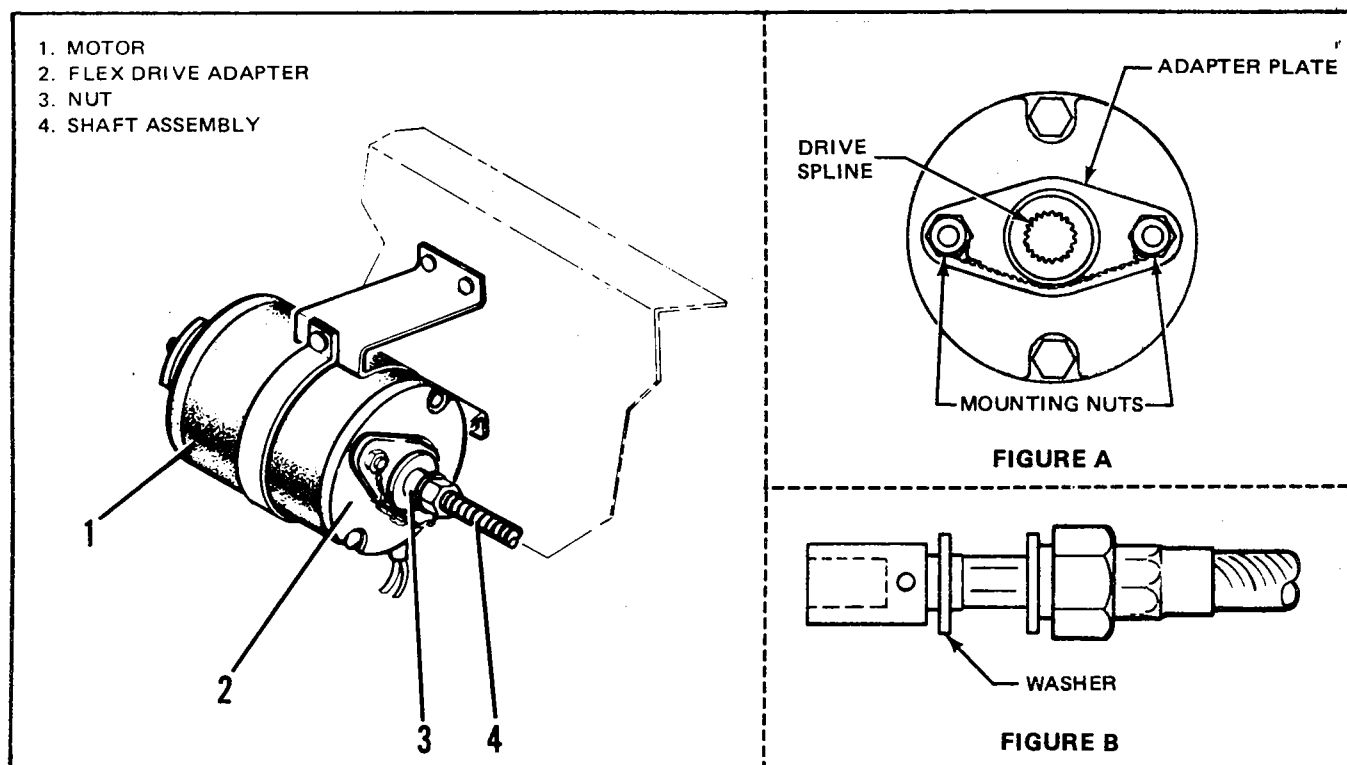
Figure 4. Wing Flap Motor

4. WING FLAP MOTOR NO LOAD RPM CHECK. (Refer to Figure 4.) This check for demagnetization of the flap actuating motor should be accomplished along with friction reduction per Instructions, No. 3, above if flap motor circuit breaker popping has been or remains a problem.

- With both flexible drive cables disconnected at the motor, examine the splined coupling for wear and security. Examine the base of the swaged portion for wear under the washer (See Fig. 4-B). Wear in excess of .005 inch deep on the swaged terminal is cause for replacement of the cable assembly.
- If signs of wear are discovered (caused by the washer), recenter the adapter plate over the motor drive spline (See Fig. 4-A). Remove motor, loosen the adapter plate attachment nuts, recenter the plate over the spline and re-attach and secure the plate (in some cases, it may be necessary to rotate the plate 180° for better alignment).

- On the exposed motor splines, paint a white strip on one of the spline teeth.
  - Energize the flap motor with the flap selector switch.
  - With the aid of a Simpson 410 Photo Tachometer or equivalent, hold the probe within one-half of an inch of the painted rotating spline shaft and observe the RPM reading on the meter. RPM in excess of 11,000 (see note 3 on page 4) will indicate demagnetized motor field magnets, and the motor should be replaced.

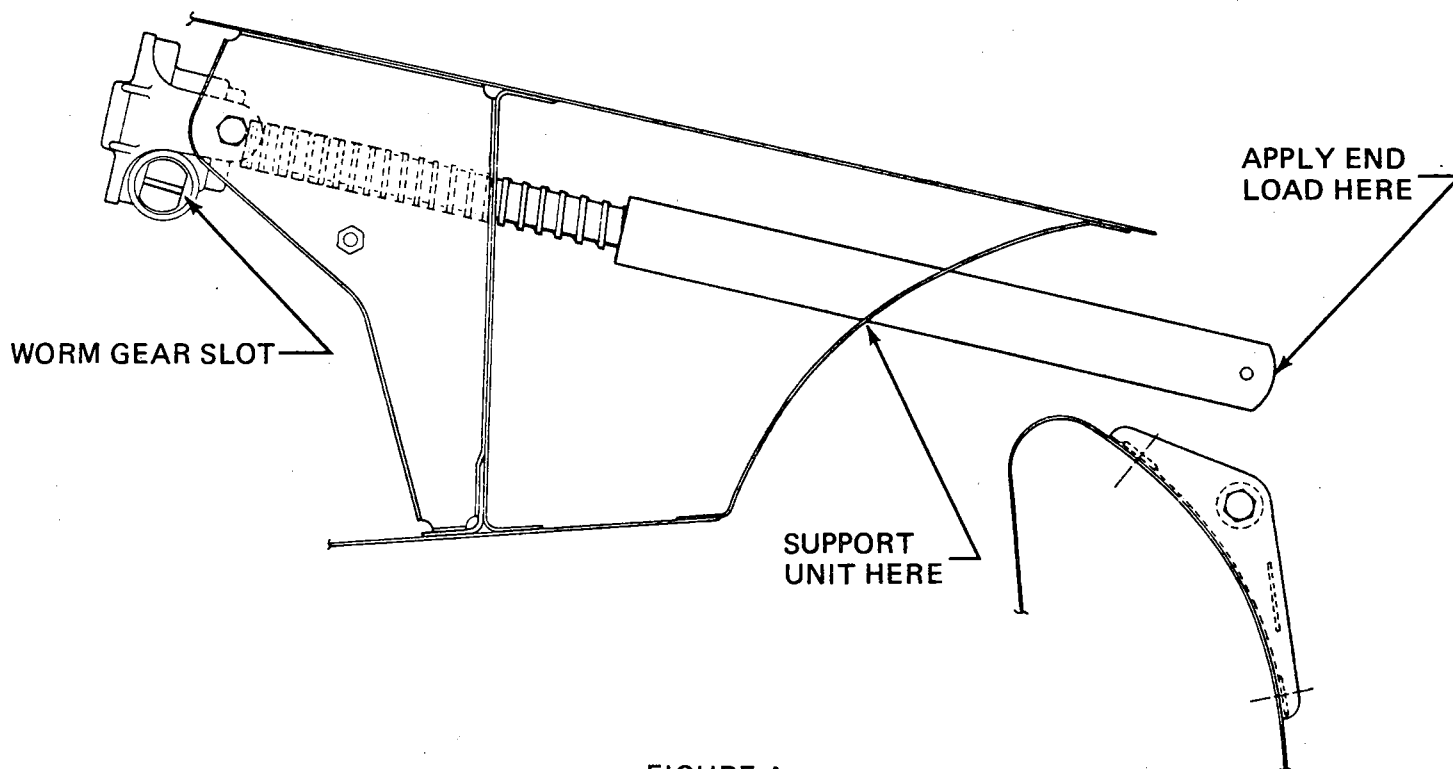
FIGURE A

1. Extend the transmission screw to the end of its travel.
2. Using a flat blade screwdriver inserted into the slot of the worm gear on the transmission (see Figure A), turn the gear 20 turns for the 4268 unit or 40 turns for the 1049 unit and note any tight or high spots as the worm gear is rotated.

The transmission should have an end load applied while turning the worm gear. (See Figure A.)
