SERVICE LETTER

No. 781

Piper Aircraft Corporation

Cockpit Forward Bulkhead/Floorboard Sealing.

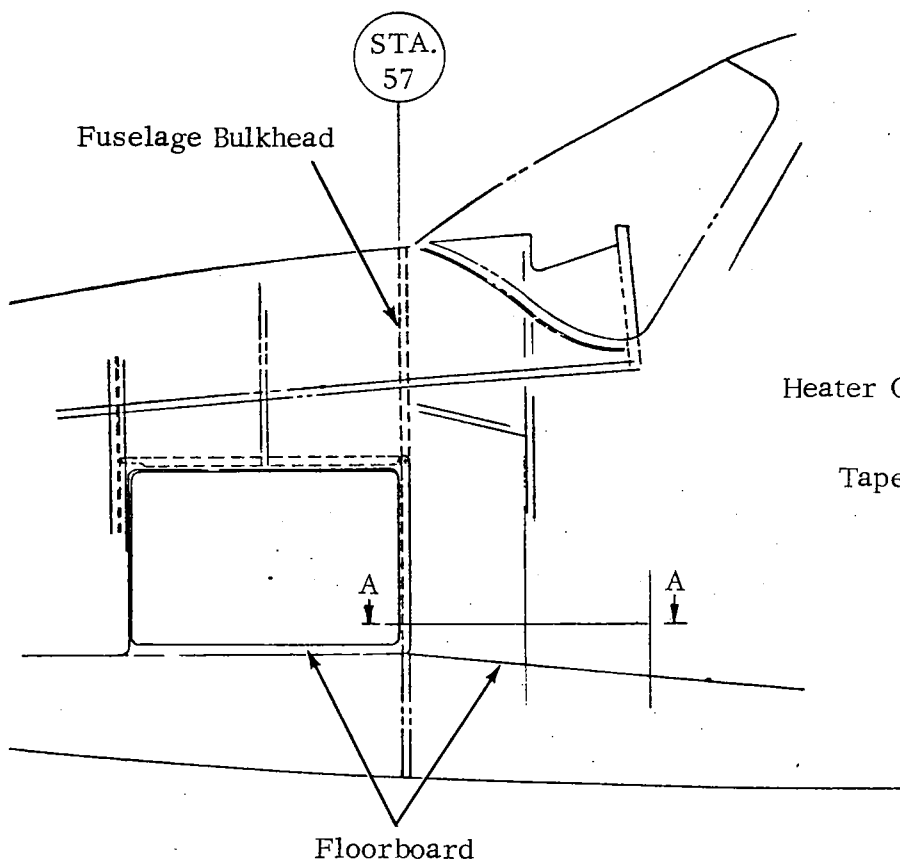
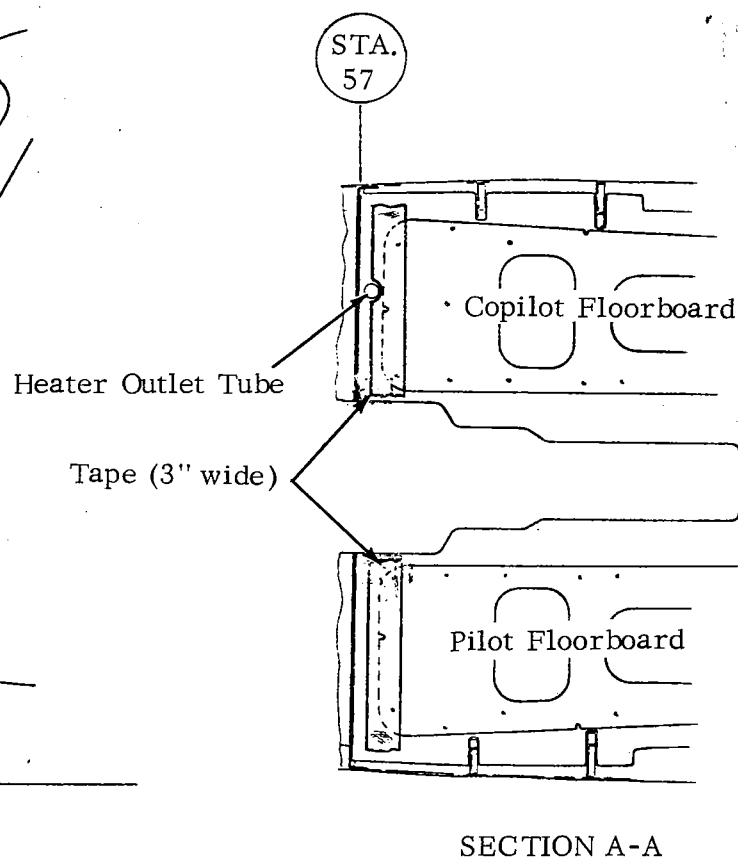
Purpose: During Chieftain environmental systems testing at the factory, it was determined that cold air can be introduced into the lower cockpit area through several bulkhead tool holes and between various structural members. This condition can compromise cabin heater effectiveness, in addition to causing crew discomfort.

1. Remove left and right access panels from forward fuselage to gain access to fuselage bulkhead at station 57.
 - a. Apply a bead of 3M #612 sealant around forward perimeter of bulkhead in order to seal all gaps between the bulkhead and fuselage skin. It is not necessary to apply sealant below the floorboard.
 - b. Seal all open holes on face of bulkhead with 3M #612 sealant.
 - c. Reinstall access panels to fuselage.
2. Raise forward end of carpets in crew compartment to gain access to pilot and copilot floorboards.
 - a. Apply a bead of 3M #612 sealant around the heater outlet tube, if installed, that is routed through the floorboard on the copilot side just aft of station 57 bulkhead.
 - b. Install 3" wide cloth or vinyl tape over forward end of floorboards in order to seal all gaps between the floorboards and floorboard support panels.
 - c. Reinstall carpet.
