SERVICE LETTER

No. 784

Piper Aircraft Corporation

Subject: Landing Gear Hydraulic System Refinement

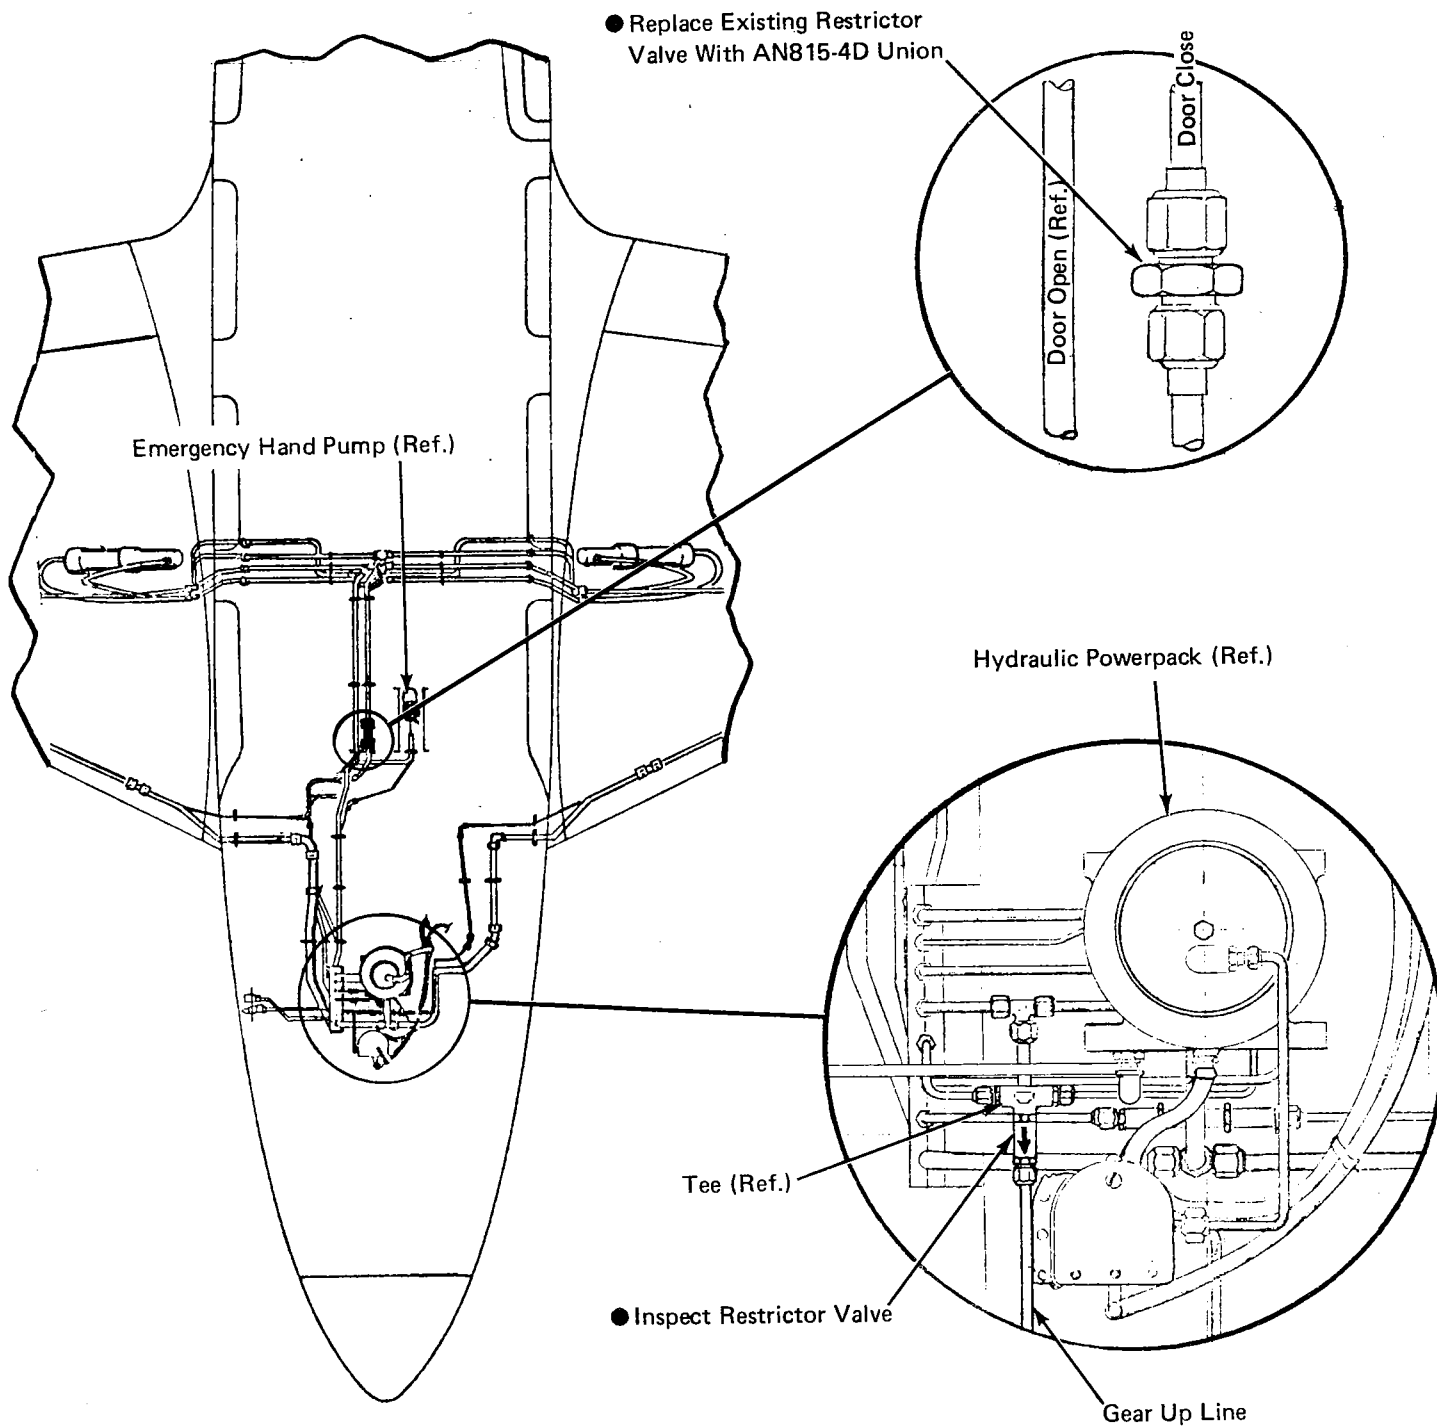
VIEW LOOKING DOWN AT HYDRAULIC SYSTEM

A report has been received from the field describing an incident in which the main landing gear doors on an early PA-31 Navajo failed to open during landing gear extension. This condition was found to have been caused by an internal failure of the "Door Close" hydraulic line restrictor valve. One later model Navajos, this valve was replaced by a union coupling, and replacement is herein recommended for the above referenced aircraft (reference attached sketch/instruction sheet and Material Required No. 1, below).

Further, a second restrictor valve is located in the "Gear Up" hydraulic line (adjacent to the powerpak) and may be subject to the same internal failure, depending on the type of valve installed. This service release recommends an inspection (and replacement, if required - see attached sketch/instruction sheet and Material Required No. 2, below) to refine the subject system on the above referenced aircraft in accordance with current production configuration.

- A. Remove the center floorboard from the forward cockpit to gain access to the hydraulic lines forward of the main spar.
 1. Locate restrictor valve in "Door Close" hydraulic line. Remove valve and install AN815-4D union (P/N 491 050) as shown.
- B. Remove access panels from both sides of fuselage nose section to gain access to hydraulic powerpack.
 1. Locate restrictor valve in tee of "Gear Up" line and inspect to determine manufacturer of valve (company name appears on valve placard).
 - a. If TACTAIR appears on valve, no further action is required.
 - b. If TAVCO INC. appears on valve, replace with new valve P/N 484 459 as shown.
- C. Add hydraulic fluid to the powerpack and bleed the hydraulic system. Check to ensure there are no leaks.
- D. Reinstall fuselage access panels and center floorboard.
- E. Make proper logbook entry of Service Letter 784 compliance.
