Subject: Correction to Service Letter No. 873

SERVICE LETTER

No. 873

Stall Warning System Refinement

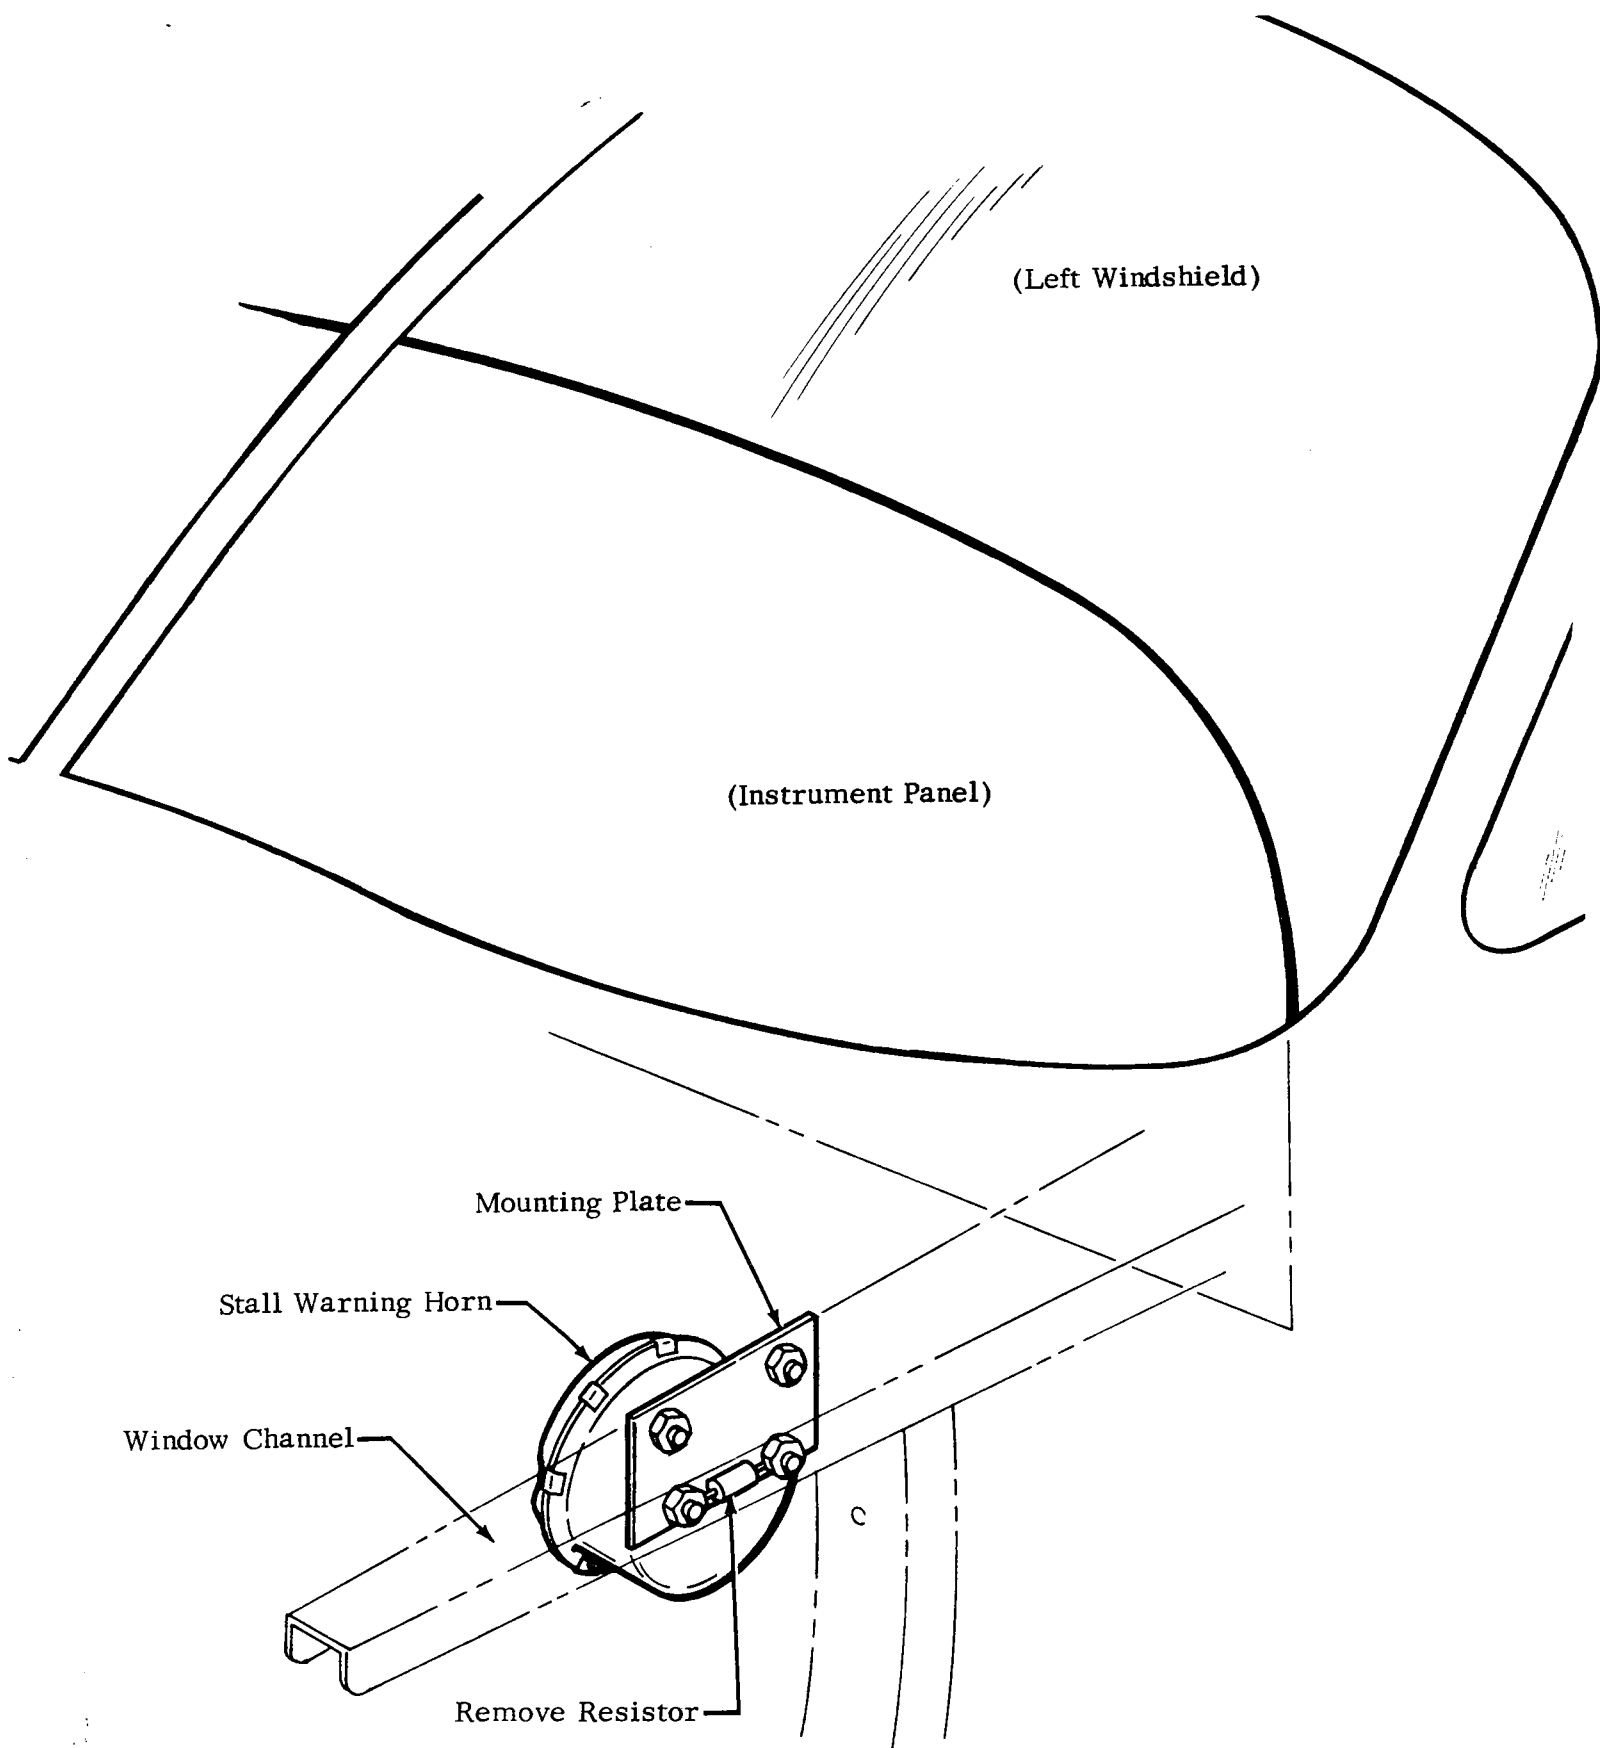
It has been determined that the capacity of ^{not} the resistor mounted across the terminals on the rear of the stall warning horn may meet specification requirements. It has also been determined that the system will function properly without the resistor. On this basis, it is requested the resistor be removed.

1. Gain access to the stall warning horn located on the left window channel forward of the instrument panel in the area of fuselage station 90.5.
2. Remove the stall warning horn.
3. Remove the resistor mounted between the positive and negative terminals of the stall warning horn, and discard the resistor.
4. Reinstall the stall warning horn.
