SERVICE LETTER

No. 874

Piper Aircraft Corporation

Low Fuel Warning Sensor Sealing

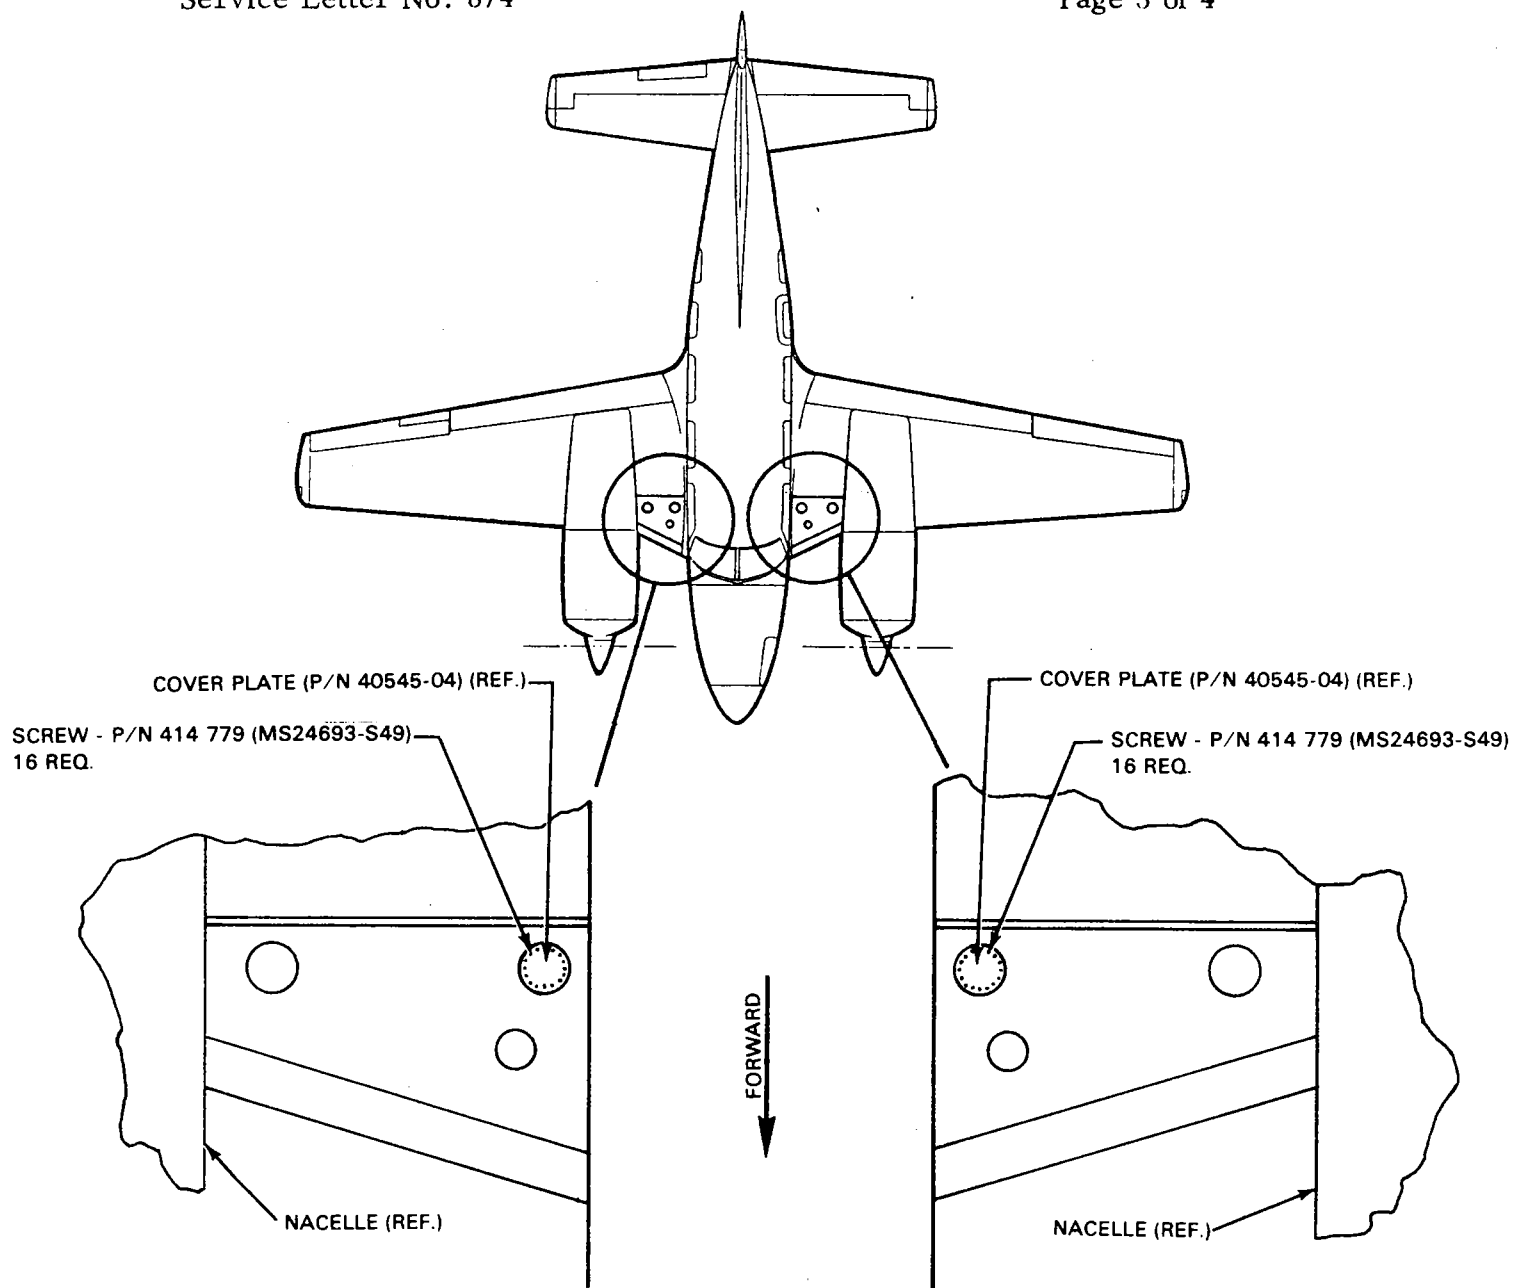
FIGURE 1

Field reports indicate that the possibility exists of fuel seepage from the area of the low fuel warning sensor attachment to the fuel cell. Such a condition, if left unattended, could allow fuel to streak the wing upper surface aft of the fuel warning sensor cover plate.

1. De-fuel the aircraft to obtain fuel level below low fuel warning sensor probe.
2. Remove MS24693-S49 screws and cover plates (Piper Part No. 40545-04) on left and right wings (See Figures 1 and 2).
3. Disconnect sender wire knife splice (See Figure 3.)
4. Remove AN4-4A hold-down bolts and AN936-A416 Washers, and lift sensor (Piper Part No. 54751-02) out of tank (Figure 3).
5. Remove cotter pin and castle nut. Disassemble sensor from fuel cell cover, and remove and discard gasket and AN960-816L washer (Figure 3).
6. Apply MIL-5-8802 B 1/2 sealant (or equivalent) between plate and mounting surface of sensor.
7. Assemble plate on sensor per details shown in Figure 3. It is acceptable to use a combination of light and regular washers to obtain alignment between the cotter pin hole and castellation. Do not exceed 45 in-lbs of torque.
