SERVICE LETTER

879

Piper Aircraft Corporation

Subject: Razor Inverter Replacement

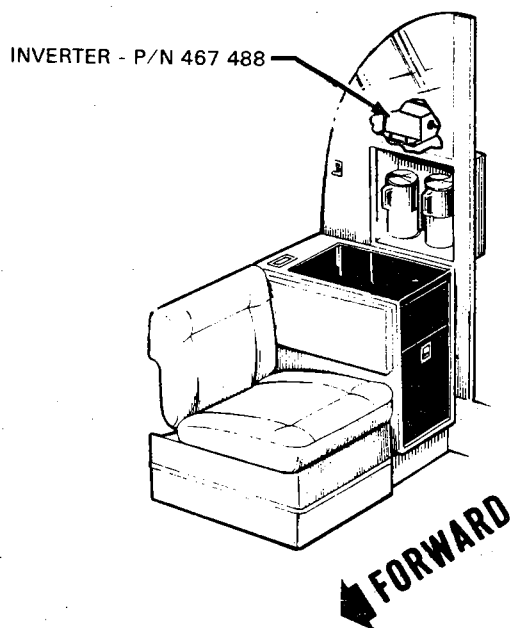
FIGURE 1

In aircraft with an aft cabinet razor inverter, there is a possibility of ADF interference which can result in ADF needle oscillation with the razor outlet switch turned "ON".

1. Gain access to Razor Inverter (Refer to attached sketch).
2. Remove existing Inverter (Piper Part Number 467 145).
3. Install new Inverter (Piper Part Number 467 488).
4. Inspect and insure cabinetry is secure.
5. Make appropriate logbook entry of compliance with this Service Release.
