VSP-29
February 27, 1981

Subject: Avco Lycoming Service Bulletin No. 452
(Air Research Industrial Division Service
Bulletin No. TP60-0121; "Turbo Inspection")

AiResearch Industrial Division Service Bulletin No. TP60-0121; Turbo Inspection.

SUBJECT: TURBO INSPECTION

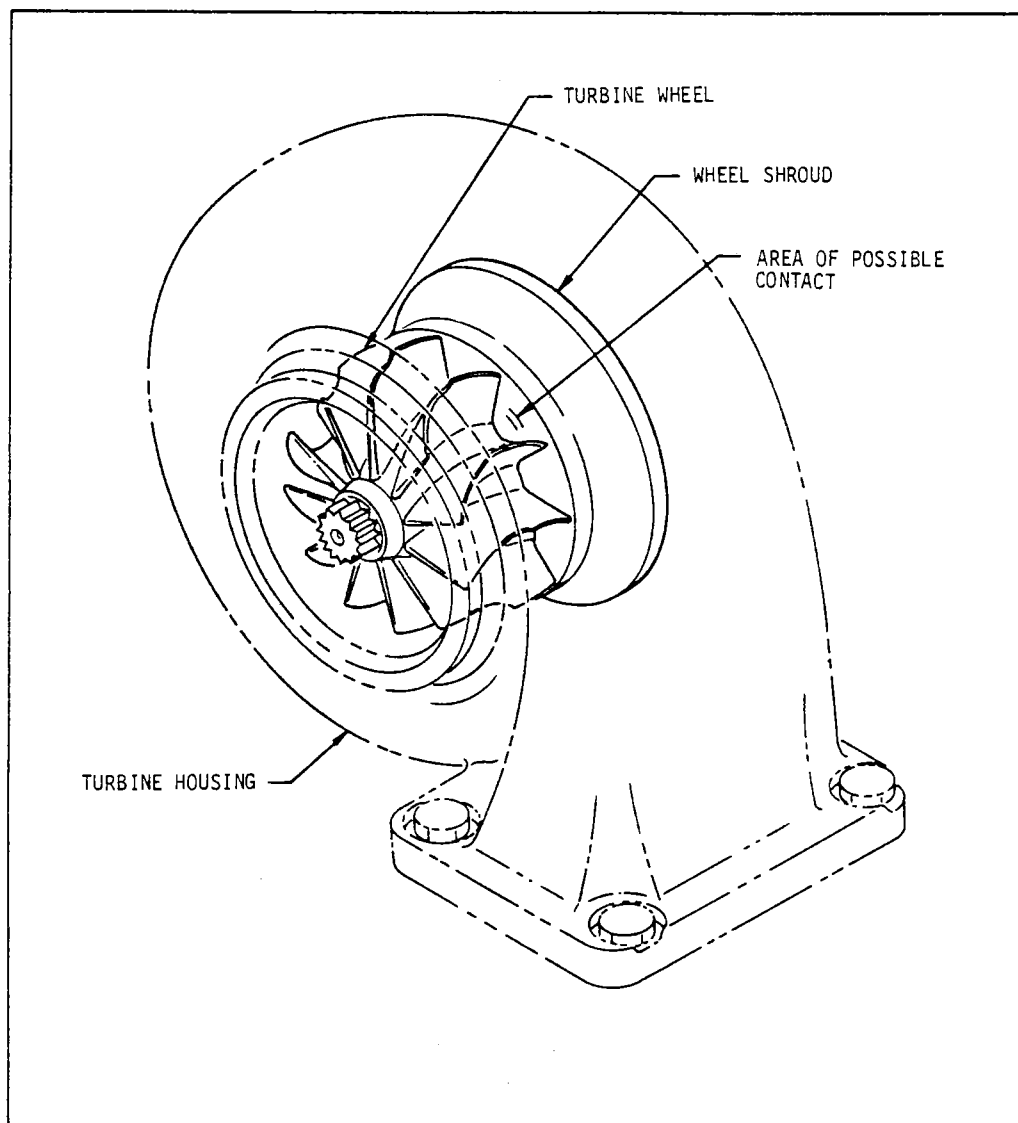
Figure 1. Inspection of Turbine Wheel and Shroud

AiResearch has become aware that under certain conditions it is possible for the stainless steel sheet metal turbine wheel shroud to deteriorate and/or come in contact with the turbine wheel damaging the wheel and shroud. Either condition will reduce the performance of the engine, and if allowed to continue there can be a significant reduction in engine power.

- a. Remove the turbocharger turbine exhaust duct to gain visual access to the turbine wheel through the discharge port of the turbine housing.
- b. Using a small flexible probe light, inspect the turbine blades for signs of damage.
- c. Inspect the face of the shroud (areas shown in figure 1) for signs of damage or contact marks from rubbing against the wheel.
- d. Remove and replace any turbocharger with damaged turbine blades or shroud, or or evidence of turbine wheel rubbing against the shroud.
