VENDOR SERVICE PUBLICATION

SUBJECT: AVCO Lycoming Service Bulletin No. 406, "Romec and Titan Fuel Pump Inspection".

Service Bulletin No. 406
Engineering Aspects are
FAA (DEER) Approved

SUBJECT: Romec and Titan Fuel Pump Inspection

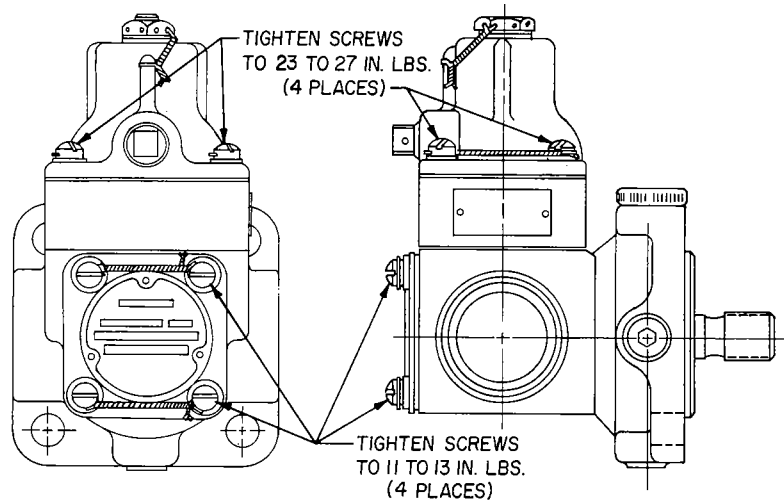
ROME
RG-9080
FUEL PUMPS

Insufficiently tightened cover attaching screws on AN type fuel pumps can be a source of fuel leakage. This condition may occur on new installations due to gasket material taking a set.

1. With a screwdriver, check every screw that is used to assemble the pump. Determine if any are loose, that is if any can be turned within the limits of the lockwire in a clockwise direction, and within the limits of the torque value specified in the following list.
2. If any screw appears to be loose, remove the lockwire and retighten evenly all four attaching screws to the torque value shown in the table.
3. Secure the screws with lockwire as shown in the applicable illustration.
4. Note compliance with this bulletin in the aircraft records.

Romec Series RG-17980 Pumps	26 to 28 inch pounds
Romec Series RG-9080 (adjusting screw cover)	23 to 27 inch pounds
(plate cover)	11 to 13 inch pounds
Titan Pumps	23 to 27 inch pounds
