VSP-30
May 20, 1981

VENDOR SERVICE PUBLICATION

Subject: Bendix Service Bulletins 599A, 609A, 610,
613, 614

SERVICE BULLETIN NO. 599A
(Supersedes Service Bulletin No. 599)
Engineering Aspects are
FAA Approved

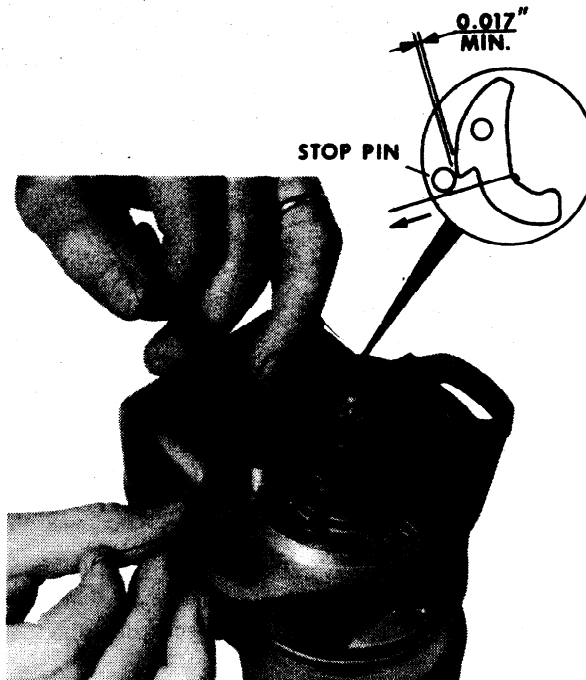
Figure 2. Checking Flyweight to Stop Pin Clearance

c. While pulling flyweight outward, insert feeler gages to measure the clearance between the heel of the flyweight and the stop pin, assuring a minimum of 0.017 inch exists.

d. If less than 0.017 inch clearance exists, this is cause for immediate rejection of the impulse coupling cam assembly, or possibly the entire impulse coupling. Refer to the applicable Magneto Overhaul Instructions for inspection procedures to determine if other impulse coupling parts are still serviceable.

6. If the impulse coupling is found to be unacceptable as a result of any of the preceding checks described, replace the entire impulse coupling assembly or worn parts according to instructions of applicable Bendix publications.
7. When inspection of the impulse coupling assembly is being performed, the stop pins in the magneto flange or housing must also be examined. Visible damage or wear in the area where the flyweight contacts the stop pin is cause for repair or replacement of the magneto, stop pin, housing or flange depending on magneto. (Reference latest revision of Bendix Overhaul Manuals Publication Forms L-205, L-645, L-945 and L-1019.)
8. When inspection procedures outlined in this bulletin have been completed, an appropriate notation must be made in the Engine Log Book referencing magneto serial number.

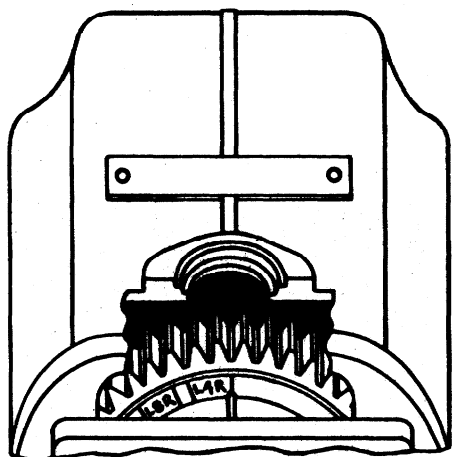
Figure 2. Alignment of Timing Marks on Distributor Gear – 4 Cylinder, Right Hand Rotation

GENERAL INFORMATION:
Field reports indicate that a quantity of remanufactured S-1200 magnetos have been discovered with the large distributor gear mistimed. To avoid damage to the distributor block and resultant ignition difficulty, the magnetos involved should be examined according to the applicable inspection method listed below.

7. If timing marks are not aligned remove magneto from engine and follow instructions in Method "B".

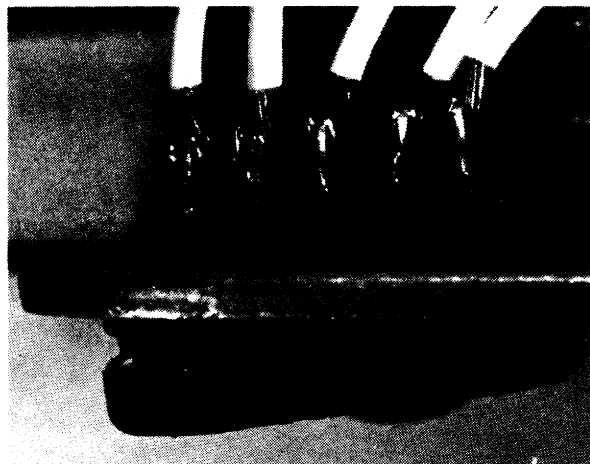
Figure 1 Defect

Bushing (connector), P/N 10-382943, may become loose in the vibrator plate and cause the grounding of both magnetos with possible loss of ignition. See figure 1 (defect).

1. Remove starting vibrator from the airframe.
2. Remove cover to expose the internal surface of the terminal bushing (connector).
3. The surface around the terminal bushing must be clean, dry, free of oil, dirt and grease.
4. Reseat the terminal bushing in the mounting plate to its full extent.
