VSP-35  
April 21, 1982

Global Navigation Service Bulletin No. 21  
(Highly recommends modification to the  
battery charging card which is installed in  
Optional Equipment Unit P/N 10600-2-2XX.)

# SERVICE BULLETIN

## MODIFICATION OF BATTERY CHARGING CARD P/N 11745-1

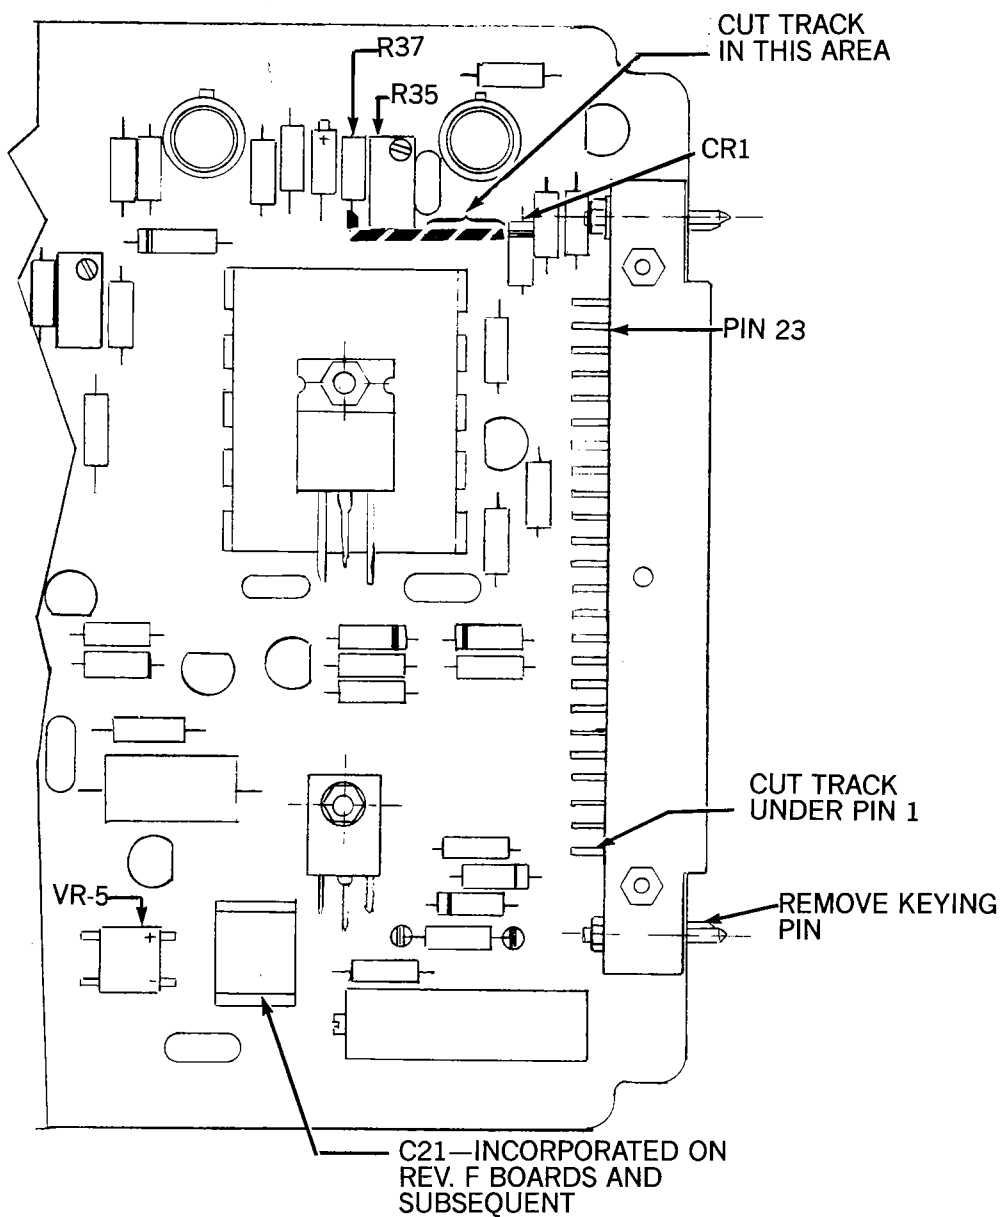
Figure 1 (Sheet 1)

There have been two verified service failures of battery charging card P/N 11745-1 in which the card overheated. Global has identified the cause and is modifying all P/N 11745-1 boards in stock and in service through a field modification program.

- (1) Remove top cover from OEU P/N 10600-2-2XX.
- (2) Remove battery charging card P/N 11745-1 from Slot J2 in OEU.
- (3) Perform the following impedance check using a digital multimeter with a minimum input impedance of 10 Megohms.
  - (a) Connect positive lead to Pin 1 on connector. See Figure 1 (Sheet 1).
  - (b) Connect negative lead to Pin 24 (ground). See Figure 2.

- (c) Check potentiometer R35 for resistance value. Resistance value may either be 20K ohms or 2K ohms. See Figure 1 (Sheet 1).

- (4) Remove keying pin from connector at end adjacent to Pin 1. See Figure 1 (Sheets 1 and 2).

- (5) Cut tracks at location A (under Pin 1) and at location B (on track near R37) with an Exacto knife or equivalent. See Figure 1 (Sheets 1 and 2).

- (7) Perform continuity check between the following and verify that the circuit is open. See Figure 1.
