# SERVICE BULLETIN

488

Piper Aircraft Corporation

Modification of Landing Gear Selector Cable Forward Attachment Pin.

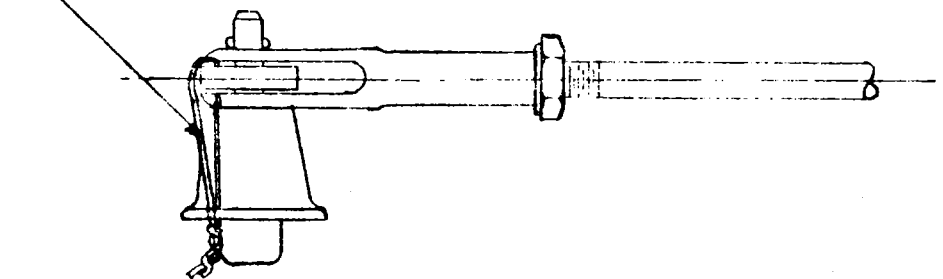
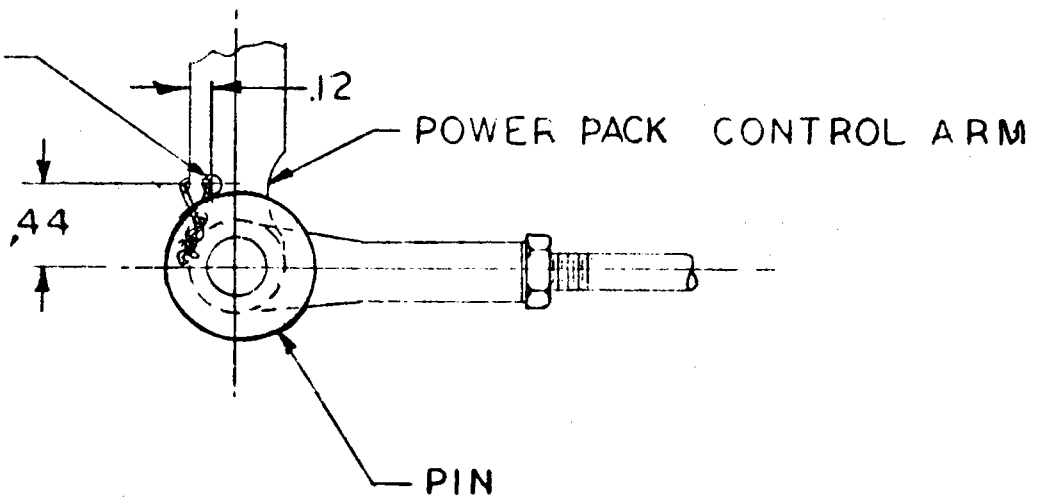
The landing gear selector flexible push-pull control cable assembly is attached to the hydraulic powerpack control arm by a cable attachment pin assembly, Piper part no. 53599-00. A recent incident at the factory indicates that this pin assembly may become disengaged, causing detachment of the landing gear selector cable from the powerpack control arm, with subsequent loss of landing gear (retraction/extension) system control.

MS20995C41 LOCK WIRE

.062 HOLE

5. Safety with approximately three inches of MS20995C41 lock wire (.041 stainless steel) through the hole in the arm and existing hole in pin knob per attached sketch.

Wrap lock wire around arm on side opposite from cable, to prevent interference with cable clevis during normal operation.
